Controlled Load Tests on a Four  
Girder Steel Bridge

A Thesis  
Presented for the  
Master of Science  
Degree  
The University of Tennessee, Knoxville

Michael David Sanders

May 1994

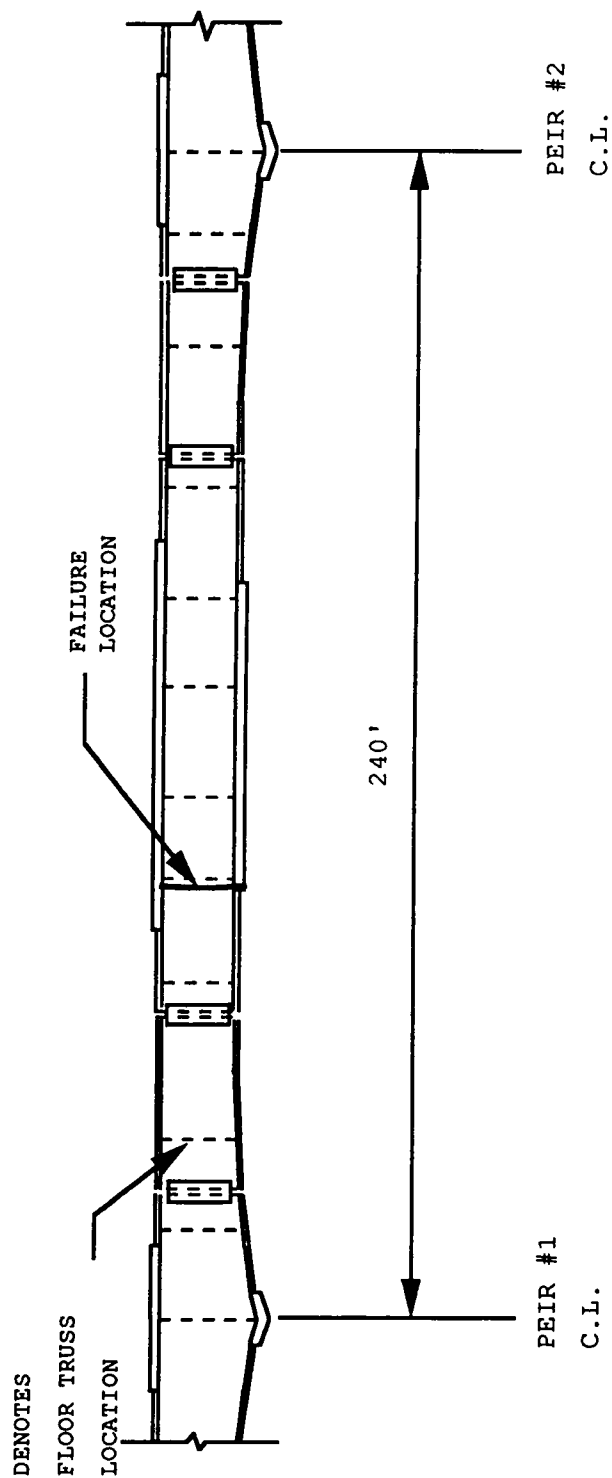
Figure 1.5 - Elevation of Girder Number 4 in Span 2

In January 1992, the Tennessee Department of Transportation discovered a fatigue failure in the outside girder on the east bound lane (girder number 4). The fracture was located near the one-third point of the 240 foot span between piers one and two directly over the main channel of the river (Figure 1.5). The fracture extended almost the entire depth of the member. A large gap was present at the bottom flange of girder number four. The outside two lanes of the bridge were immediately closed to traffic on each side. Measures were then taken to repair the damaged girder. A retrofit of the cantilever to girder web connection was also implemented. This was intended to eliminate the out of plane distortion of the girder web which initiated the failure. In January 1993, a research project was begun by the University of Tennessee Transportation Center to investigate the Holston River Bridge fatigue failure. This Project had four objectives which were spelled out by a proposal to the Tennessee Department of Transportation. These objectives were (1) determine the

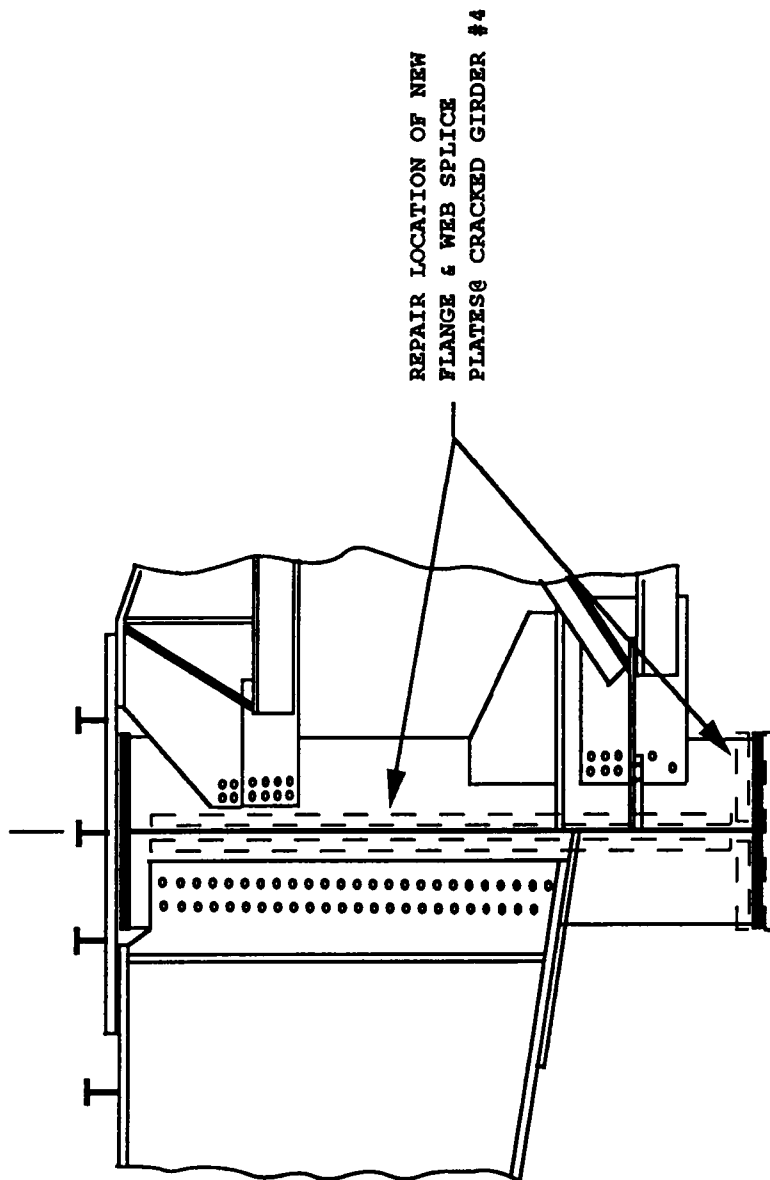
Figure 3.1 - Repair Plates at Failure Location

Immediately after the discovery of the fracture and closing of the outside traffic lanes, actions were taken to repair the damaged girder. Several large high strength bolts were attached to the bottom flange of the girder. Four steel girders were placed on the bridge deck directly above the fracture location. These girders were connected to the bridge girder with hanger rods. Hydraulic rams were then used to jack the girder back into place. While lifted from above by the hanger rods the bolts on the bottom flange were tightened. The gap in the girder was closed as much as possible by this method. The girder was then welded back together. Splice plates were added to further strengthen the repair. Plates were bolted to both sides of the bottom flange and to both sides of the girder web (Figure 3.1). This method did reduce the deflection of the fractured girder; however, it did not completely eliminate it. The deflection of the bridge deck is still quite noticeable. During rainy weather this is more evident due to the ponding of water directly above the fracture location.

This ponding however is confined to the shoulder lane and is most likely not significant enough to cause any problems to the structure or to traffic.

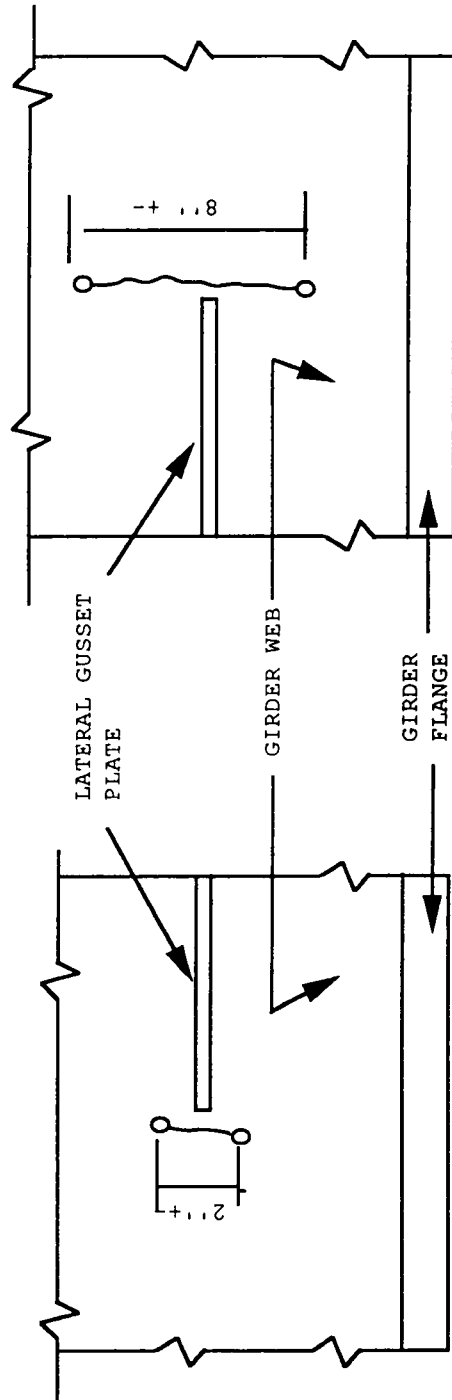
Figure 3.2 - Fatigue Cracks and Retrofit Holes at Ends  
of Lateral Gusset Plate on Interior  
of Girder Number 4

After the repair of the girder fracture was complete, additional repair and retrofitting of the bridge began. Other cracks were present in the girder web besides the main fracture. Adjacent locations were also found to have damaged components. This damage included cracks in gusset plates of the floor truss at the fracture and damaged connections at adjacent floor trusses. Holes drilled to arrest the growth of cracks near the fracture location are visible (Figure 3.2). Bent gusset plates and loose bolts are also still evident at adjacent floor truss locations.

A retrofit of the cantilever to girder flange connection was used to eliminate the situation that was believed responsible for the fracture in girder number four. At the time of the failure it was believed to have been initiated by out of plane forces exerted on the girder web at the bottom of the cantilever to girder connection. Before retrofitting, the bottom flange of the cantilever bracket was connected to the girder web at a point approximately one and one half feet above the

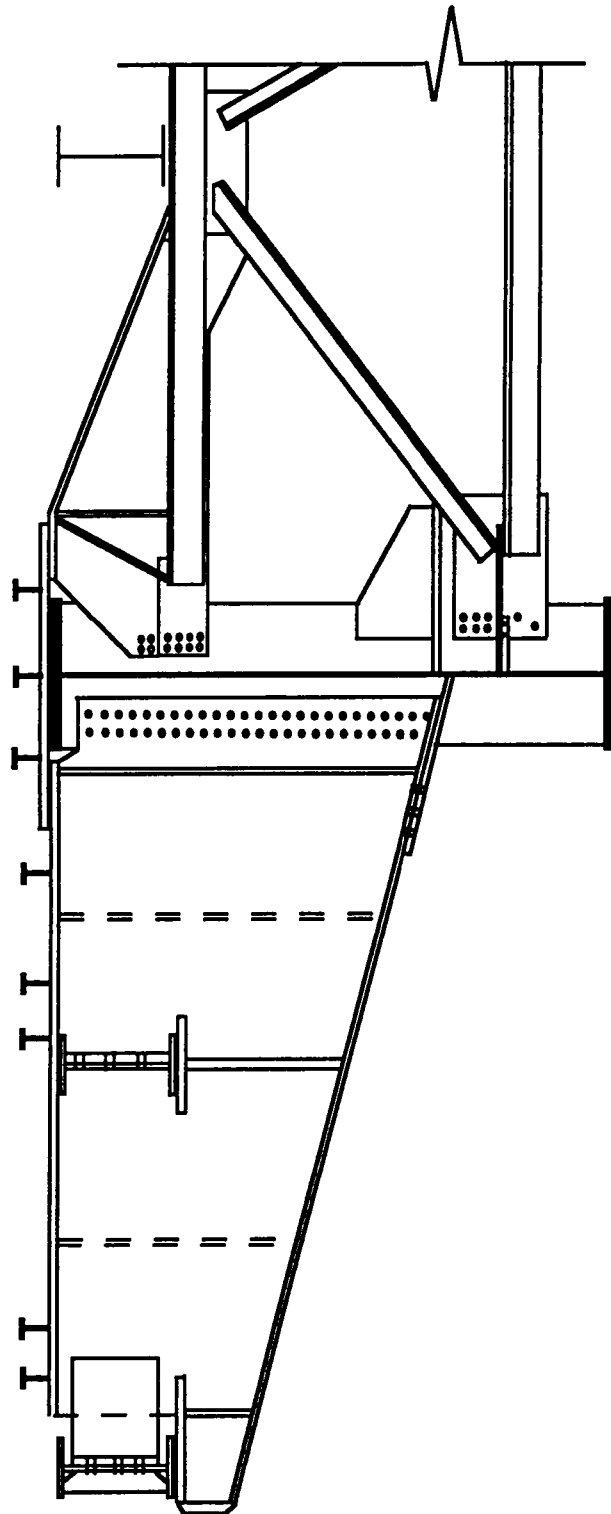
Figure 3.3 - Cantilever to girder Connection Prior to Retrofit

bottom floor truss to girder connection, located on the opposite side of the girder web (Figure 3.3). The retrofit consisted of attaching a new plate to the bottom flange of the cantilever bracket. The new plate extended the bottom of the cantilever to girder connection down one and one half feet. The bottom gusset of the retrofit plate now connects to the girder web directly opposite the bottom floor truss to girder connection (Figure 3.4). The intent of this measure was that any forces from the cantilever would now be transferred directly into the floor truss. With the girder web stiffened at the bottom cantilever connection by the floor truss, out of plane distortion is thereby greatly reduced. Another consequence of the retrofit is that the bottom lateral gusset plate of the new plate backs up the web gap created on the opposite side of the girder web at the floor truss connection. This web gap situation, not the cantilever connection, was later determined to be the most probable cause of the fatigue cracking that initiated the fracture in girder number four. The specifics of this web gap detail are discussed in depth in the next section of this chapter.

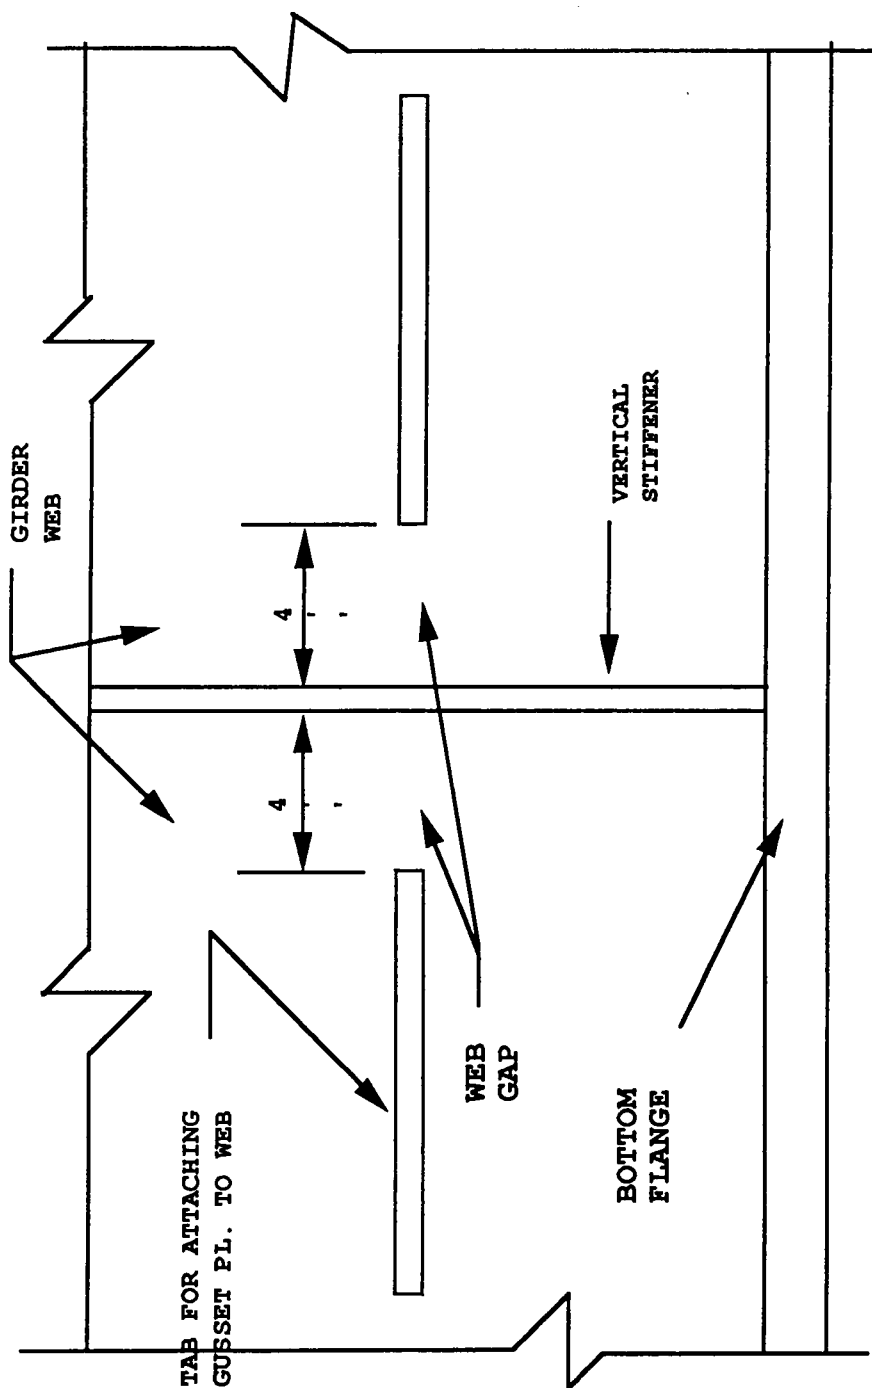
Figure 3.8 - Web Gap on Flange of Exterior Girder

The bottom connection of the floor truss to girder web connection is a major point of interest in this project. The lateral gusset plate that serves to connect the bottom chords of the truss and the bridge's diagonal X-bracing to the web of the girder is notched to accommodate the vertical stiffener located on the web (Figure 3.7). This detail solves the problem of intersecting welds at the gusset stiffener intersection. The gusset is bolted to tabs that are welded horizontally along the web of the girder on each side of the vertical stiffener. These tabs end four inches from the vertical stiffener. This forms a four inch web gap on each side of the vertical stiffener (Figure 3.8). This web gap is a length of unstiffened web that is subject to out of plane distortion. Forces introduced by the floor truss tend to pump the girder web in and out. When out of

plane distortion occurs, this portion of the web behaves similarly, to a beam with two fixed ends, put into double curvature, and having a length of four inches. This detail is classified as a category E, but considering the small gap involved, performance may be worse than that of category E (16). Small out of plane distortion over this short distance can result in high stress ranges within this gap.

This out of plane distortion within the web gap was determined to be the most likely cause of the girder failure. During the last thirty years hundreds of bridges have developed fatigue cracks to some degree. The largest category of this cracking is a result of unequal out-of-plane displacements across small sections of girder webs(6). Cracking usually extends along the weld toes and perpendicular to maximum stresses(11). In a case such as this, where a horizontal web gap is present, the problem is particularly serious. In-plane bending stresses are in the same direction as the secondary out-of-plane stresses that cause the cracks. Cracks due to the out-of-plane stresses then tend to form perpendicular to the flexural bending stresses (i.e. vertical). With the crack oriented in this manner it would continue propagating due to the cyclic flexural

stresses, resulting in fracture of the girder. In this situation the growth of the crack could be relatively rapid(11).

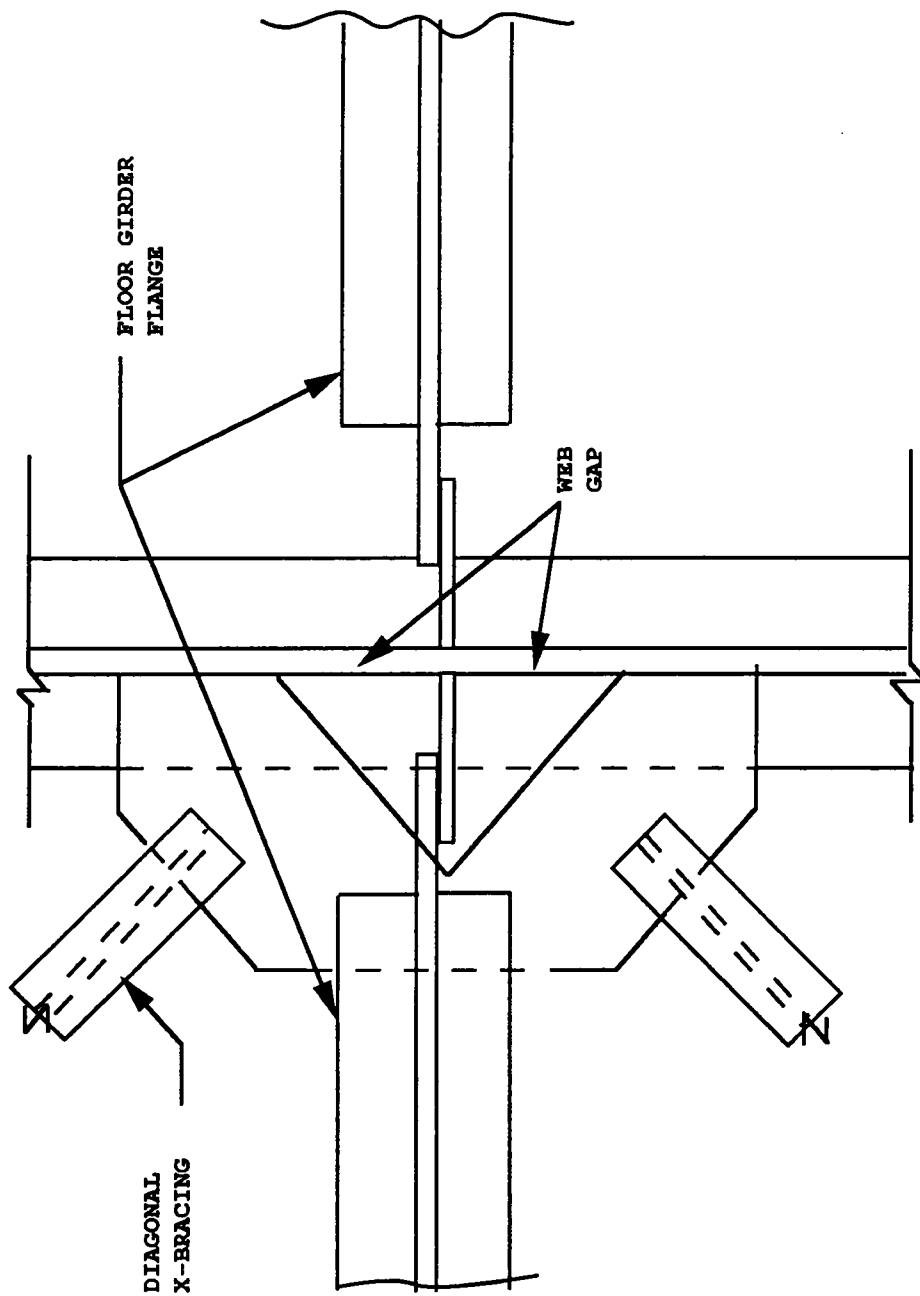
Figure 3.9 - Web Gap at Floor Girder to Main Girder Connection

A similar detail is also present at the floor girder locations (Figure 3.9). At the connection of the floor girder to the fascia girders the bottom cantilever gusset plate backs up the web gap. However, at the floor girder to interior girder connection the web gap is unstiffened on the other side of the web. This web gap was instrumented in order to determine if high out-of-plane stresses were present. In addition to the web gap, strain gages were also placed on the web to detect any out-of-plane distortion at the end of the lateral gusset plate.

Coped flanges of floor girders have been developing cracks in other structures. The floor girders on this bridge have their flanges terminating near the end connections to the girders. The termination of the girder flange to web weld at this point results in a

category E detail(6). With both flanges removed the section modulus of the girder is greatly reduced. This can increase the bending stress in the web plate by 200 or 300 percent at these locations (6). These factors combine to form a location prone to fatigue cracking. The floor beams, therefore, were examined in detail during this study.
