# **PROBLEMS WITH EXPANSIVE PYRITIC SHALES IN EAST TENNESSEE**

**Department of Civil and Environmental Engineering,  
The University of Tennessee, Knoxville, TN  
Fall 1998**

**Submitted for the University Honors Program  
Dr. Thomas Broadhead, Director**

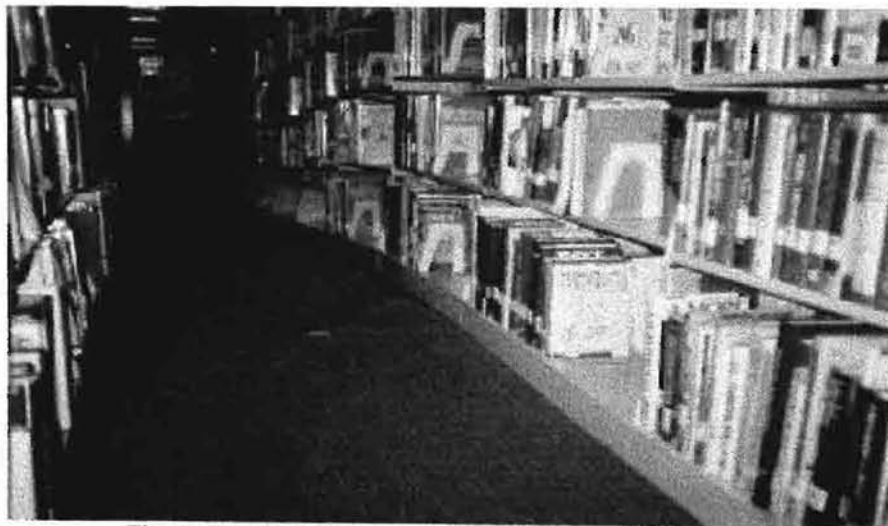
Fig. 1. Heaving of floor under bookshelves at JC library

The library was constructed in 1979, and signs of floor slab displacement (see Fig. 1) in the northern section of the building were detected within one year (personal communication, Tim Siegel 1998). An investigation was conducted in 1982 by Barge, Waggoner, Sumner, & Cannon, but it was concluded that instability of foundation materials was the cause. The floor slab was repaired, but over the next few years,

cracking and displacement of the floor slab continued to occur, and signs of heaving spread to the southern section of the building. In 1989, another investigation was initiated by Westinghouse (now Soil & Material Engineers). Preliminary data collection included the excavation of test pits, sampling from boreholes, a survey of building elevations to note changes from the investigation in 1982 to the current investigation, and the installation of thirteen crack gages. In most areas, a 0.3-foot crushed limestone base and a 3- to 6-foot shale fill, on top of black shale bedrock with thin limestone layers, was discovered under the floor slab (Westinghouse 1990). Though all soil and rock materials were wet, no groundwater was encountered in the test pits. It is likely that springs and seeps through the bedrock are present under the building. Several geotechnical tests were conducted on collected samples, including grain size analysis (ASTM D422, D1140), Atterberg limits (ASTM D423, D424 method), unit weight, moisture content (ASTM D2216), Standard Proctor moisture-density relationship (ASTM D698), Standard Proctor one-point verification, and the consolidated-drained direct shear test (EM 1110-2-1906). In addition, an x-ray diffraction analysis was conducted on samples of the bulk shale and scrapings from joint surfaces, which all showed the presence of gypsum crystals. A total sulfur analysis was also conducted on several samples, which showed a sulfide sulfur content of 0.08–0.63 % and a sulfate sulfur content of 0–0.49 %. Because a shale sample with as little as 0.1% sulfide sulfur is considered expansive and 1–2% is considered highly expansive, it is evident that there is significant expansion potential in nearly all areas where samples were taken. Further analysis of this site showed that the dead load pressure on the column footings was 400–1600 psf, much lower than potential heave

At the conclusion of the investigation, the cause of heaving was determined to be the growth of secondary minerals (mainly gypsum) in the shale fill and bedrock from the oxidation of pyrite. The general heave rate was determined to be 0.25 inches per year (Westinghouse 1990). Some of the most noticeable structural damage included heaving of the floor slab of 4–5 inches in some areas, heaving of the column footings of approximately 1.2 inches, cracking of the brick veneer on the outside of the building, a 1-inch displacement of the sidewalk, mis-aligned window sills and door frames, and bulging of the walls. Photos of typical distress are shown in Figures 2-5. Though the retaining wall showed no damage, it was thought that it might later experience creep-like translation or rotation due to gypsum formation in the backfill.

- Option 1.) Remove current floor slab and install a structural floor system with an 18 inch crawl space,  
Apply a bitumen coating to bedrock surface,  
Use existing footings or install intermediate footings with a 10 ksf design bearing pressure (dead load),  
Install resin-anchored rock bolts with a 10 ksf prestress in areas where dead load is not 10 ksf,  
Replace backfill of retaining wall with non-calcareous stone wrapped with filter fabric,  
Install rock bolts in the footing of the retaining wall.  
Estimated Design Life = 50 years  
Estimated Costs = \$ 700,000 (not including design fees)

- Option 2.) Temporarily repair areas with most damage and threat to the public, including floor slab, partition walls, and ceiling, until a new library can be constructed
- Estimated Design Life = 3 – 5 years  
Estimated Cost = \$ 15,000 (not including cost of new library)
- Option 3.) Maintain current building through periodic maintenance construction  
Conduct procedures in Option 2.) with a 3 – 5 year frequency.  
Estimated Design Life = 10 – 15 years  
Estimated Cost = \$ 15,000 every 3 – 5 years

In the end, Option 3 was chosen for maintenance of the current building until the new, \$12 million library could be built 3 blocks away.

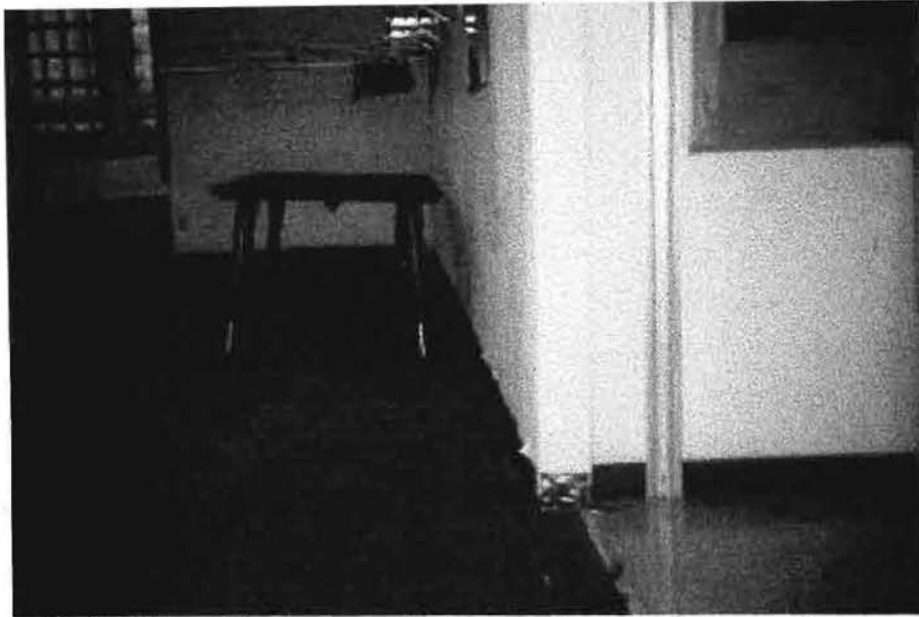
Fig. 2. Tilting of floor and separation between floor and wall in recreation room

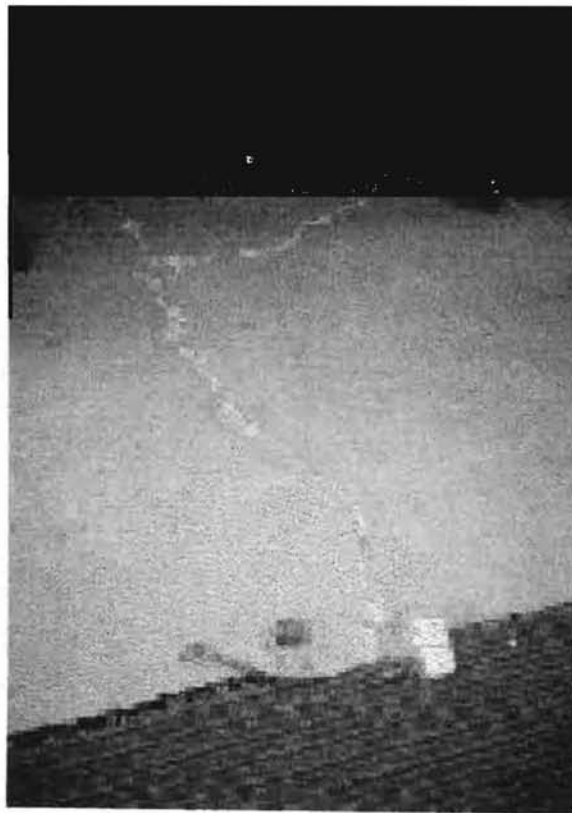
Fig. 3. Cracking of floor slab in staff area

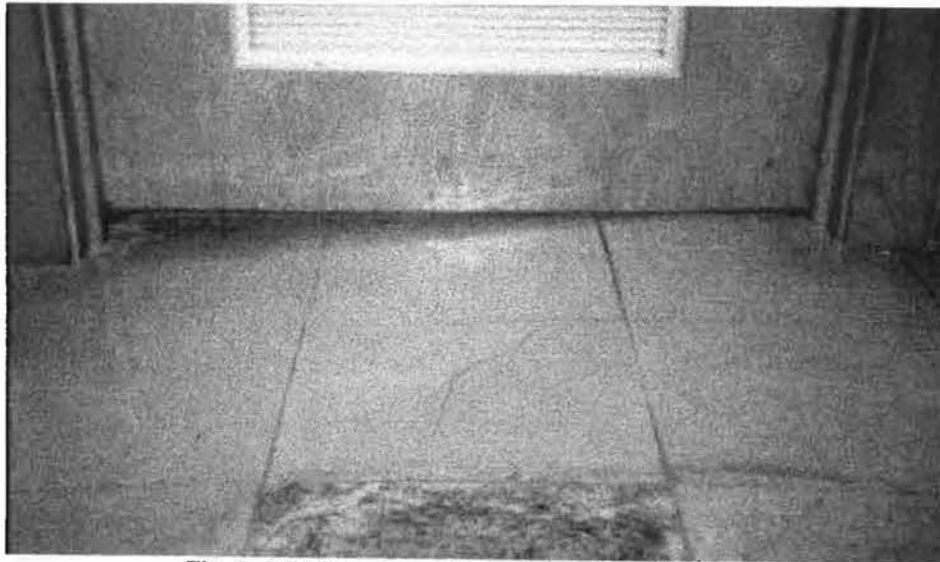
Fig. 4. Misaligned door frame due to heave in floor slab

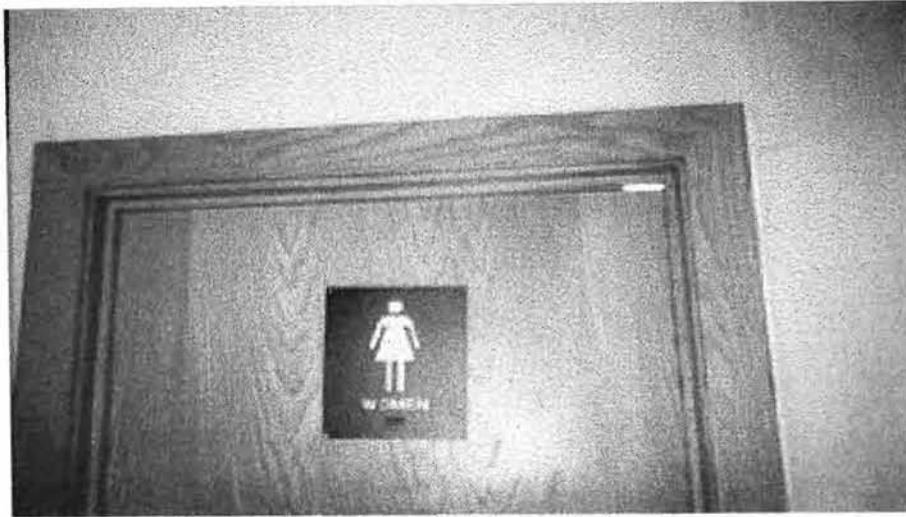
Fig. 5. Misaligned door frame at women's restroom

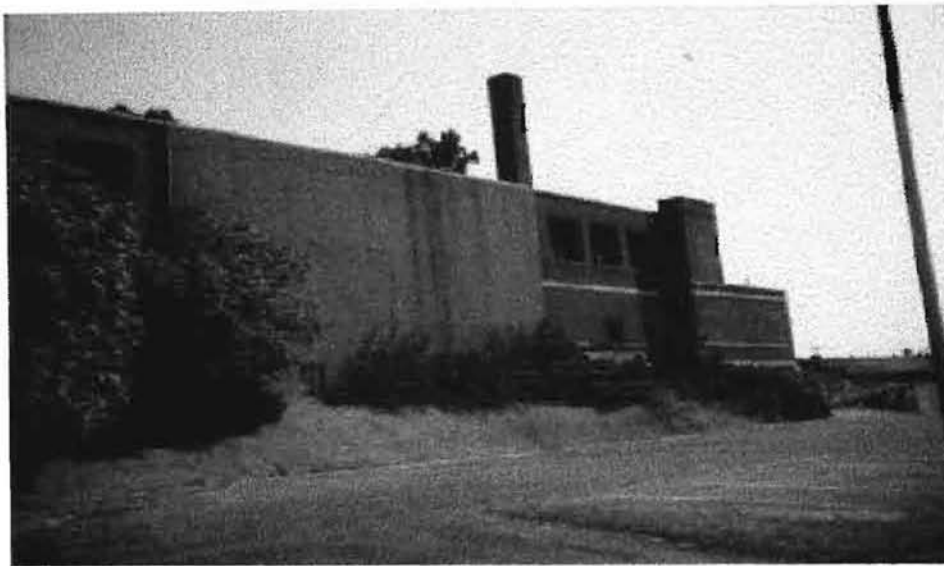
Though it is unknown when structural distress was first noticed, the first major effort to correct the problem was the installation of two reinforced concrete buttresses in the storage room at basement level in 1955. In 1978, an investigation was initiated by Soil and Material Engineers (S&ME) for the City of Johnson City in order to examine the continuing structural distress, including the severe cracking in one of the buttress walls.

Fig. 6. Gymnasium of the Old Southside Junior High School, view towards SE

Though damage to the west wall was attributed to instability of the wall footing, the primary cause of damage to the south wall and southeastern corner was excessive lateral pressure in the shale backfill due to gypsum growth. The lateral stress on the wall was inducing bending stresses approaching the wall's moment resisting capacity. It was

- Option 1.)     Remove the locker room floor slab at least 12 feet back from the wall
- Remove existing backfill, replace with #67 stone compacted in place, and install a drain pipe
- Install a tieback system at mid-height of the wall, anchored in shale and extending through wall and connected to a whaler

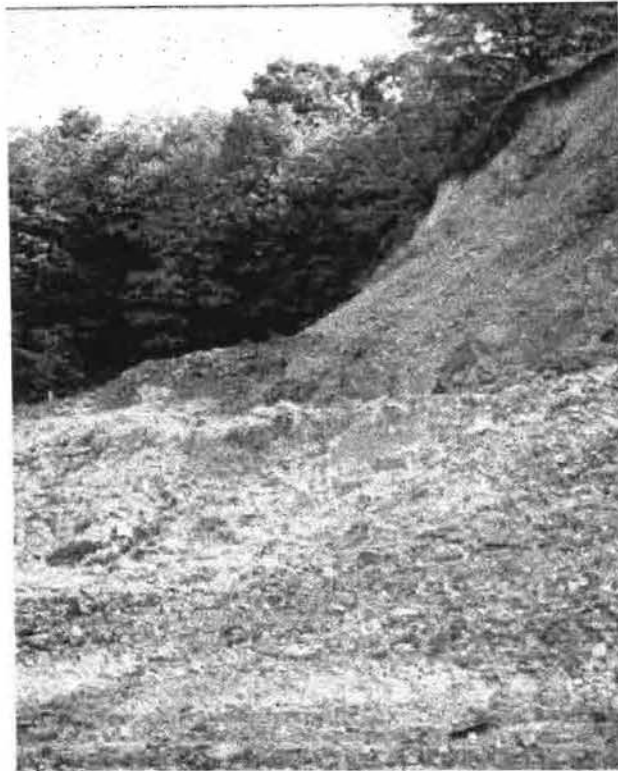
Fig. 7. Steep shale embankment adjacent to gymnasium

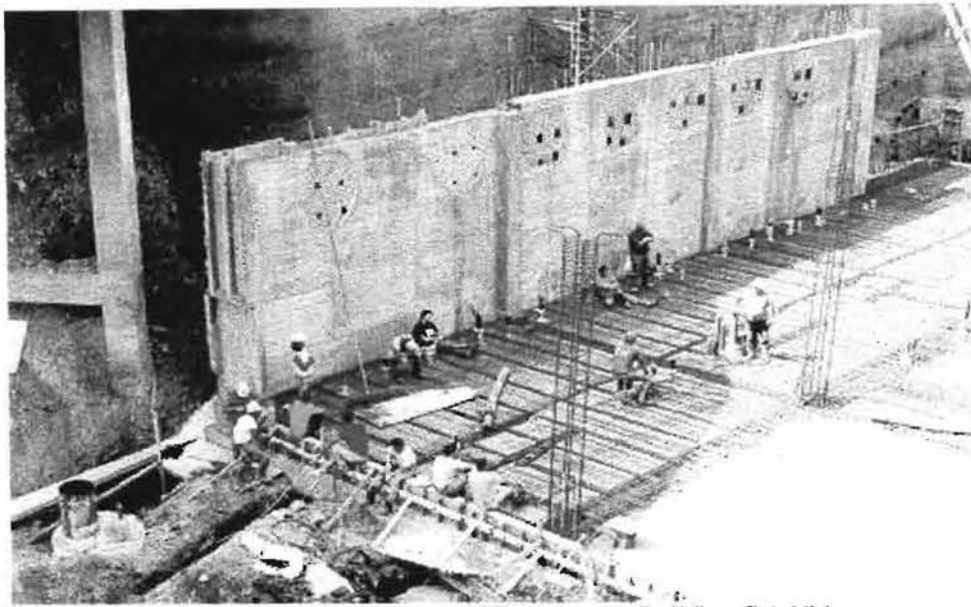
Fig. 8. Carton forms in the structural floor system, Building C Addition

- Option 1.) Seal exposed shale bedrock with asphaltic coating immediately after final cut elevation
  - Install resin-anchored rock bolts to minimum 10 ksf prestress
- Option 2.) Construct a structural floor system with crushable cells (see Figs. 8-10)
  - that allow for 8 - 10 inches of expansion under the floor slab
  - Place a vapor barrier between the cells and shale layer
  - Cover fresh shale surface with clayey soil or heavy polyethylene sheeting to prevent sulfate attack on floor slab
  - Use Type V concrete in all caissons to prevent sulfate attack
  - Install resin-anchored rock bolts to 10 ksf prestress

Ultimately, a structural floor system was constructed for the Building C addition, and the lower level of Building D was paved with asphaltic concrete. Rock bolts were installed in both areas, and Type V sulfate-resistant concrete was used in the caissons and footings (personal communication, J.M. 1998). To date, these areas have experienced no structural distress.

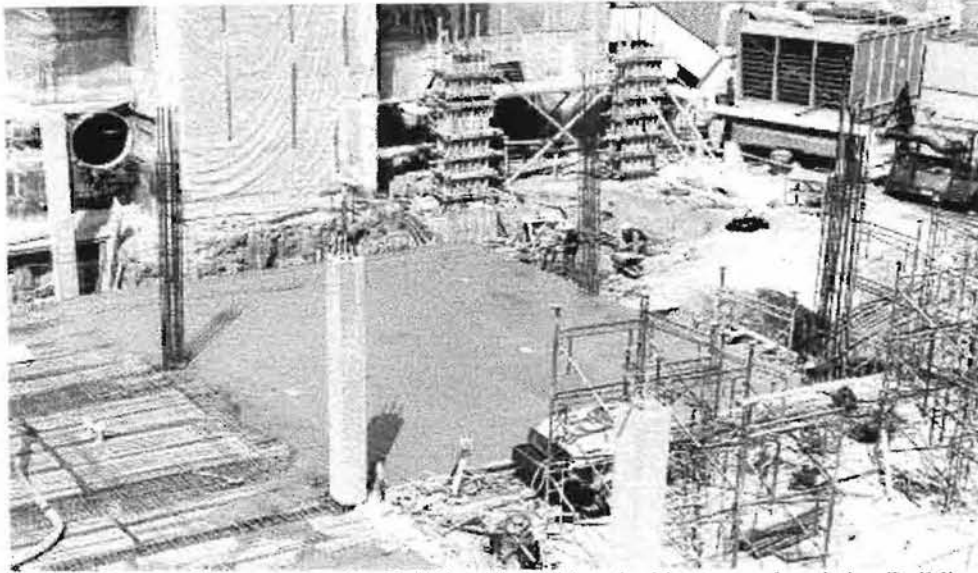
Fig. 9. Structural floor system for Building C Addition, looking towards existing Building

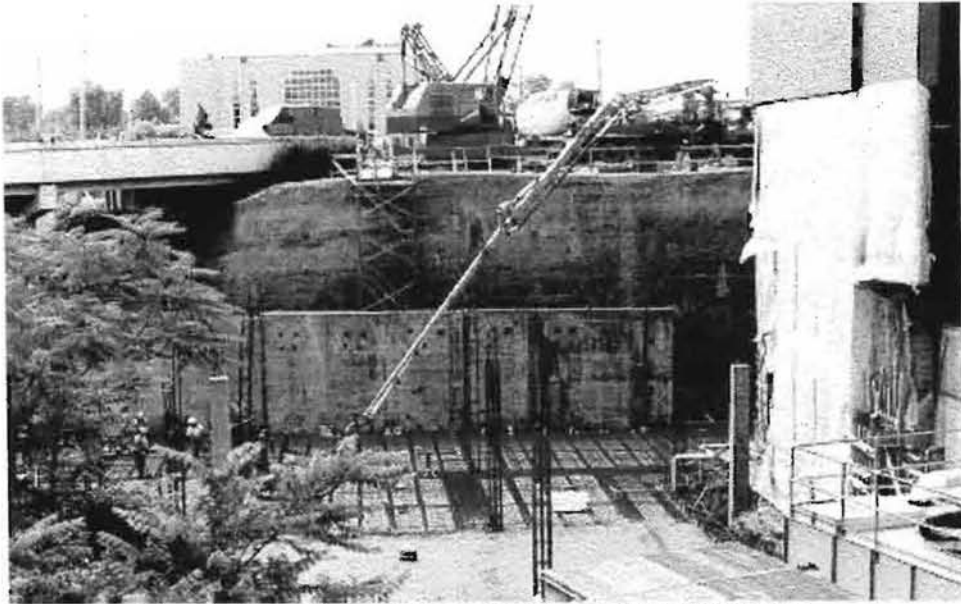
Fig. 10. Excavation and floor system for Building C Addition

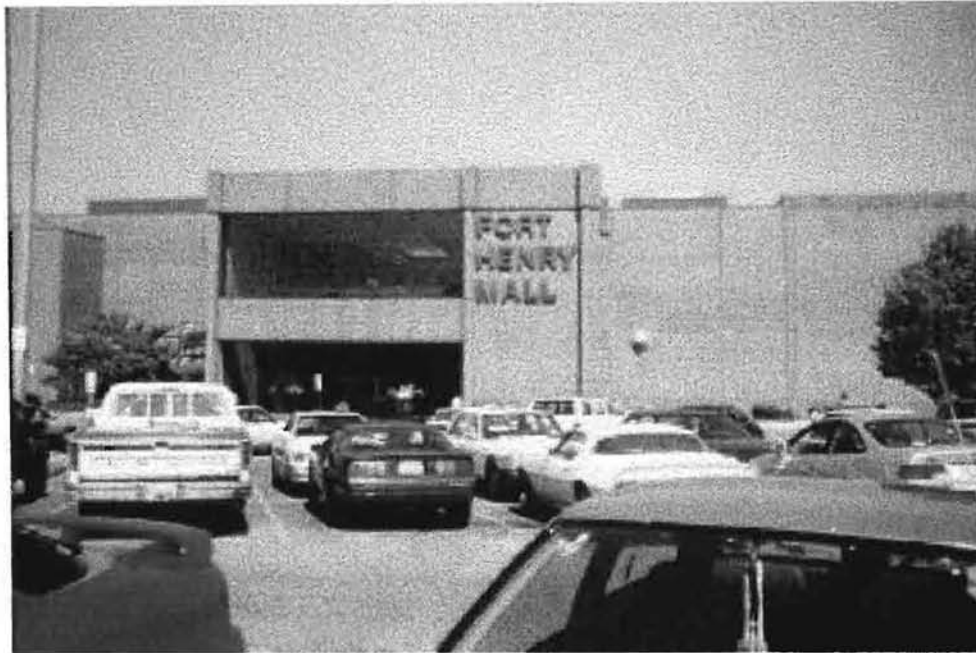
The Fort Henry Mall is located at the intersection of Fort Henry Drive and Memorial Boulevard in Kingsport (see Fig. 11). Heaving of the floor slab and buckling of partition walls were noticed near the movie theater lobby, a Naturalizer Shoes store, and a Lens Crafters store of Fort Henry Mall in the early 1990s, and investigations were conducted in early 1992 and 1993 by S&ME (S&ME Job 1401-93-022-A). Based on visual observations, heave had reached one to two inches in some locations. This heaving resulted in broken floor tiles, mis-aligned doors, aesthetic problems, and possible unsafe walking conditions. During the investigation, it was determined that at some point, pumps were installed in a corridor behind the movie theater screens in order to prevent flooding of this area during periods of elevated water table. The pumps now maintain the

Fig. 11. Fort Henry Mall, main entrance

Borings were drilled at the site, and hard, black, calcareous shale was encountered immediately below the vapor barrier and base course of crusher run. Total sulfur analysis and bacteriological testing were conducted on samples; the percentage of sulfide sulfur in the samples ranged from 0.603 to 0.874 %, while the percentage of sulfate sulfur ranged from 0.089 to 0.302 % . As was expected, more oxidation and therefore higher sulfate sulfur content was encountered at higher elevations in the shale. From these values, the theoretical remaining heave would be 8 to 15 inches, which could occur over several decades. Apparently, heaving has occurred and is expected to occur only in the floor slab areas, not in the column footings where loading is sufficient to counteract the heave (S&ME Job 1401-93-022-A).

- Option 1.) Remove the damaged floor slabs  
Install a structurally-supported slab with rock bolts
- Option 2.) Install rock bolts directly through the floor slab
- Option 3.) Conduct minor repair on floor slab  
Saturate shale with water directly under slab
- Option 4.) Inject potassium hydroxide to kill bacteria and slow reaction
- Option 5.) Maintain current floor slab until extensive repairs can be conducted in the future.

Option 1.) and 2.) were perhaps the most expensive and disruptive practices, but Option 2.) was highly recommended due to the documented success of rock bolts. Immediate repair included grinding down discontinuities in the floor slab and tiles, and leaving a space between the top of damaged walls to allow for movement without buckling. Rock-bolting was chosen as a long-term repair, with a recommended installation depth of 10 feet and a lateral spacing of three to four feet (S&ME Job 1401-93-022-A). To date, no significant heaving problems have been noted.

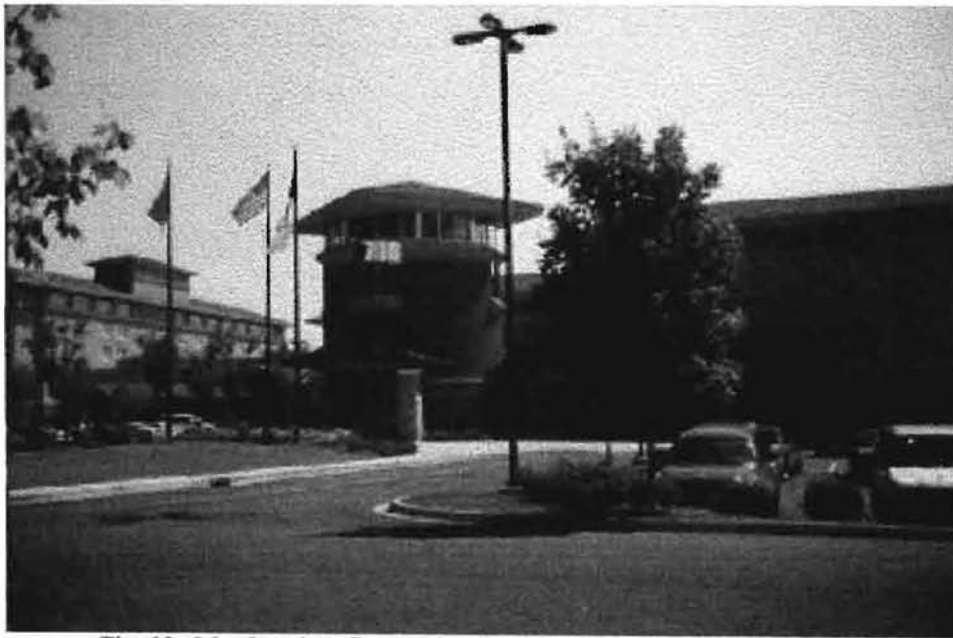
The Meadowview Convention Center and Hotel is located on Meadow View Parkway, directly off Exit 52 of I-181 (see Fig. 12). Construction of the facility began in 1995, and by this time, geotechnical engineers in East Tennessee had become much more familiar with pyritic shale problems. In the preliminary design stage, geotechnical exploration showed that black, unweathered, Sevier shale was present at the foundation and/or floor slab subgrade elevation. Therefore, preventative measures were taken to insure no structural distress would occur (personal communication, Tim Siegel 1998).

Fig. 12. Meadowview Convention Center and Hotel, main entrance

0.447 to 0.515 %, which on the basis of laboratory tests, classified the shale as marginally expansive. However, an excavation of 3 to 12 feet uncovered hard, unweathered shale in the basement and escalator pit area, and the sulfide sulfur content there was found to be 0.703 % (S&ME Job 1401-92-390-G). Because this area was particularly susceptible to expansion, S&ME recommended that rock bolts, pre-stressed to 10 ksf, be installed in the shallow foundations. In addition, S&ME recommended that crushable cells that allow for 8–10 inches of vertical heave should be placed beneath the basement floor slab (personal communication, Tim Seigel 1998).

Ultimately, the installation of rock bolts was determined to be too expensive. Instead, the initial site grade was raised 4 feet in order to build the center on the more weathered shale layers and a floor system was constructed in the basement and escalator pit areas. The pit was built on six piers, and cardboard forms were placed under the footing to allow for up to 10 inches of expansion (personal communication, Jim Belgeri 1998). These preventative measures appear successful; no structural distress has been observed.
