IDENTIFICATION OF TRAFFIC CONTROL PROBLEMS  
IN HIGHWAY CONSTRUCTION ZONES

A Thesis  
Presented for the  
Master of Science  
Degree  
The University of Tennessee, Knoxville

Danny Ray Middleton  
March 1979

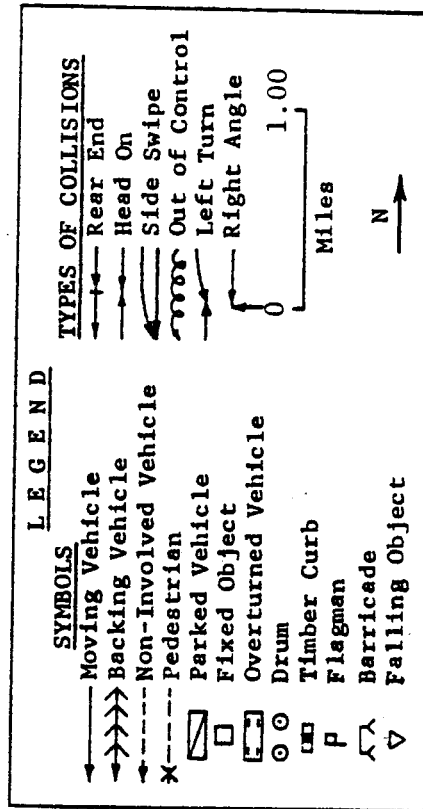
Figure 3-3. Collision Diagram--August 4, 1975 to March 31, 1976.

A few problem areas related to inadequate traffic control within the construction zone were either stated or implied in the accident reports, in the collision diagram or in the Special Provisions and have been discussed below. Specific details of traffic control were not available concerning all problem areas, thus limiting any effort to achieve a thorough evaluation. Accidents referred to in this discussion correspond to similarly numbered accidents in the Construction Related Accident Listing (Table 3-1) and in the Collision Diagram (Figure 3-3).

In accident number two, the out of control vehicle struck the parked equipment and thus possibly increased the severity of the accident. The equipment should have been parked further off the roadway even though sufficient advance warning was apparently given to approaching motorists concerning the detour ahead.

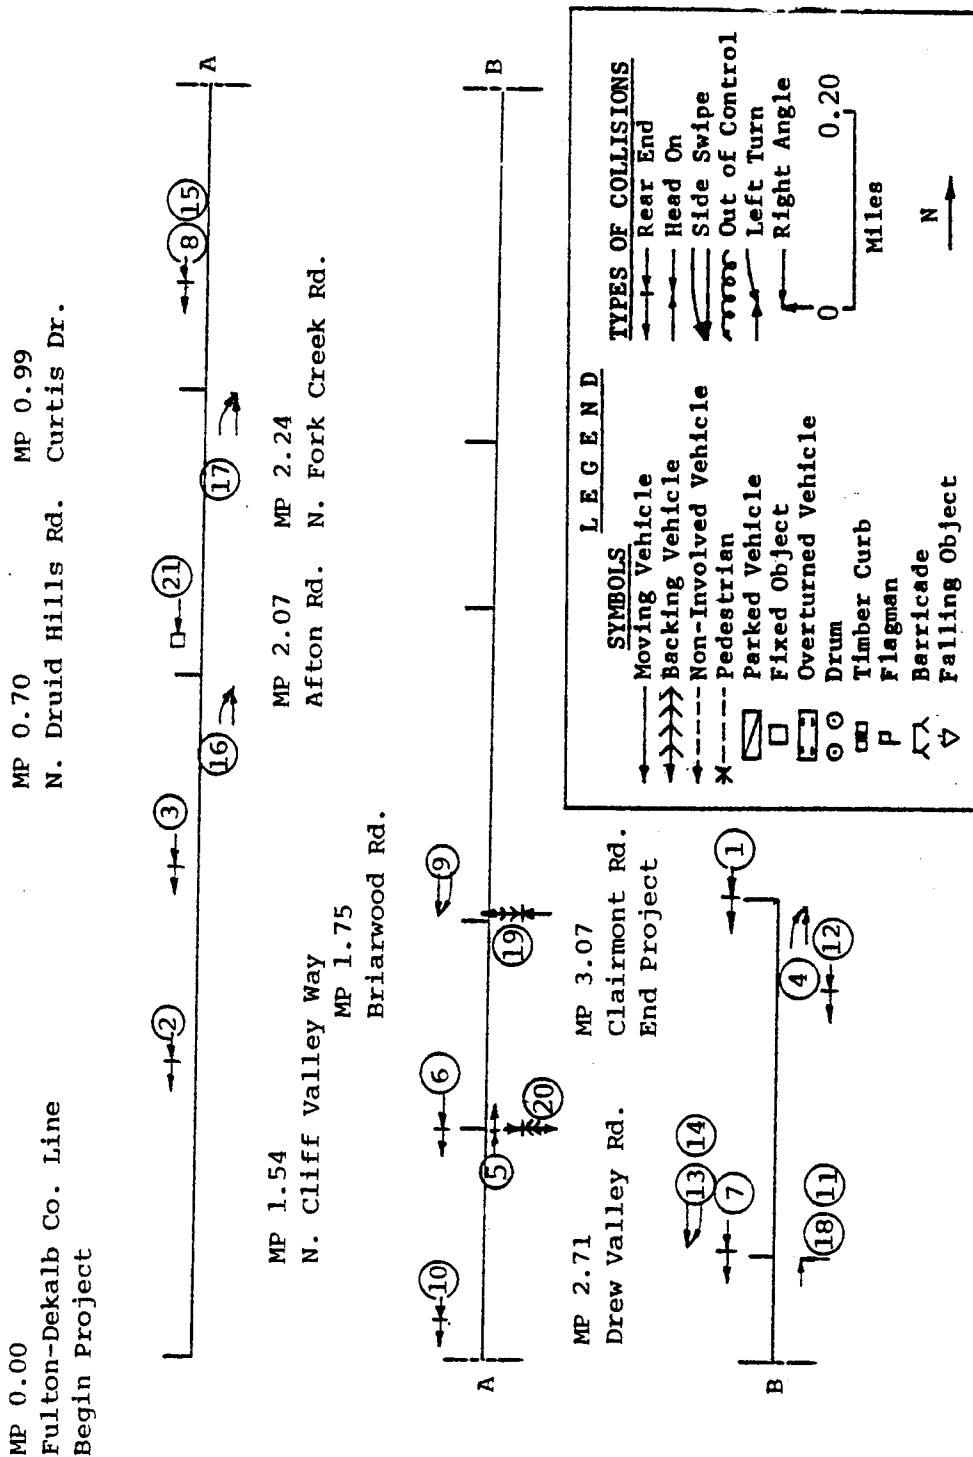
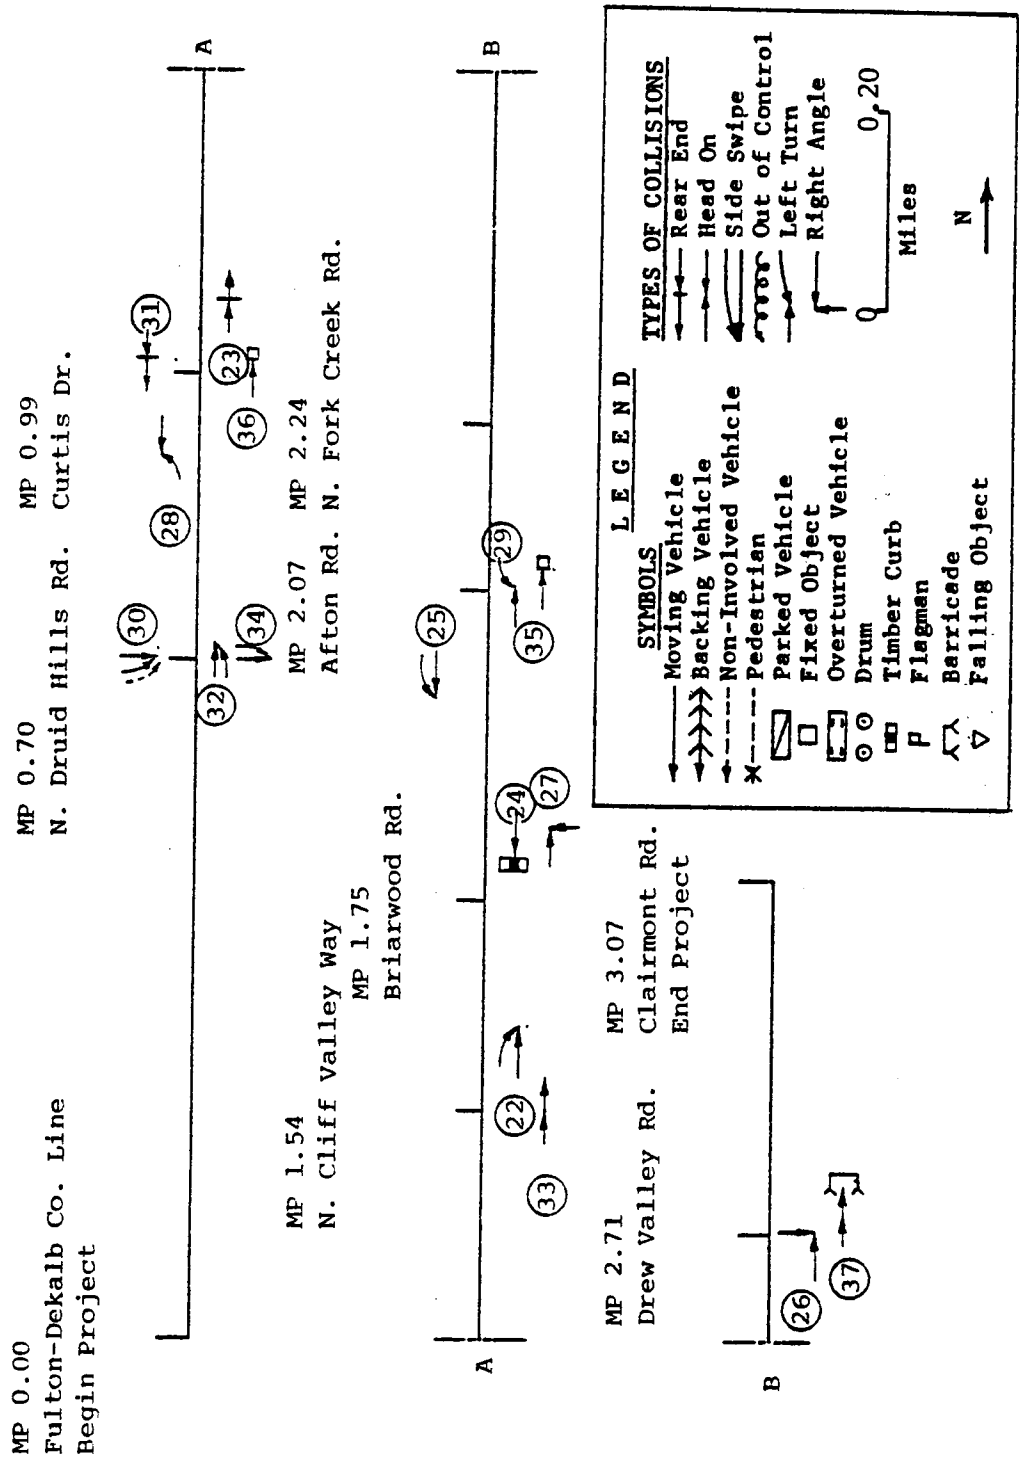
Figure 4-2. Collision Diagram--October 29, 1973 to September 23, 1974.

Figure 4-3. Collision Diagram--September 24, 1974 to July 1, 1975.

4. Problems evolving from ineffective advance warning and/or improper placement of flagmen were evident in accident numbers 12 and 31. The flagman in accident number 12 was on the opposite side of the street from the approach path of the two vehicles involved. The vehicle had just traversed a crossover reverse turn; therefore, placement of the flagman may have been a significant contributing factor. No information was given on advance warning for the flagman. The lack of flagmen for the road grader in accident number 26 was a contributing factor.

5. Improper methods were used to effect a lane closure in accident number 30. The advance signing for the closure was not given, but two Type I barricades placed within the traffic lane formed the abrupt closure without a taper. This closure was also very close to the Druid Hills intersection where motorists were likely to be making additional decisions and maneuvers within the traffic stream. This factor increased the complexity of the problem even more.

6. Loose construction material on the pavement was a contributing factor in accident numbers 1, 2, 7, 9 and 29. This problem is prevalent on the vast majority of construction sites and is one which requires constant attention by inspectors.

7. Construction vehicles were parked improperly in accident number 19. Two vehicles were parked parallel to the centerline of the main roadway at the Briarwood Road intersection. These vehicles not only blocked Briarwood Road but also created a hazard for motorists traveling through on the main line roadway.

8. No advance warning of a street closure was a factor in number 20. The accident report states, "this area is a hazard due to construction." The street closed in this case was the entrance to a large shopping center.

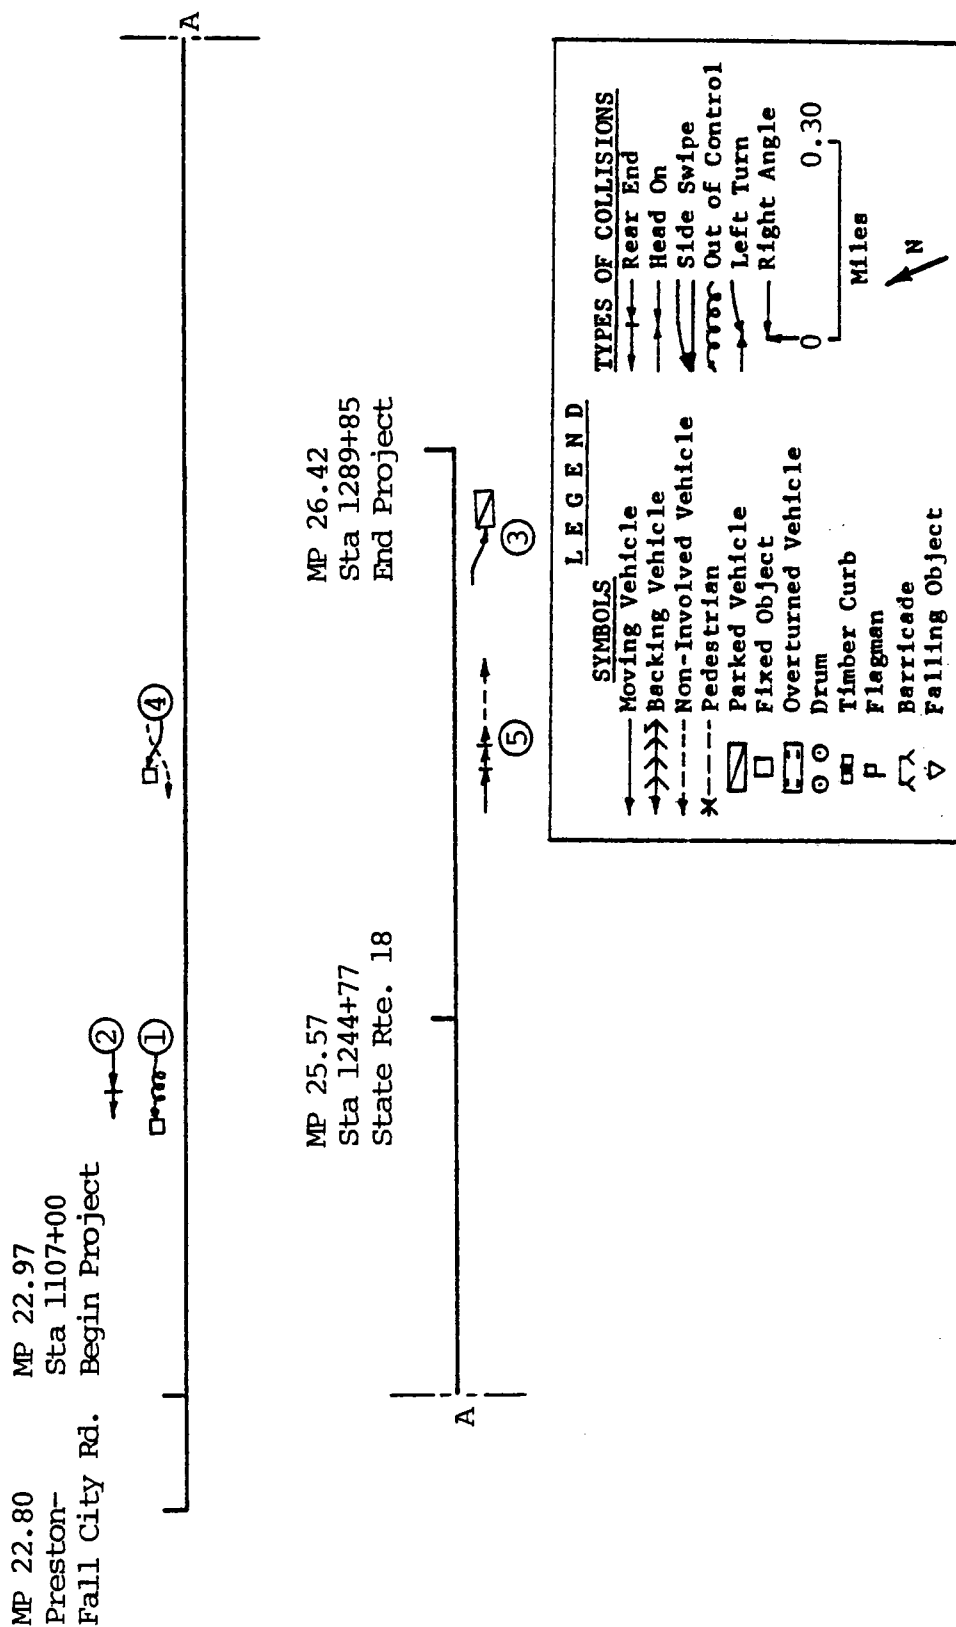
Figure 5-5. Collision Diagram--April 23, 1975 to April 14, 1976.

2. Loose construction material on the pavement should be removed as quickly as possible. Mud on the pavement was a contributing factor in accident number one.

4. This roadway section was at the time of construction a four-lane undivided highway signed as Interstate 90. Permanent Interstate signing should have been removed until completion of this project, at which time the roadway would meet Interstate standards.

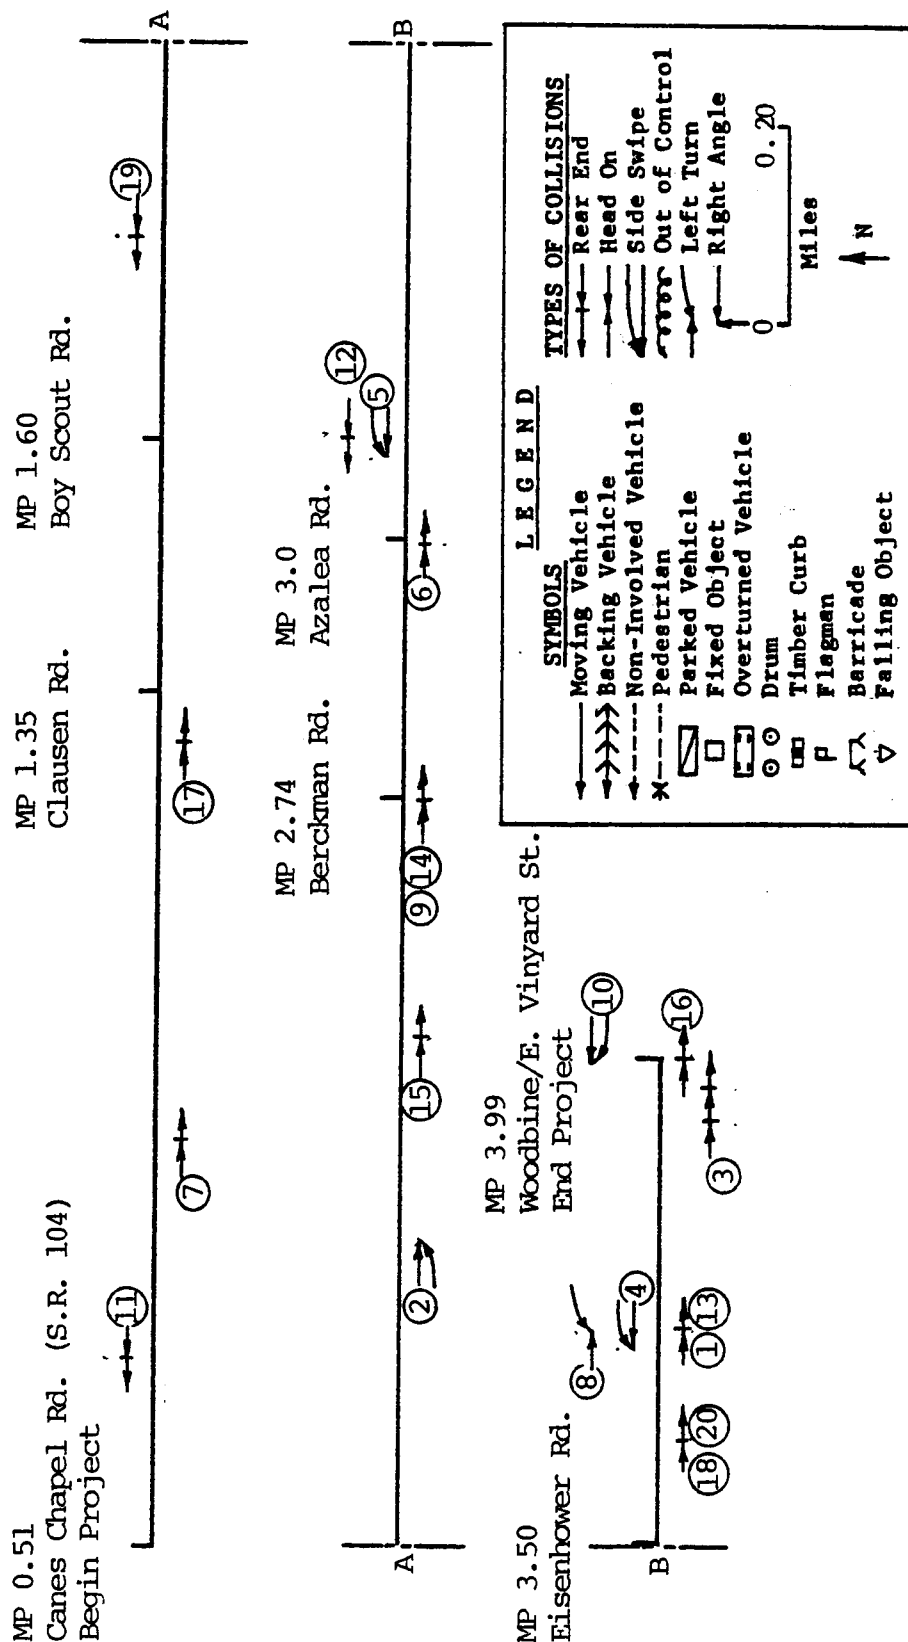
Figure 7-4. Collision Diagram--February 27, 1976 to September 1, 1976.

Analysis of this project indicated an increase of 76 accidents during the construction period, of which 20 were directly attributable to the construction. There was only one area of concentration of accidents near the end of the project. Eight accidents occurred as a result of, or were at least related to, the lack of lane lines on the newly paved surface. Other potentially hazardous conditions were found to exist during construction but these were not apparent contributors to accidents.

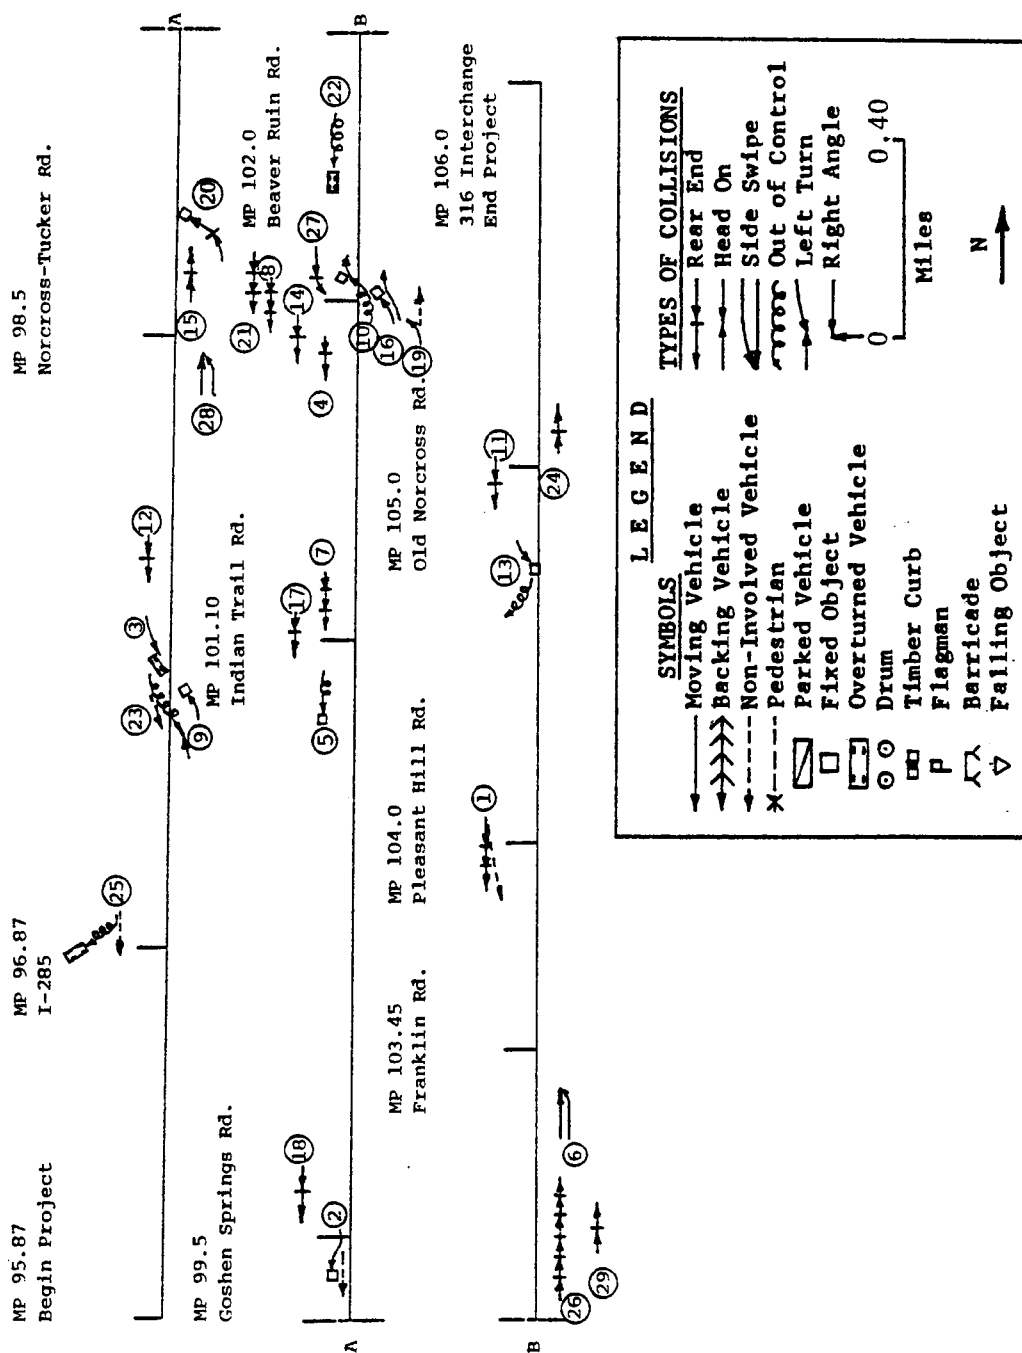
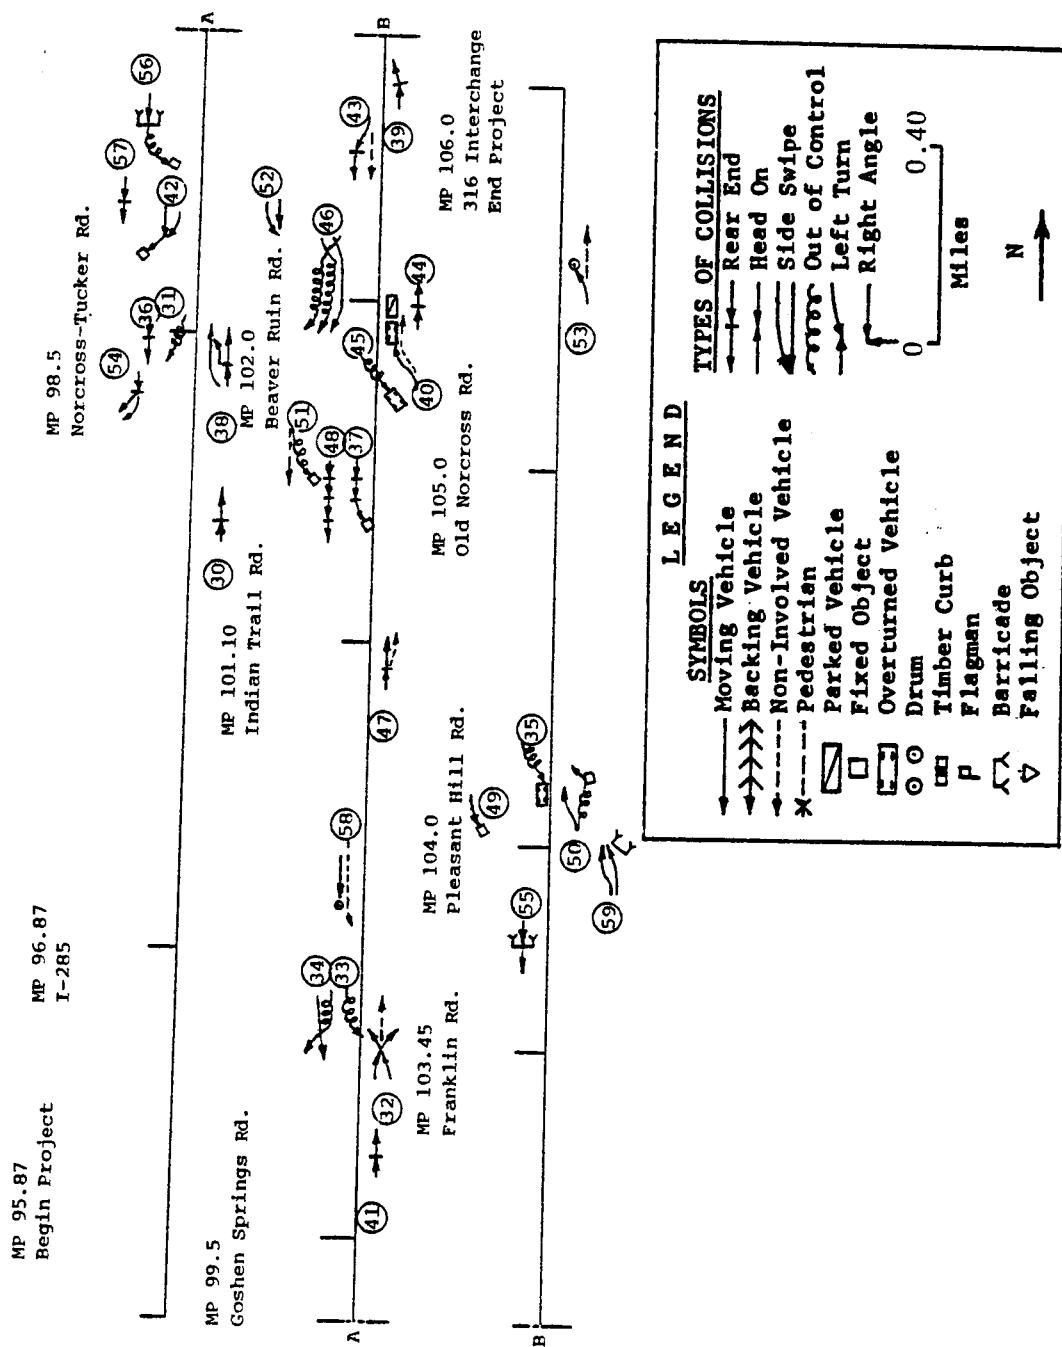
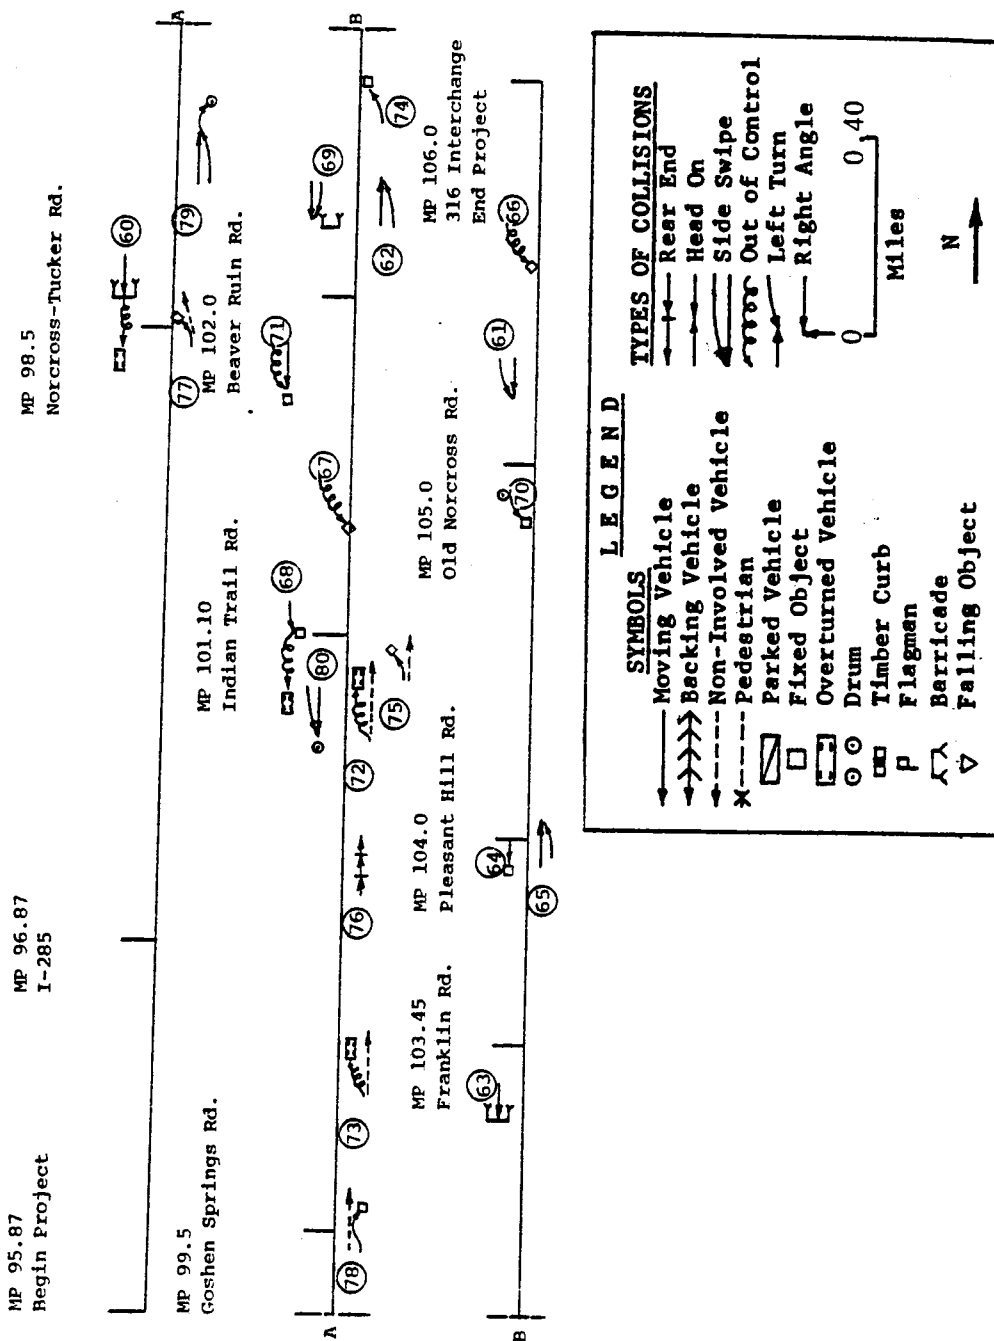
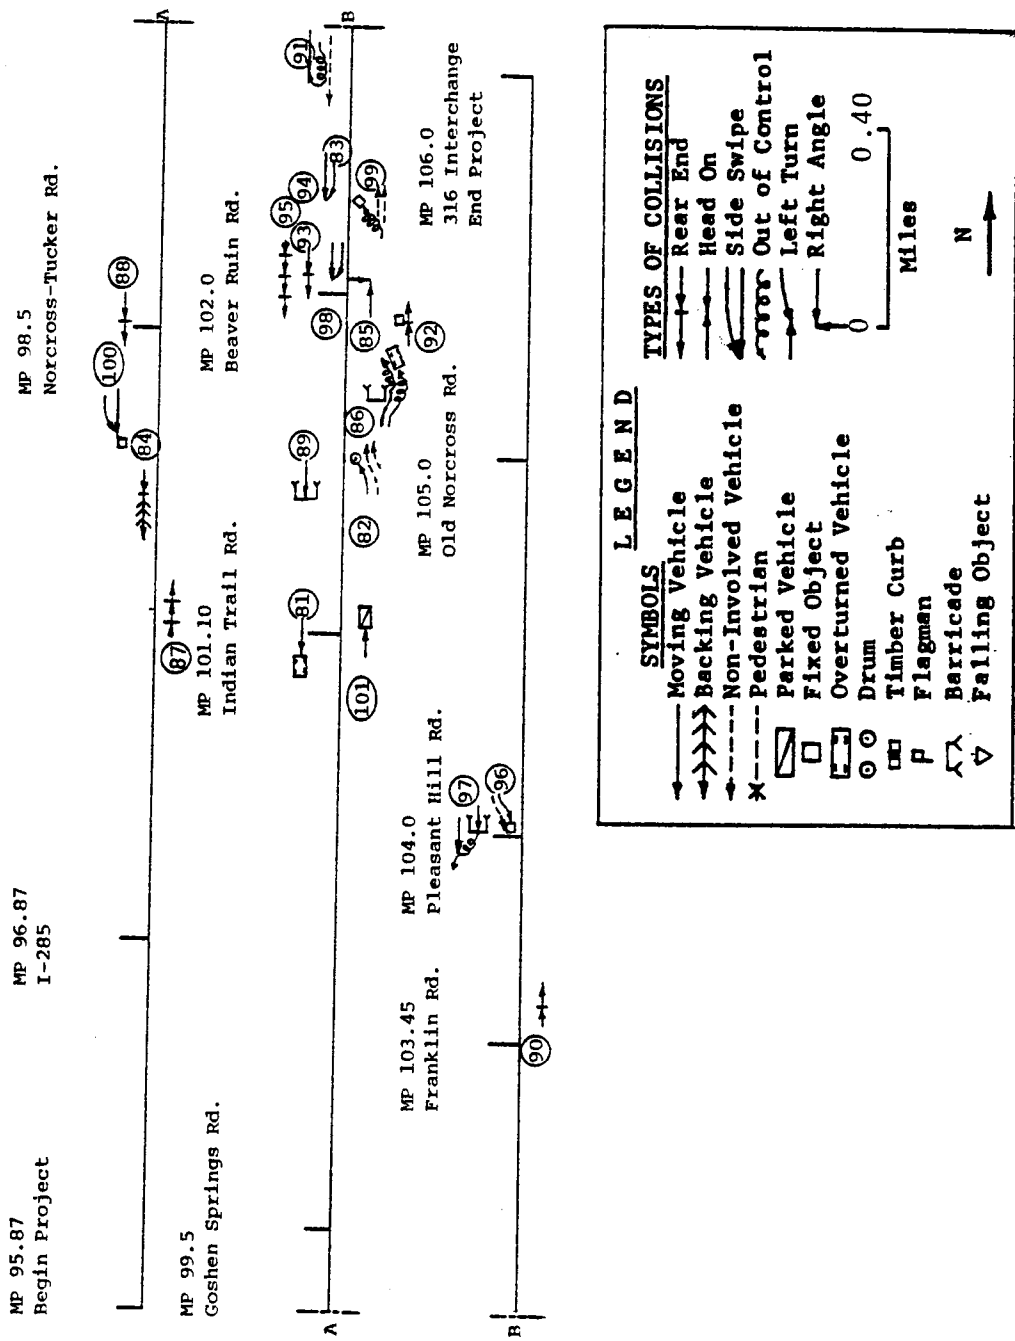
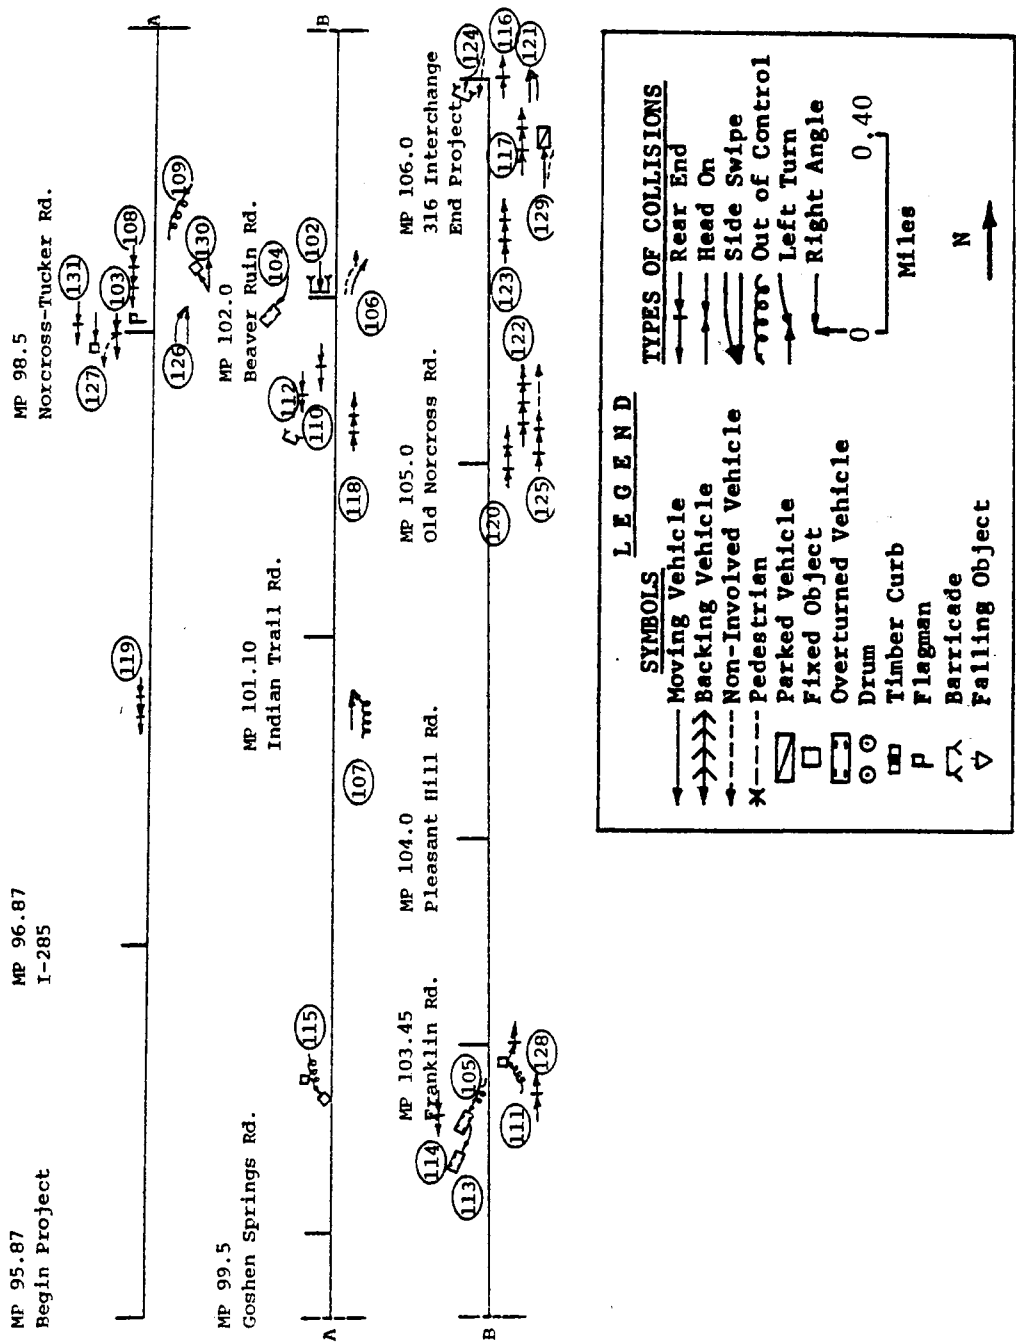
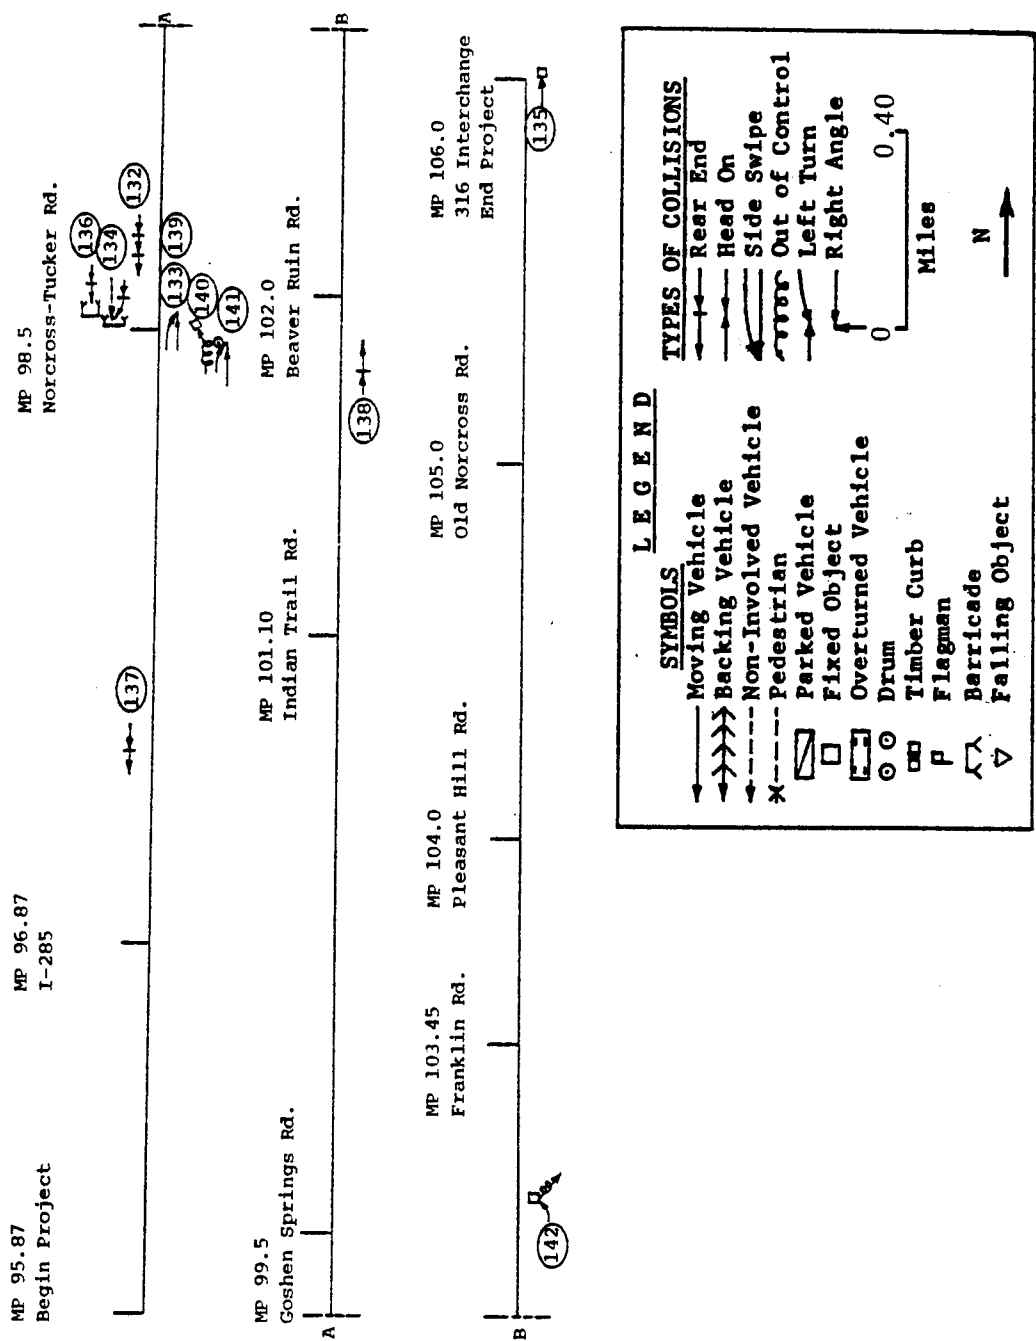
1. There was an apparent problem with enforcement of a portion of the Special Provisions as indicated by accident numbers 33, 34, 80, and 142 which show a lack of adequate drainage; numbers 46, 47, 48, and 124 had loose material on the roadway surface; numbers 117 and 119 indicated one lane traffic when two lanes had been specified for the entire construction period; both sides of the traveled way were under construction as indicated in the accident report for accident number 48 and

others, when the specifications called for work on only one side at a time.
