# MSE 489 Senior Design Class Project 2

## Final Project Report Failure Analysis of Leaking Stainless Steel Pump Casing

Author: Marybeth Parker  
Date: April 13, 2011

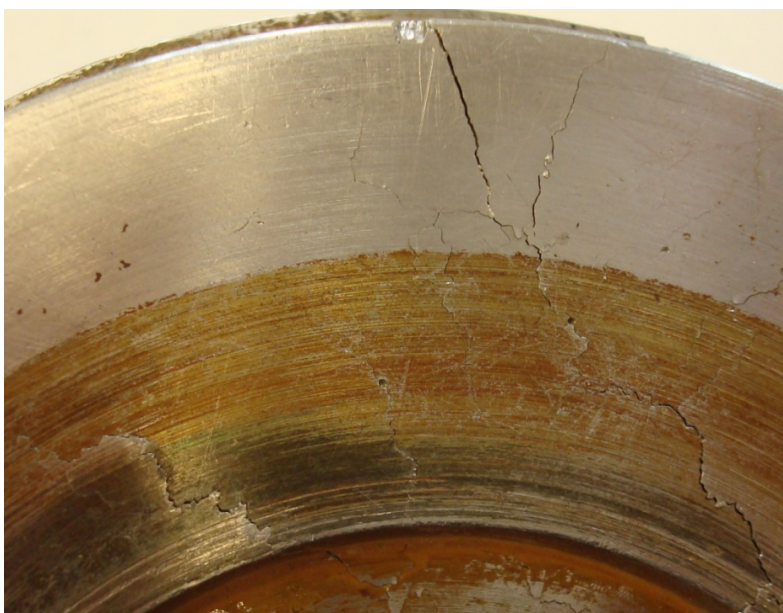
The stainless steel pump casing being analyzed in this project was taken from a centrifugal pump used at Sea World to circulate artificial sea water in Baby Shamu's tank. This pump began leaking after about one year of service, but other similar pumps worked well for several years. The failed pump was cast using CN7M which is a special austenitic casting alloy designed for use in corrosive environments especially sulfuric acid and other reducing chemicals [2]. The leaking was caused by cracks in the pump casing shown in Figure 1.

Figure 1: Cracks in the casing of a centrifugal pump.

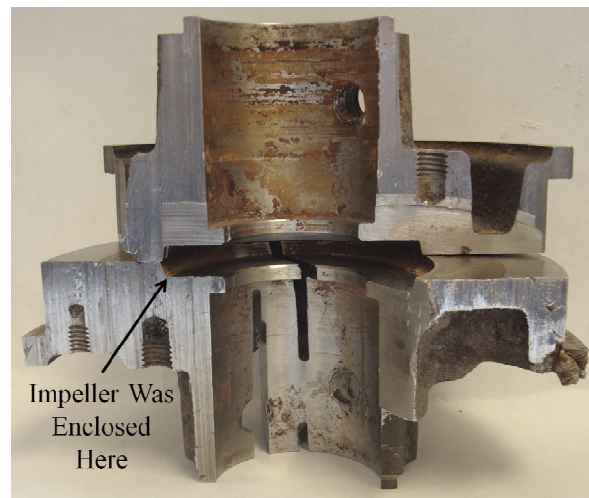
Figure 3: As received pump housing. Impeller location is indicated on figure.

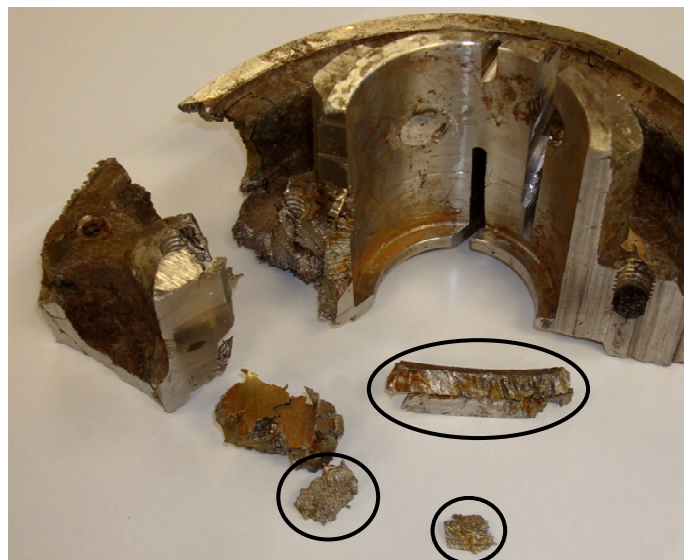
Figure 4: Broken pieces after fracture. The circles pieces were used for SEM work.

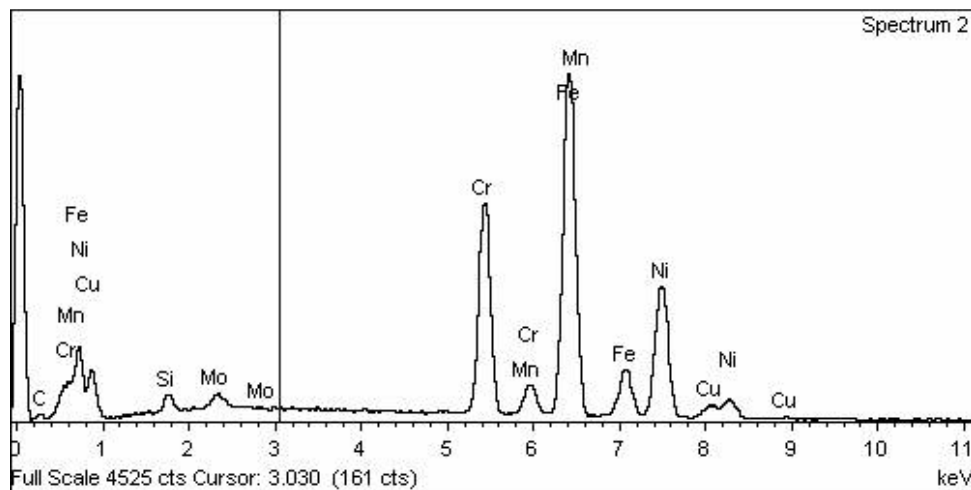
The EDS results are shown in Table 2 and Figure 5. The results are very close to the standard, but the chromium and copper are low and the nickel is high. Since EDS is only an approximate measure of composition and the differences are not large, these inconsistencies are not critical.

Figure 5: Energy Dispersive Spectroscopy spectrum.

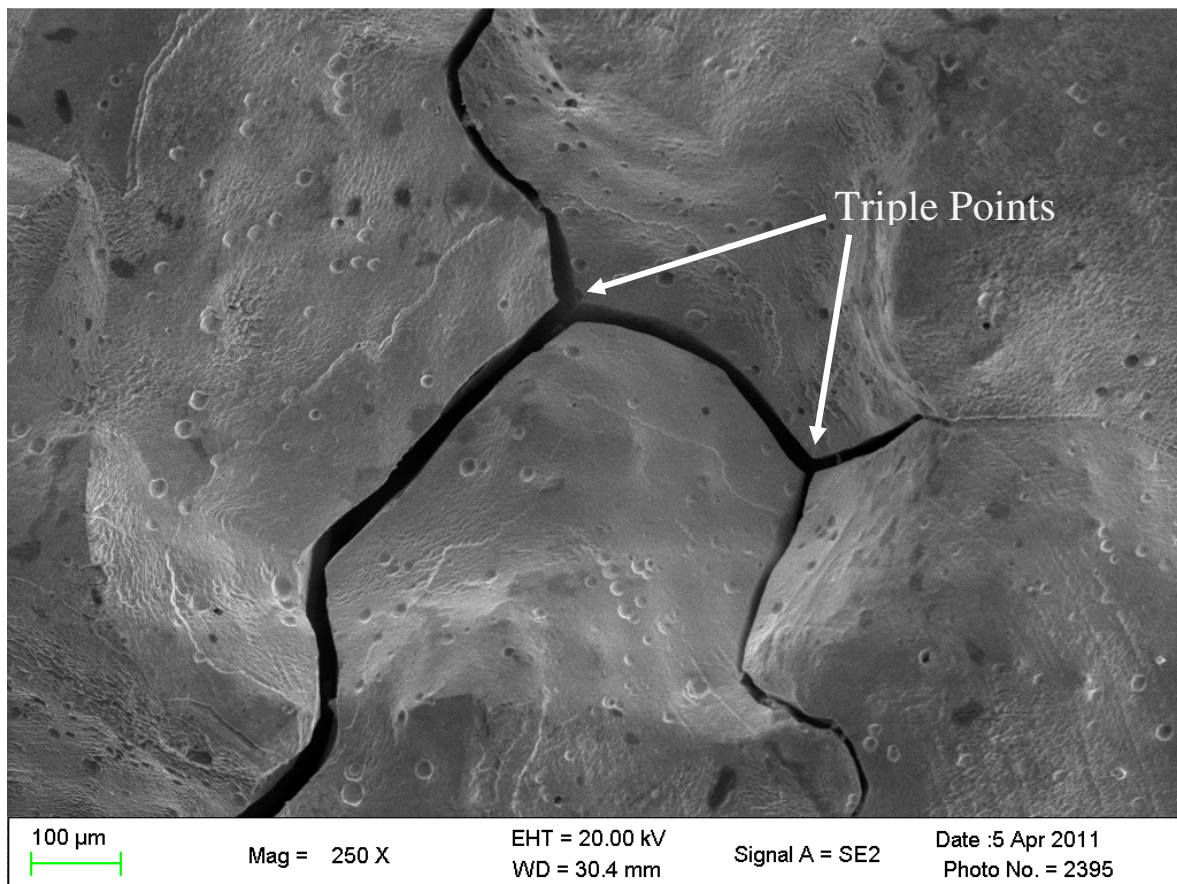
The fracture seen when the broken pieces of pump housing were analyzed was intergranular fracture. Triple points are the point where three grains meet and are characteristic of intergranular fracture. Two triple points can be seen in this material in Figure 6. This micrograph also shows signs of corrosion pits and spots on the surfaces of grains.

Figure 6: Micrograph taken at 250 x magnification shows intergranular fracture.

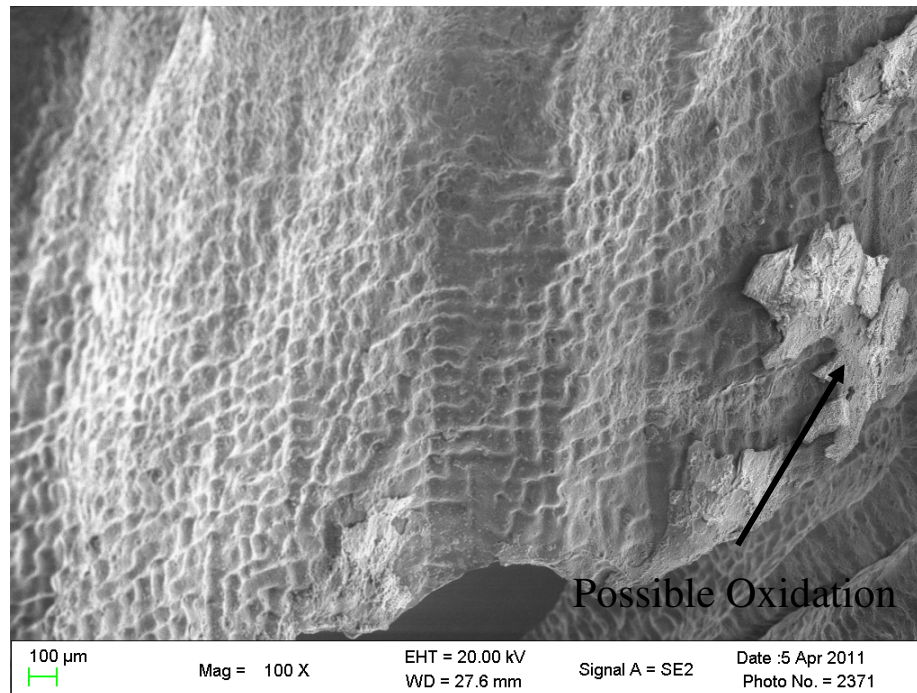
While these grain surfaces are smooth, other grains showed regular texture suggesting dendrites as shown in Figure 7. Some possible oxidation is also showing in this picture. Other parts of the fractured sample showed signs of corrosion on the surface grains as shown in Figure 8. None of these fracture surfaces shows signs of transgranular fracture such as microvoid coalescence, chevrons and other lines from crack propagation, or smooth flat faces from cleavage [2]. Intergranular fracture indicates that the bonds between grains were weaker than the grains themselves. If the grains were weaker than the grain boundaries, cracks would have traveled through them instead of around them. This is evidence for intergranular corrosion because this failure mechanism would have weakened the grain boundaries.

Figure 7: Micrograph taken at 100 X showing evidence of dendrites on grain surface.

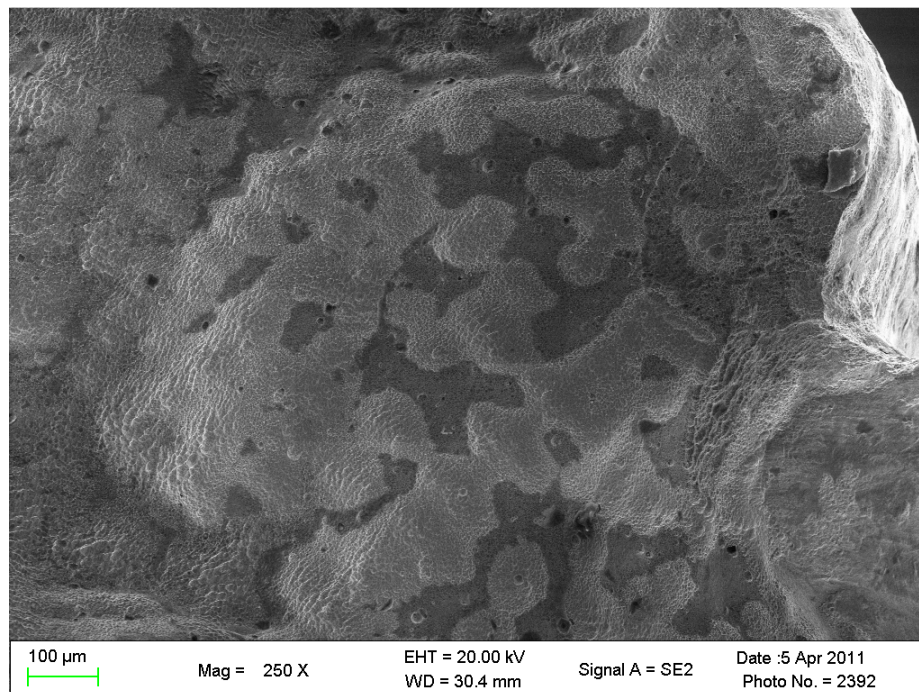
Figure 8: Micrograph taken at 100 x showing signs of corrosion on grain surface.

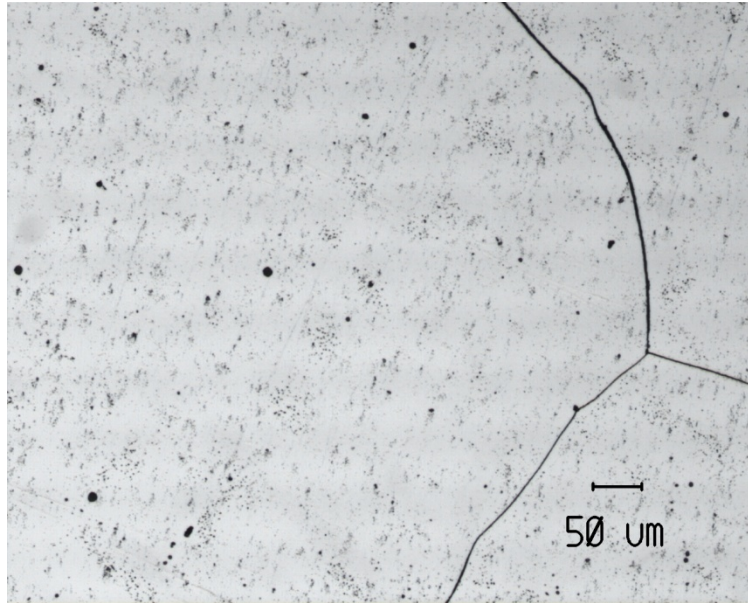
A micrograph for the pump housing at 100x and 200 x can be seen in Figures 8 and 9. Dark spheres are most likely inclusions while the small clusters of spots may be carbides.

Figure 8: Micrograph of pump steel taken at 100 x magnification with oxalic etch.

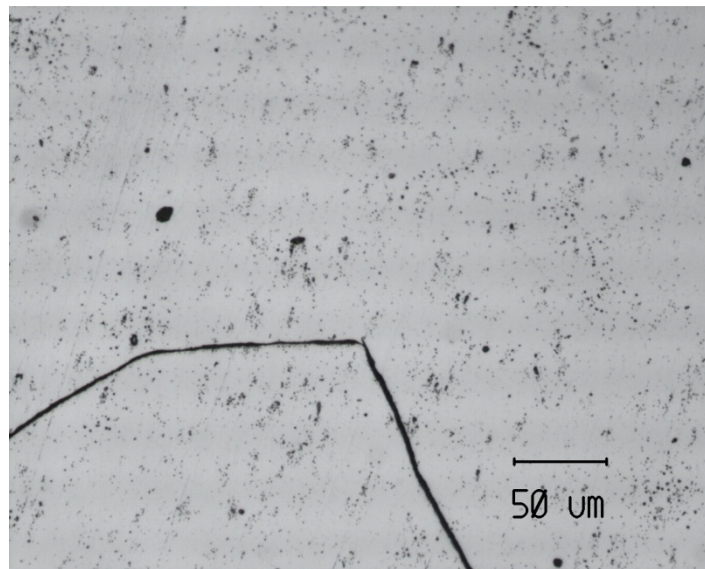
Figure 9: Micrograph of pump steel taken at 200 x with oxalic acid etch.
