Studies of High Temperature Hydrogen Related Damage in  
Welded Carbon Steel Components used in  
Refineries

A Thesis Presented for the  
Master of Science  
Degree  
The University of Tennessee, Knoxville

Maneel Bharadwaj  
May 2015

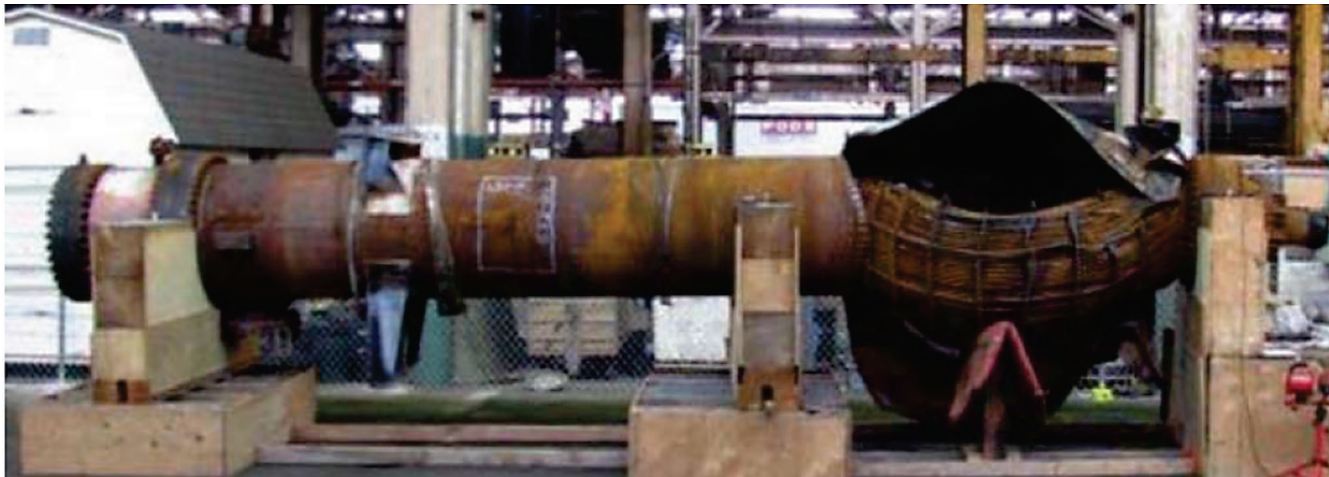
Figure 5. Tesoro Anacortes Heat Exchanger E (NHT-6600E) showing Rupture and Subsequent Fire which resulted in Seven Fatalities on April 2, 2010 <sup>38, 40</sup>.

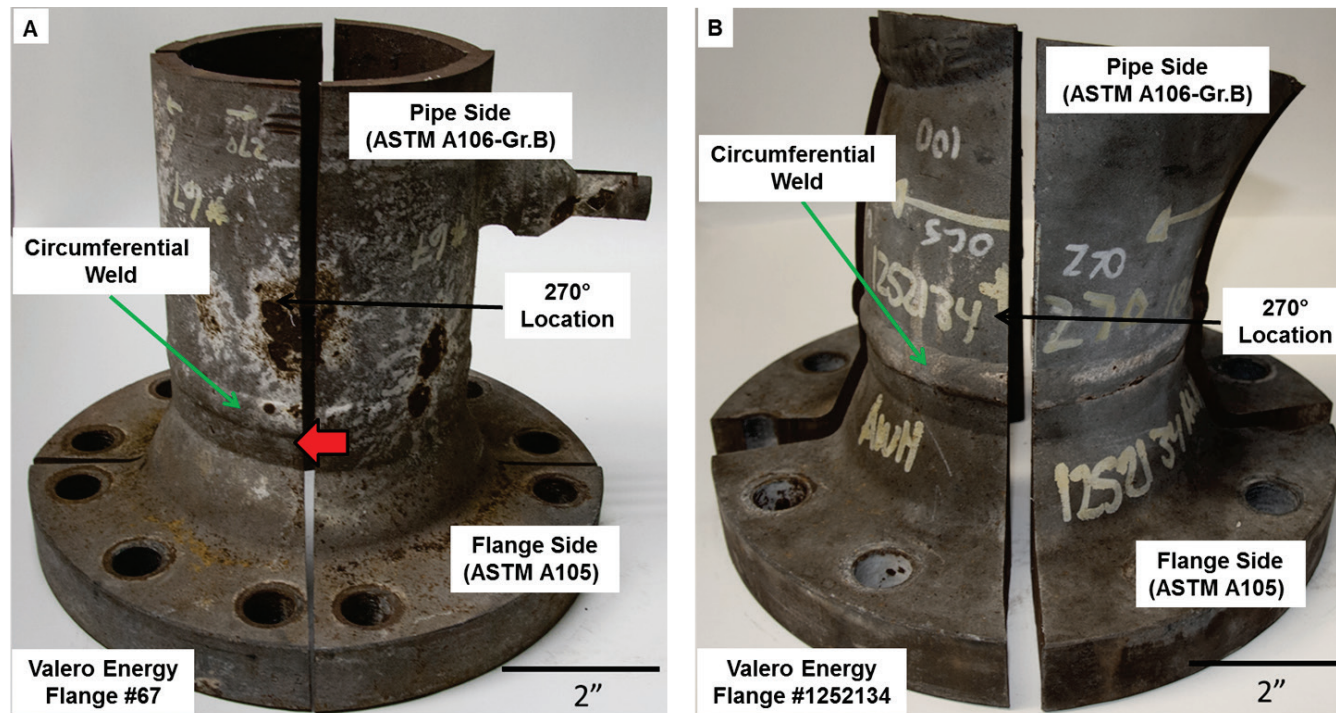
Figure 26 Valero Energy Flange-to-Pipe Weld Components As-Received by UTK, (A) Flange #67 and (B) Flange #1252134. (A) Cracking was observed in the Flange Base Metal of Flange #67 as indicated by the Red Arrow at the 270° Location when Evaluated by Valero Energy (using ultrasonic inspection). (B) Valero Flange #1252134 was indicated not to have any Service-Damage, based on Ultrasonic Inspection by Valero Energy <sup>82</sup>.

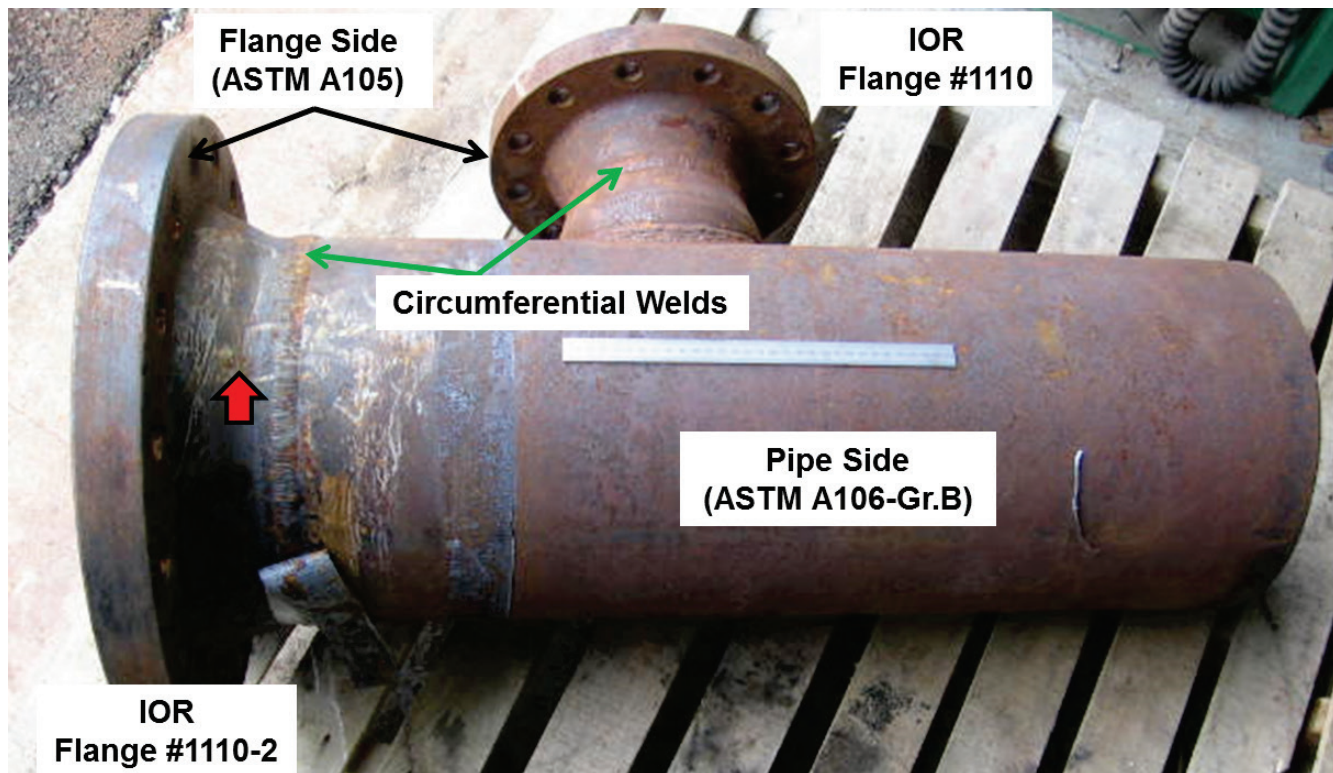
Figure 27. Photograph of Irving Oil Refinery Flange-to-Pipe Welded Component #1110-2 prior to the Receipt by UTK. Photograph Extracted from the Failure Analysis Report Prepared by Wayland Engineering<sup>80</sup>. Cracking was observed in IOR Flange #1110-2, as shown by the Red arrow.

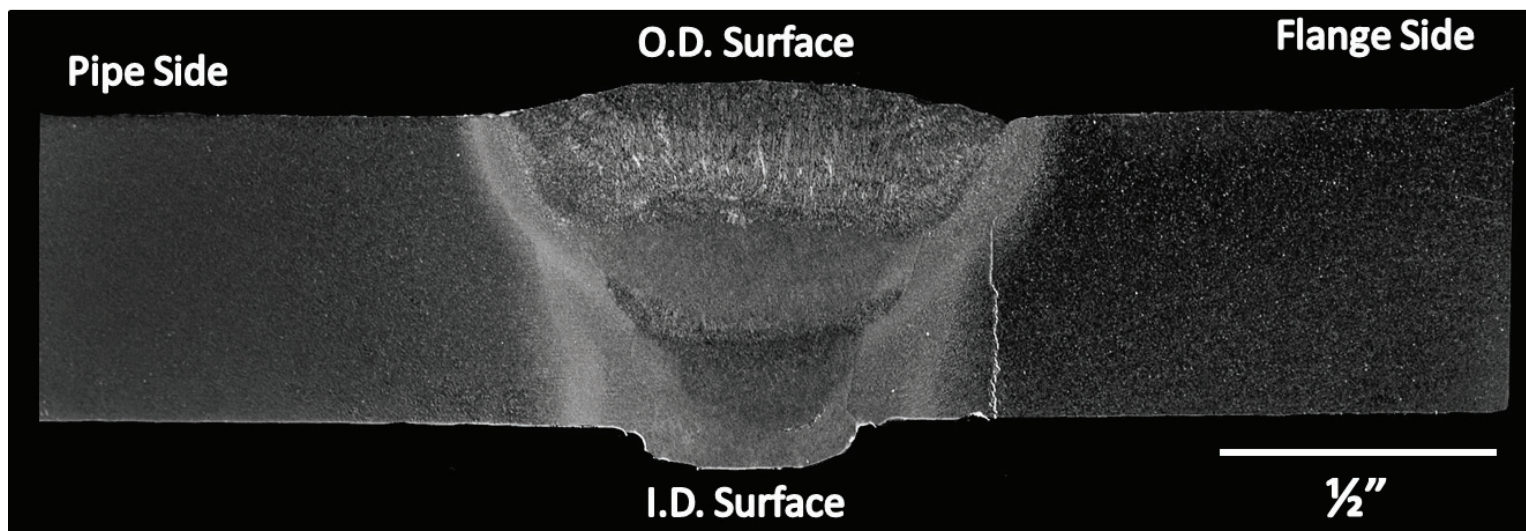
Figure 33. Photomacrograph of Valero Flange #67 showing Cracking in the Flange Side. Cracking Initiated just outside of the Visible HAZ on the Inside Diameter Surface (ID Surface) and Propagated towards the Outside Diameter Surface (OD Surface). Crack Terminated in the Heat-Affected Zone, 2% Nital Etch.

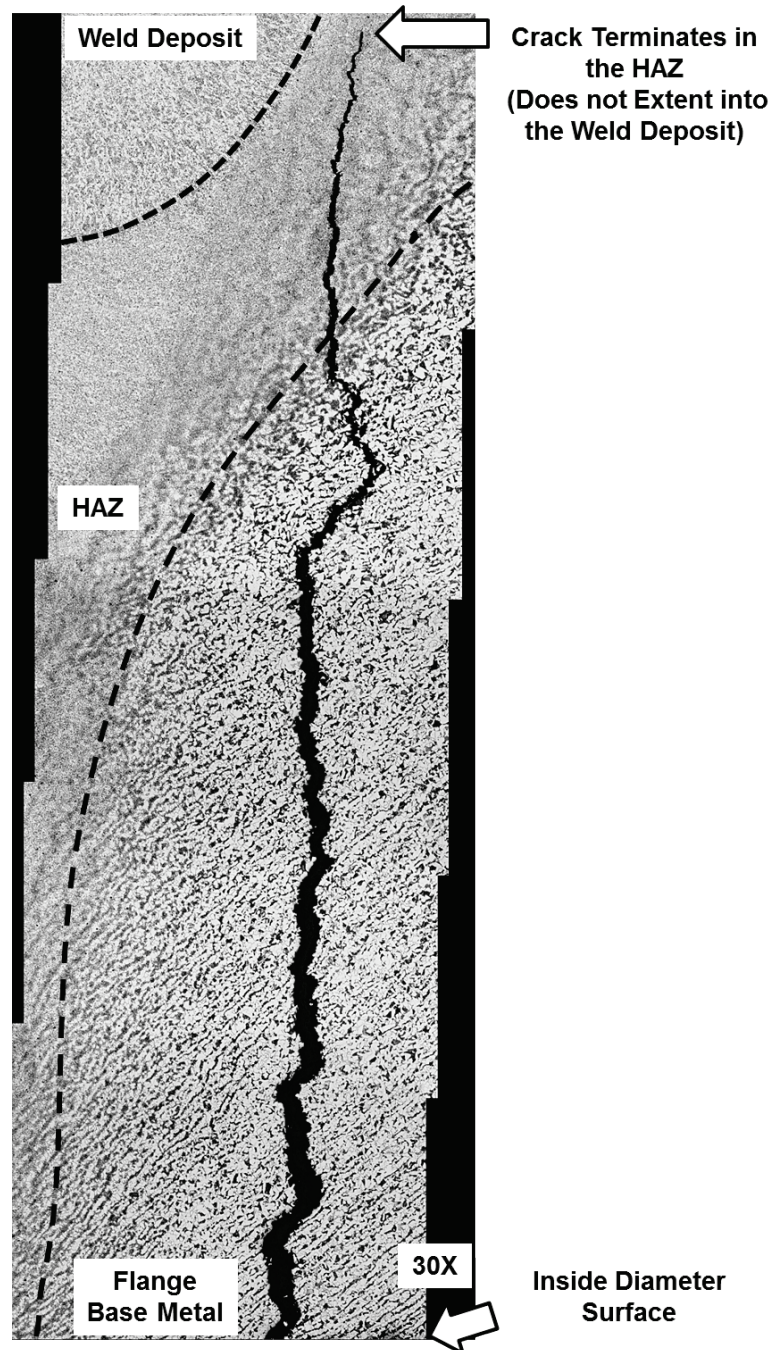
Figure 34. Panorama showing the entire Crack in the Valero Flange-to-Pipe Welded Component #67. Cracking was observed in the Flange Base Metal just Outside of the Visible HAZ and Appears to have Initiated at the Inside Diameter Surface, 2% Nital Etch.

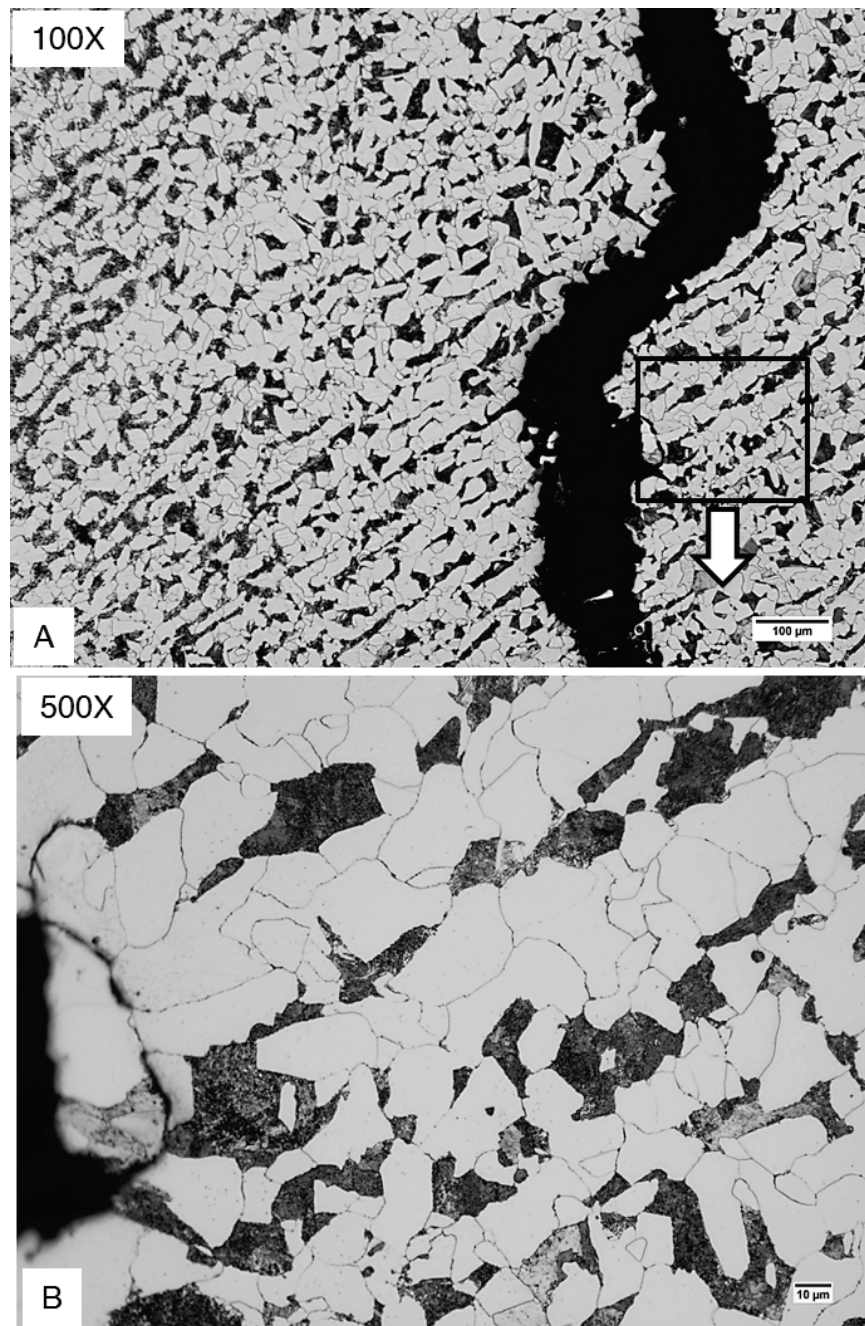
Figure 35. Photomicrographs showing the Crack Location in Valero Flange #67 adjacent to the Inside Surface in the Flange Base Metal. Internal Decarburization was not Evident, 2% Nital Etch.

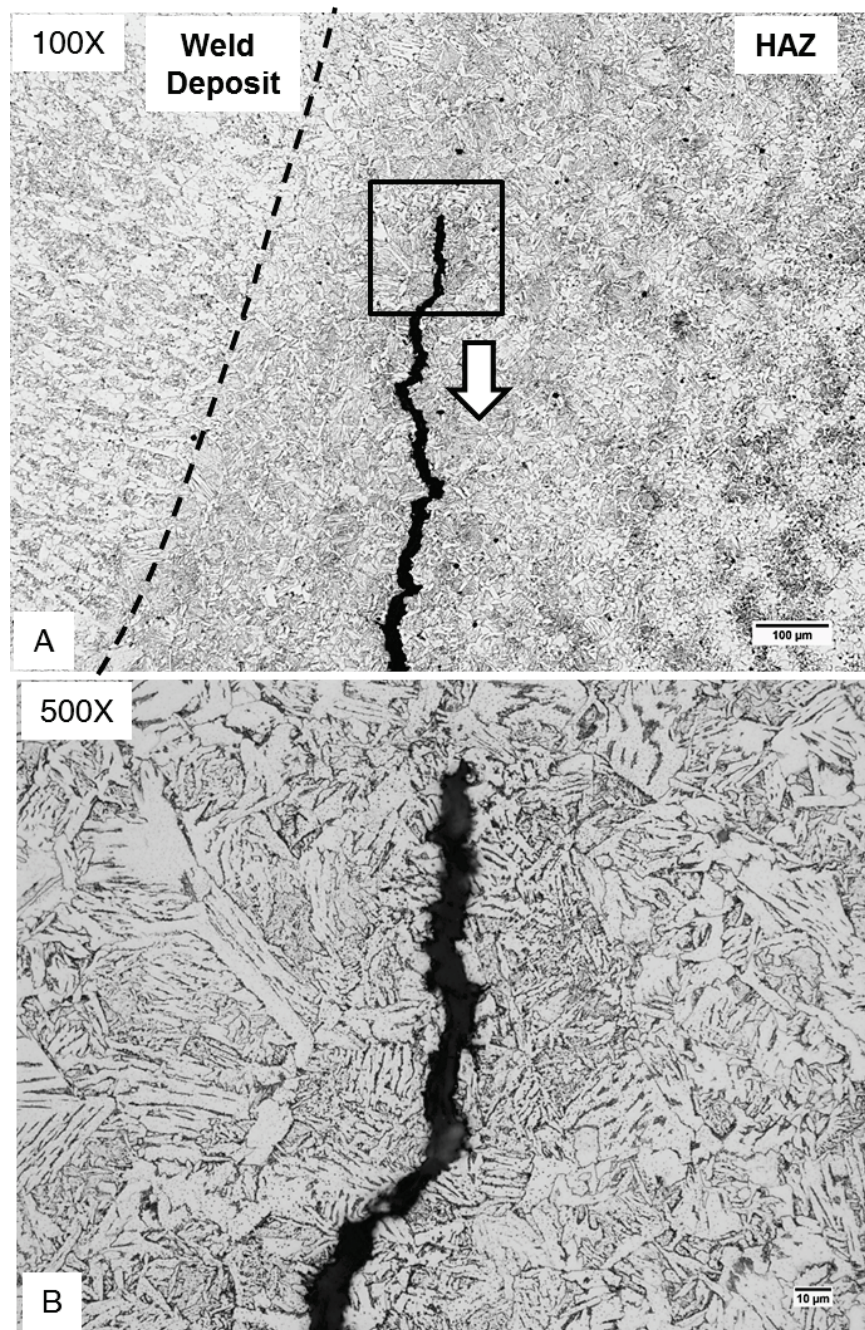
Figure 36. Photomicrographs showing the Crack Termination Location in the Flange-HAZ of Valero Flange #67. Internal Decarburization was not Observed in any Area Adjacent to the Crack, 2% Nital Etch.

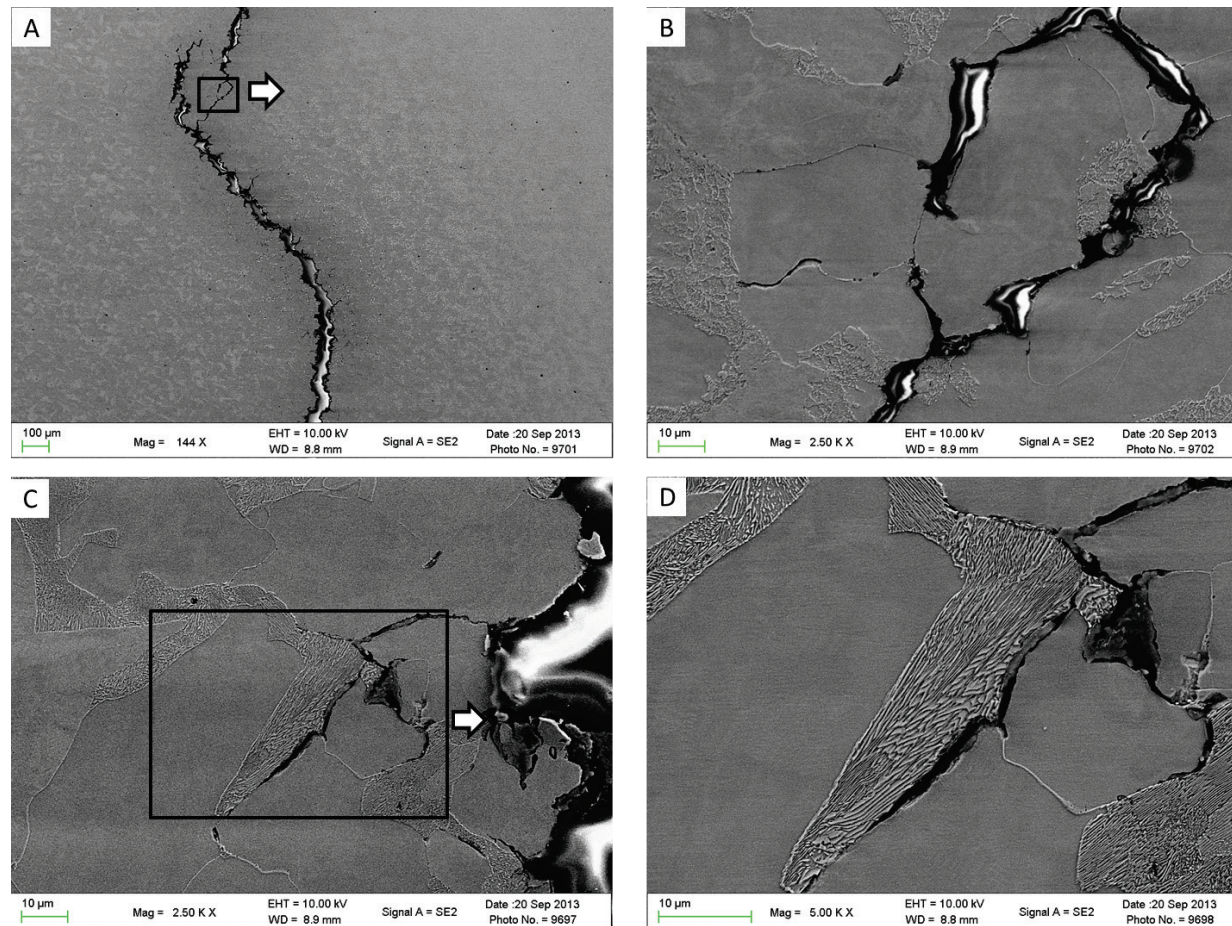
Figure 37. SEM Micrographs showing the Branching Nature of the Crack in Flange #67. Cracking Morphology was a Mixture of Intergranular and Transgranular (~50% each). No Evidence of Decarburization was Evident, 2% Nital Etch. (Note: Bright Regions inside the Crack are due to Charging of Epoxy Mounting Material during SEM Examination).

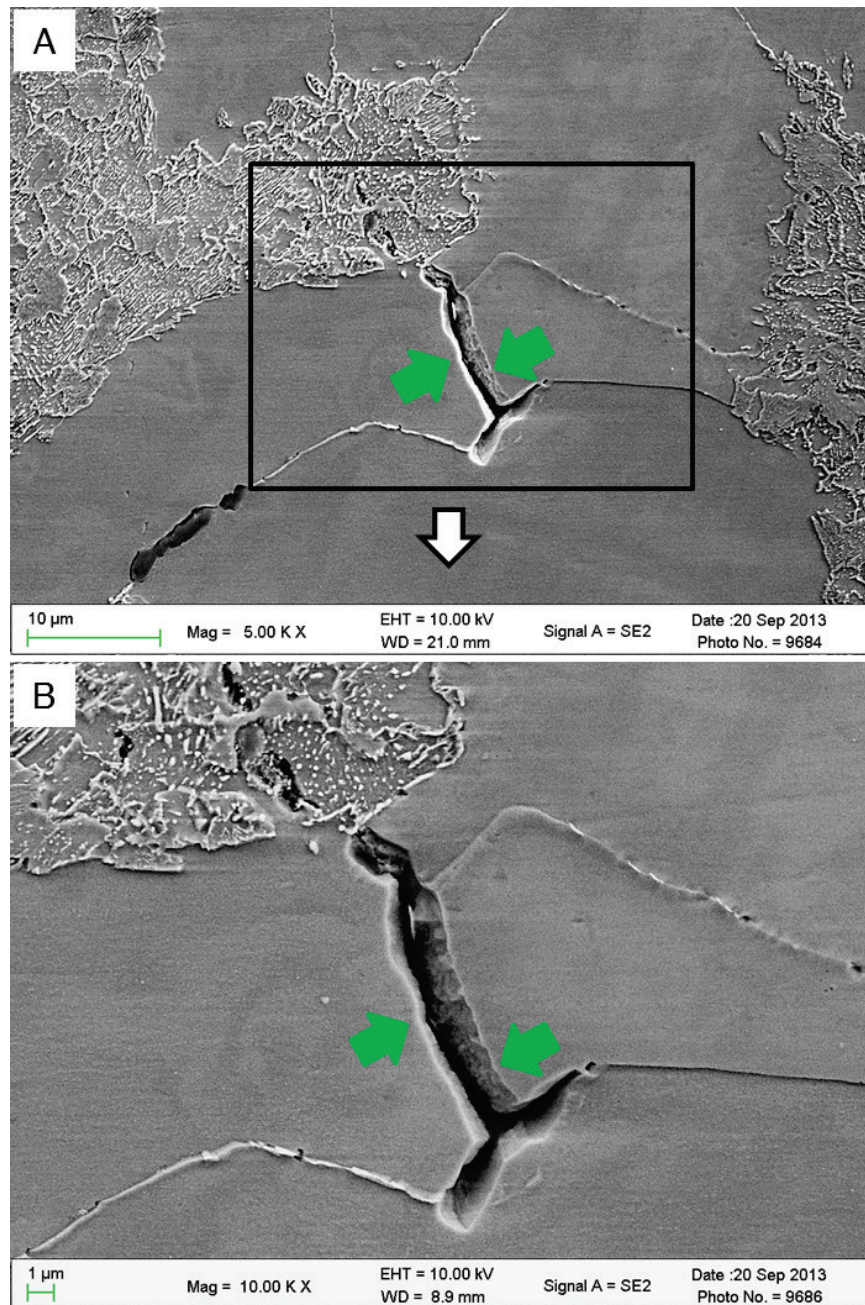
Figure 38. SEM Micrographs showing Grain Boundary Separation at a Ferrite-Ferrite Triple Point (Green Arrows) in Valero Flange #67 at the Crack Termination Location (HAZ).

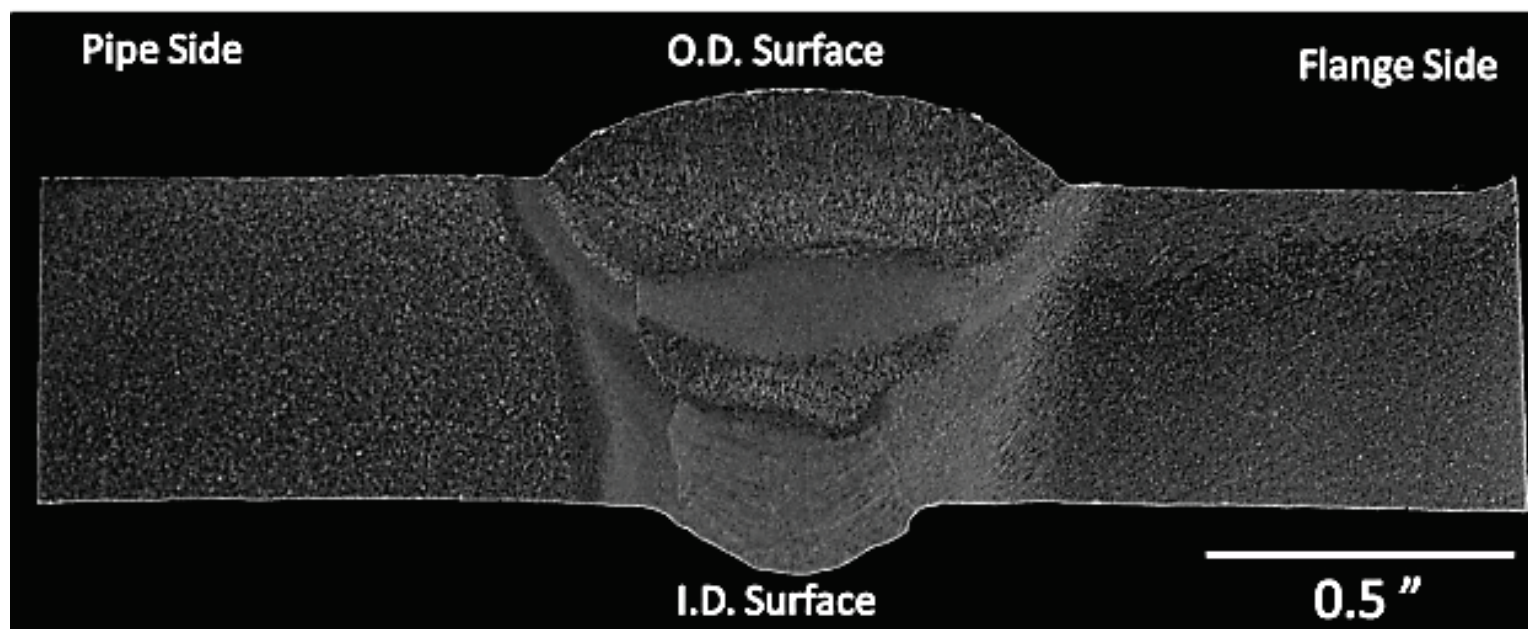
Figure 41. Photomacrograph of Valero Flange-to-Pipe Welded Component #1252134, 2% Nital Etch. No Evidence of Decarburization or Cracking was observed in any Locations in Flange #1252134.

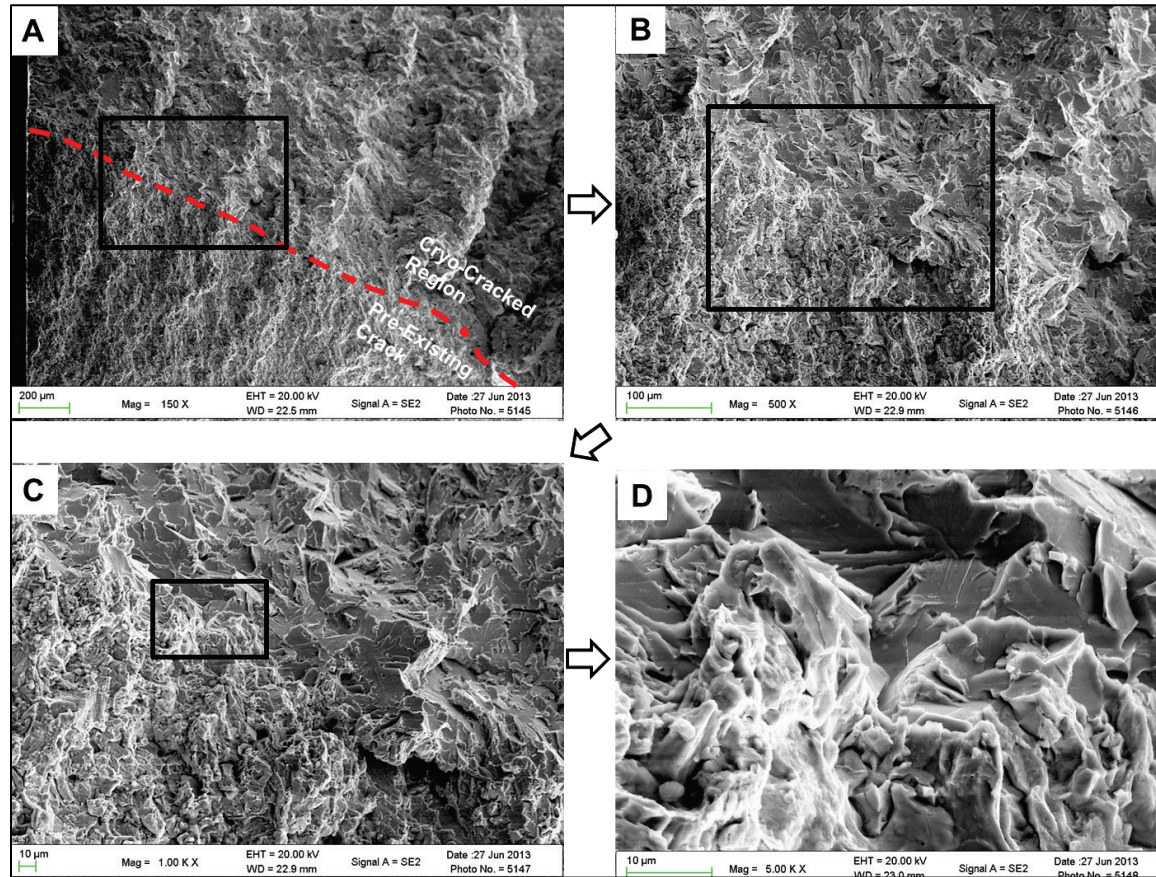
Figure 45. SEM Fractographs of a "Cryo-Cracked" Sample Extracted from Valero Flange #67 showing Partial Oxidation in the Pre-Existing Cracked Surface and Transgranular in the "Cryo-Cracked" Surface.

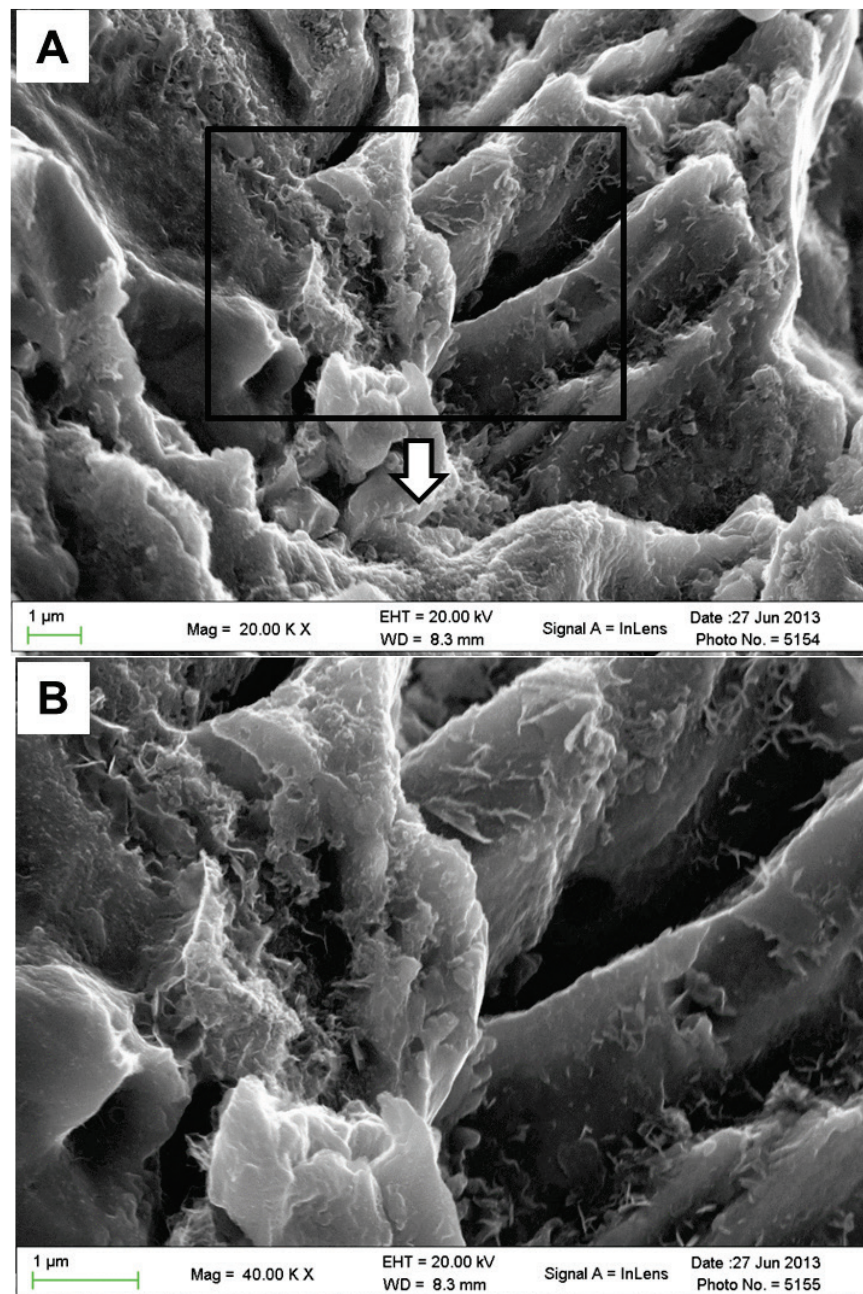
Figure 47. SEM Fractographs of Valero Flange #67 in the Pre-Existing Cracked Region shows Intergranular Cracking Morphology Masked by Partial Oxidation.

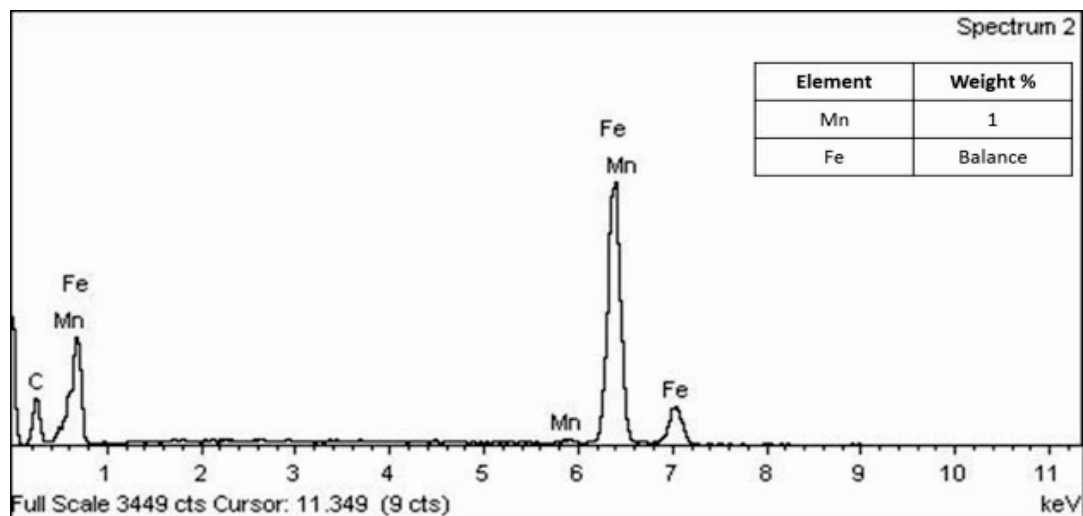
Figure 49. EDS Analysis of the Pre-Existing Cracked Surface at a Location Immediately below the Crack tip in Valero Flange #67. The Spectrum does not show the Presence of the Chlorine as Compared to the Analysis at the Location Adjacent to the Inside Diameter Surface (Figure 48).

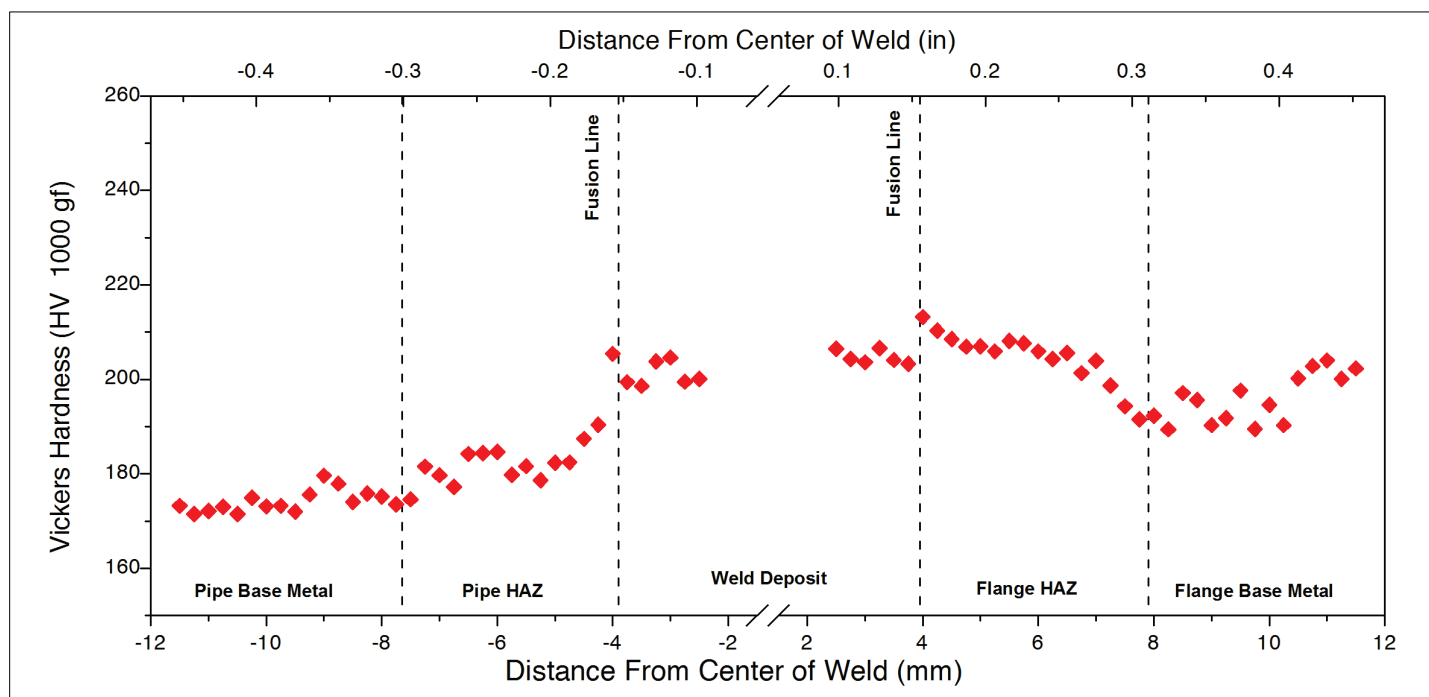
Figure 51. Vickers Micro-hardness Traverse on the Flange-to-Pipe Welded Component #67 across the Flange and Pipe HAZs using 1000 gf load. The Traverses are Similar and Reflect the Starting Hardnesses of Flange and Pipe Material. The Traverse shows no Evidence of Softening or Hardening Behavior just outside of the Flange HAZ (where cracking was observed).

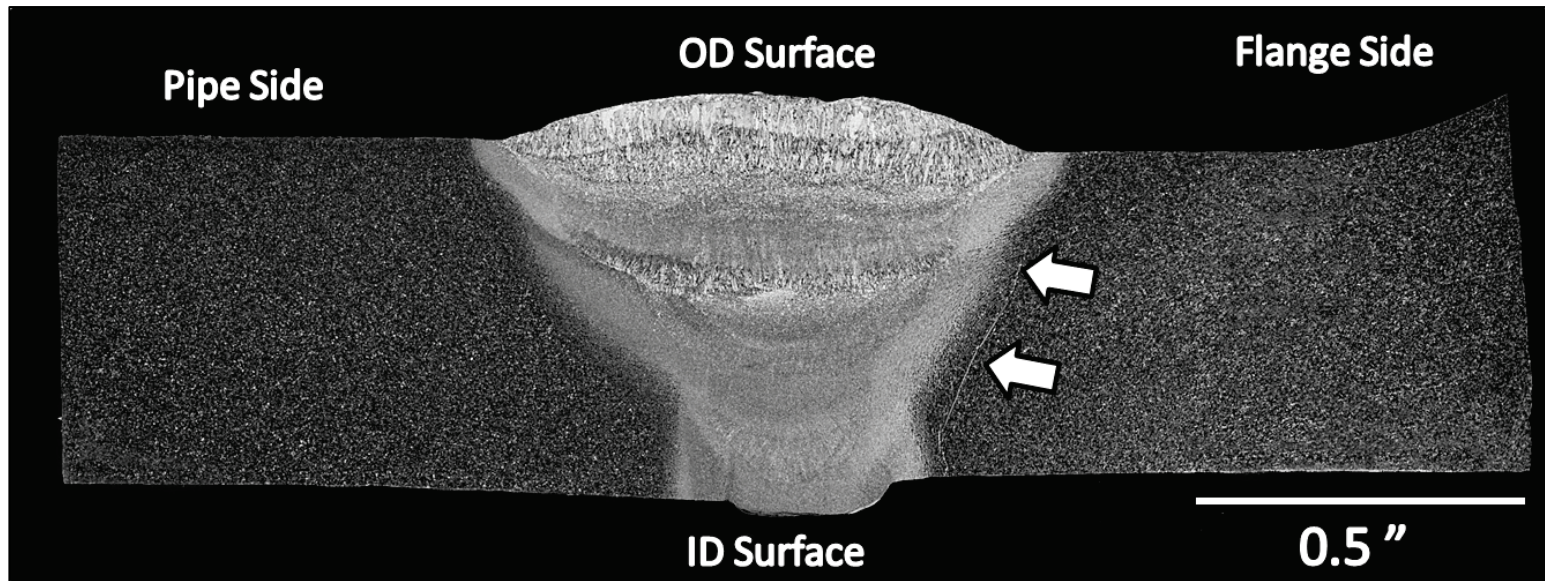
Figure 52. Photomacrograph of the Irving Oil Refinery Flange-to-Pipe Welded Component #1110-2 (section #1110-2-1), White Arrows showing the Crack Location just Outside the Visible HAZ in the Flange Base Metal, 2% Nital Etch. Crack initiated at the Flange ID surface and Propagated  $\frac{3}{4}$  of the Flange Wall.

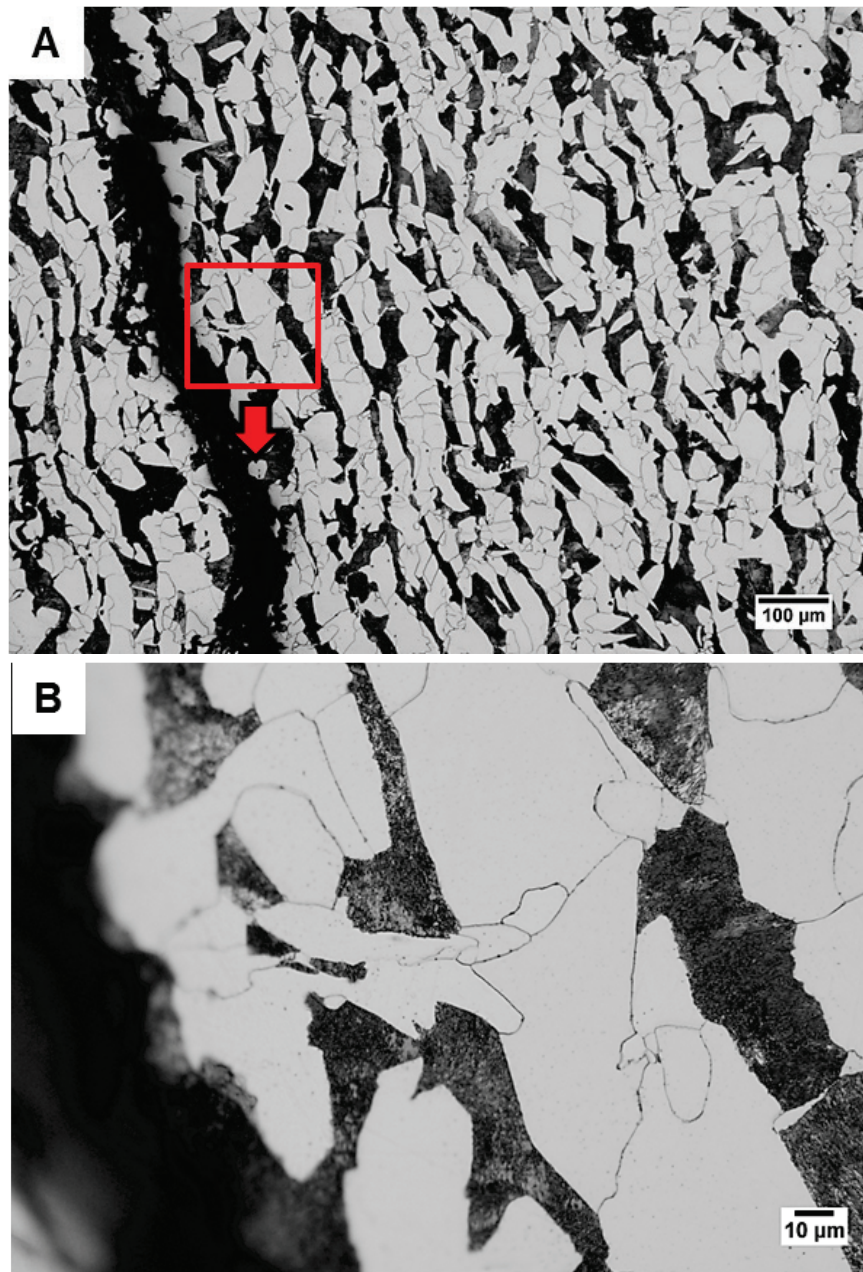
Figure 53. Photomicrographs of the IOR Flange #1110-2 adjacent to ID Surface. Cracking was observed just outside the Visible HAZ in the Flange Base Metal, which Initiated at the Inside Surface and Propagated towards the Outside Surface Parallel to the Weld Fusion Line (~ 5 mm away from weld fusion line), 2% Nital Etch. Decarburization was not observed at any Locations

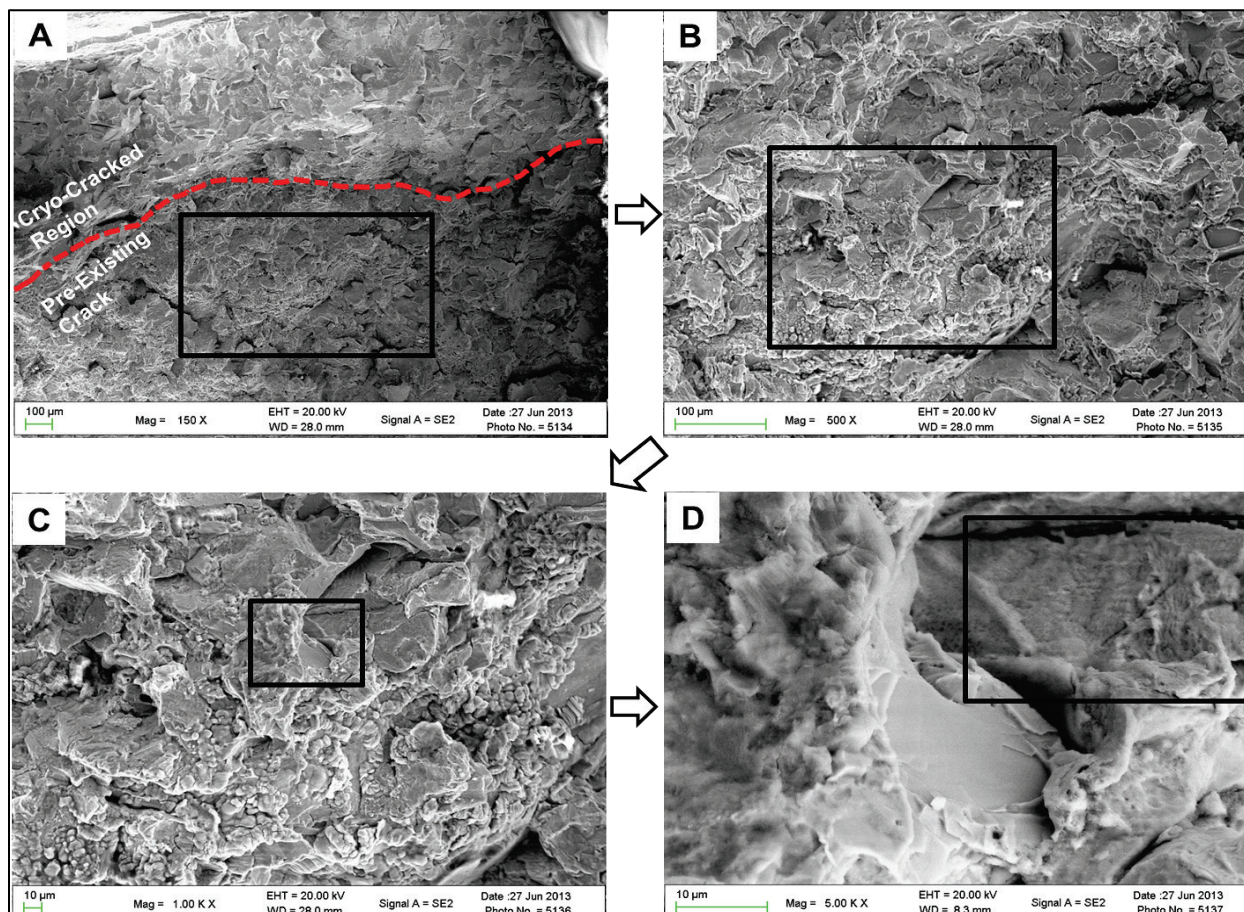
Figure 58. SEM Fractographs of the “Cryo-Cracked” Specimen in IOR Component #1110-2 showing the region immediately below Crack Tip showing Intergranular Morphology with Evidence of Partial Oxidation.

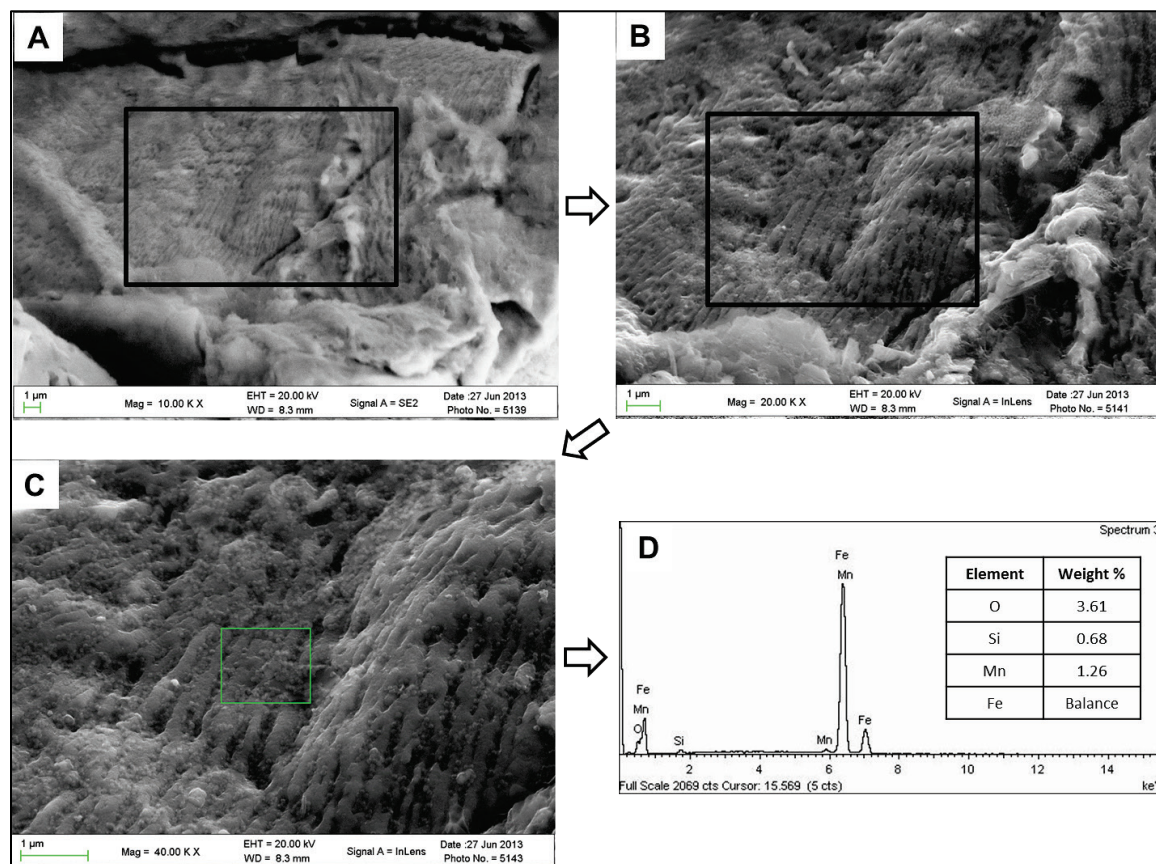
Figure 59. SEM Fractographs of the “Cryo-Cracked” specimen in IOR Flange-to-Pipe Welded Component #1110-2, showing Lamellar Appearance. D) EDS Analysis of the Region inside the Green Box in Figure 59C showing the presence of Oxygen, Manganese, and Silicon. No Evidence of Methane Bubbles or Cavitation was Observed on the Fracture Surface.

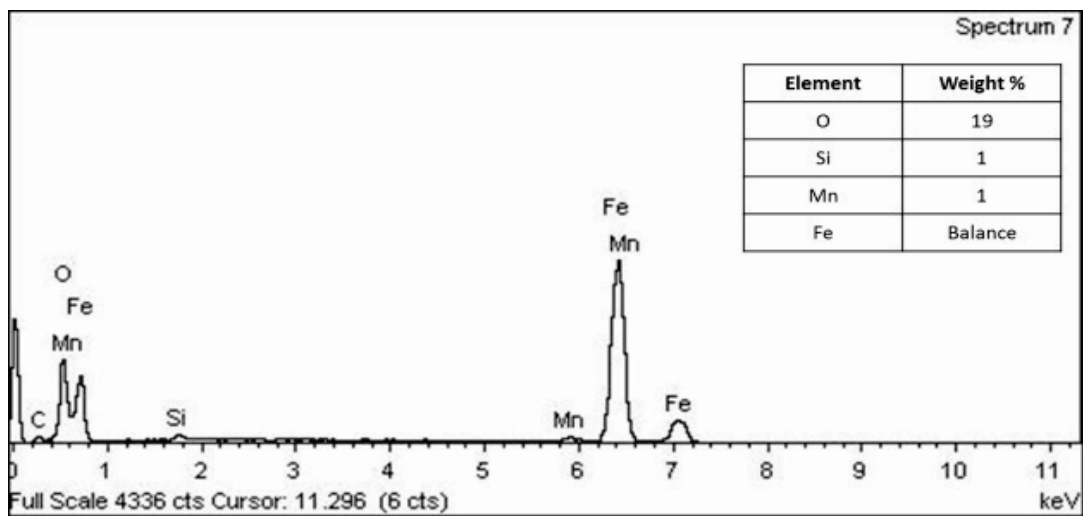
Figure 61. EDS Analysis of the Pre-Existing Crack Surface at the Location immediately below the Crack Tip in IOR Flange-to-Pipe Welded Component #1110-2. No presence of Sulfur was detected compared to the 2 wt. % Sulfur detected at the Location adjacent to the Inside Diameter Surface (Figure 60).
