**Experimental and Analytical Study of Dynamic Behavior of Bridge  
Superstructures Subjected to Overheight Vehicle Collisions**

A Dissertation Presented for the  
Doctor of Philosophy  
Degree  
The University of Tennessee, Knoxville

Yuan Jing  
May 2017

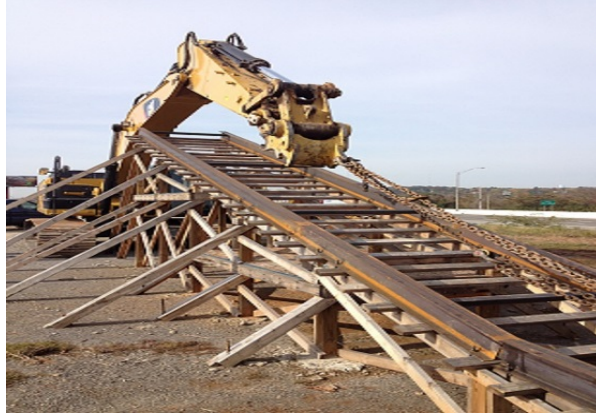
Figure 2.3 Track System and Excavator

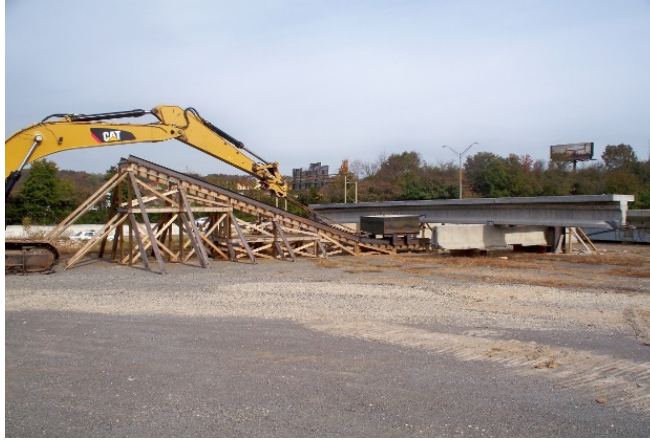
Figure 3.2 Prestressed Concrete Girder Setup

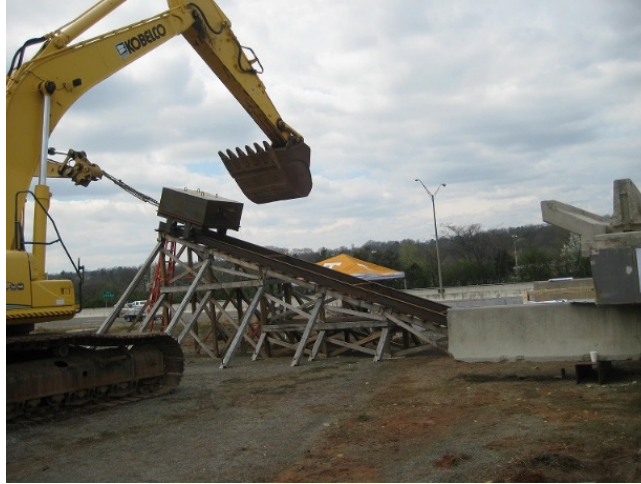
Figure 3.12 Impact Cart and Second Excavator

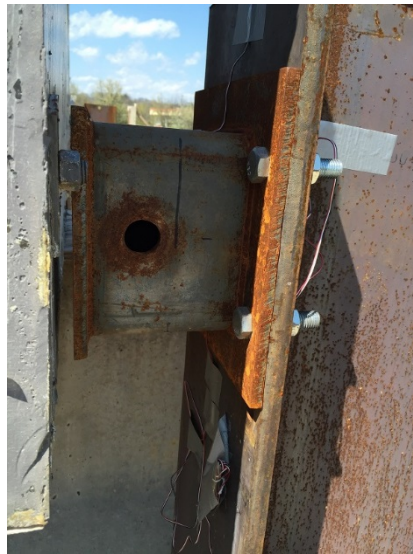
The distance between the specimen and the backstop HSS steel tubes after impact was about 1.59 cm (0.63 in.), as shown in **Fig. 3.15**.

Figure 3.15 Distance between Specimen and Steel Tube after Impact

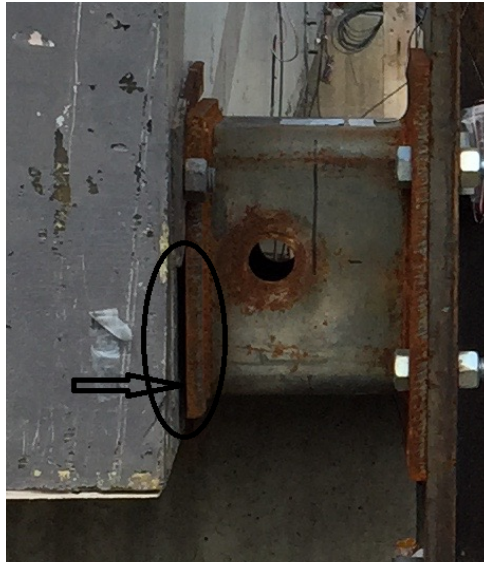
Figure 3.20 Lateral Boundary Condition of HCB Bridge

The dimension of steel tube is 20.3 cm x 20.3 cm x 1.27 cm (8 in. x 8 in. x 0.5 in.), the area used to calculate the compression force is  $A = 20.3 \text{ cm} \times 1.27 \text{ cm} = 25.8 \text{ cm}^2$  (4.0 in.<sup>2</sup>). The maximum compression forces from gages SG17-SG20 are 21.9 kN (4.92 kips), 427 kN (96.1 kips), 73.8 kN (16.6 kips), and 343 kN (77 kips) respectively. Therefore, the compression forces from top strain gages can be neglected compared to the forces from bottom strain gages. The reaction force was calculated as the sum of compression forces from two bottom strain gages, as shown in **Fig. 3.21**.

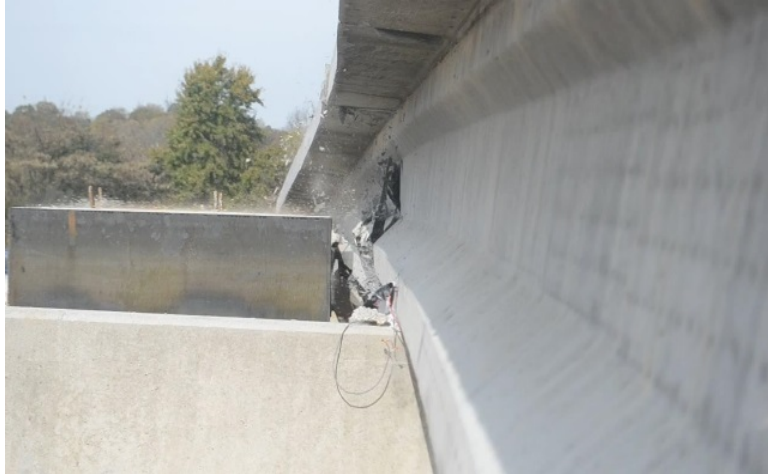
Figure 4.13 PC Girder at  $t=0.1$  s from Side View
