# **Land Use Change and Fluvial System Dynamics in Upper North Potato Creek, Copper Basin, Tennessee**

**A Thesis**

**Master of Science Degree**

**The University of Tennessee, Knoxville**

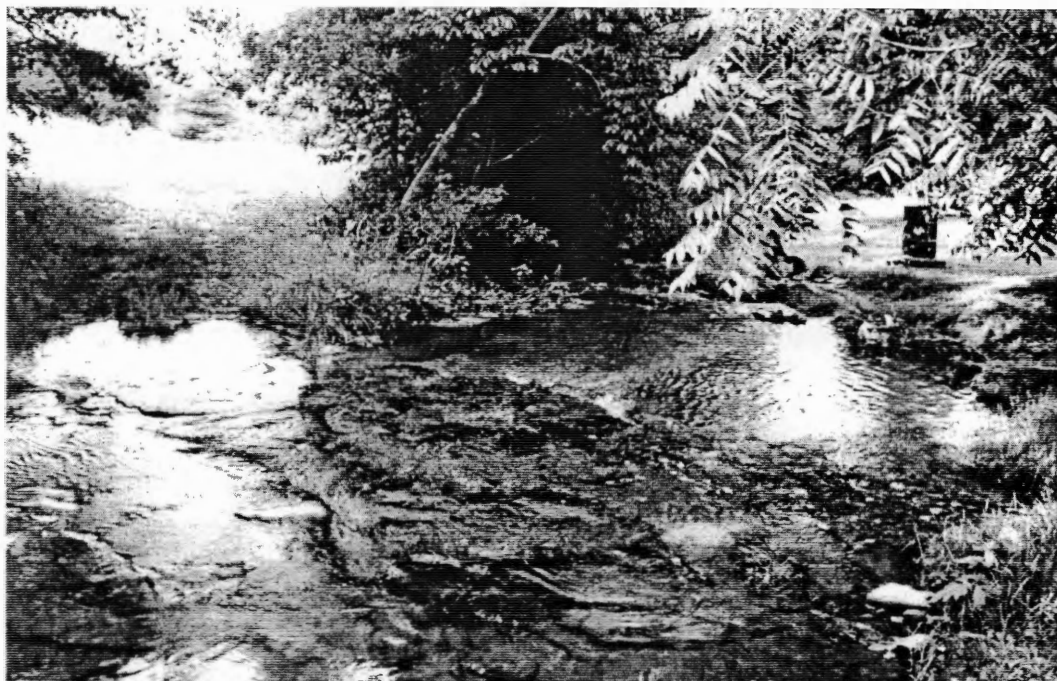
Figure 2.4 Photograph of the Prince Site Looking Downstream

Site 1 (“Prince”), the highest of the three sites, is a 100 m reach located on the property of long-term resident Gene Prince (Figures 2.2, 2.4). The channel at this site is almost entirely in bedrock. The stream gradient increases as water cascades over tilted bedrock shelves. Loose sediment and small boulders are present in small quantities along pools in this section, but they are scarce. A thin wooded corridor borders the east side of the creek and a grass lawn borders the west. Based on my criteria, this reach appears to represent typical stream reaches in the upper watershed.

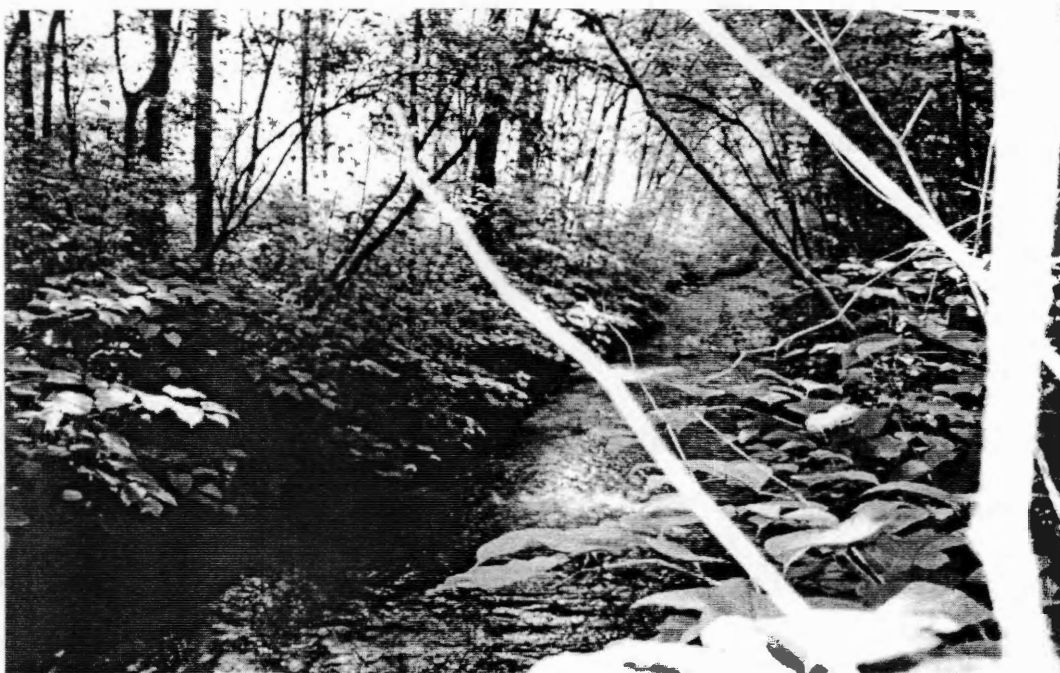
Figure 2.5 Photograph of the Bethlehem Site Looking Upstream

Site 2 (“Bethlehem”) is located along Bethlehem Rd. (Figures 2.2, 2.5). Here, North Potato Creek is filled with fine to coarse sand, cobbles, and small boulders. Bedrock is visible on the streambed throughout this 200 m reach. The creek is bordered

on either side by a narrow floodplain with heavily vegetated terraces 1.5 meters above it. This reach appears to represent the stream in the middle portion of the watershed.

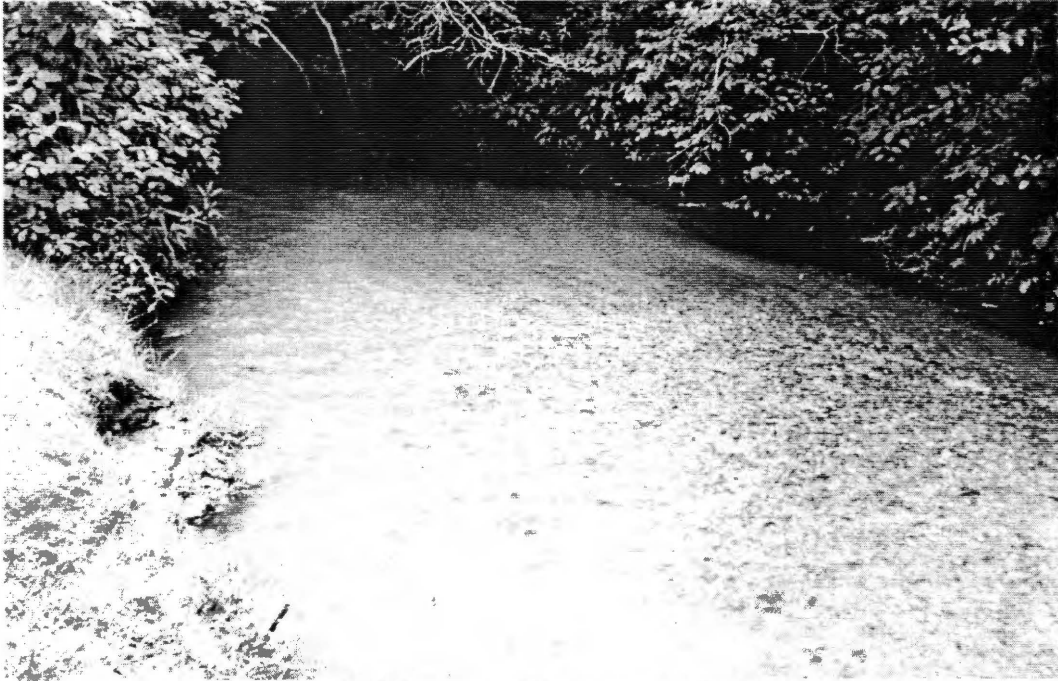
Figure 2.6 Photograph of the Monastery Site Looking Downstream

At Site 3 (“Monastery”), the lowest site, the stream flows through the grounds of a monastery 1 km above a sediment dam (Figures 2.2, 2.6) built to trap sediment. Upstream from the dam, water flows tranquilly over a bed surface covered with mostly sand and gravel deposits. Occasionally, boulders and bedrock can be found in the channel, but initial observations revealed a deep layer of sand and gravel-sized sediment on the channel bed. According to the residents, sediment moves at a rapid rate and the bed morphology will noticeably change following a high flow event, at times forming a new pool or riffle sequence. Indicators of present sediment movement are both bank erosion and depositional bars. This 200 m reach appears representative of North Potato Creek in this section of the watershed. Below this site, however, the stream is manipulated with holding ponds and mining operations and is too inaccessible and allegedly dangerous to study.
