LINKING CHANNEL INSTABILITY TO URBANIZATION  
IN THE UPPER BEAVER CREEK WATERSHED,  
KNOX COUNTY, TENNESSEE.

A Thesis  
Presented for the  
Master of Science  
Degree  
The University of Tennessee, Knoxville

Esther Sullivan Parish  
May 2002

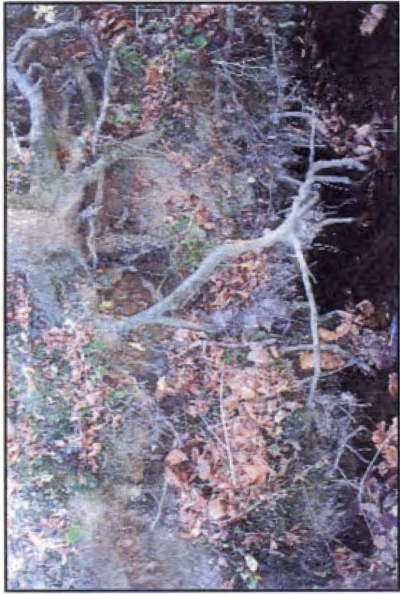
A. An undercut bank with exposed tree roots at KB01.

**Figure 3-2. Examples of Bank Erosion**

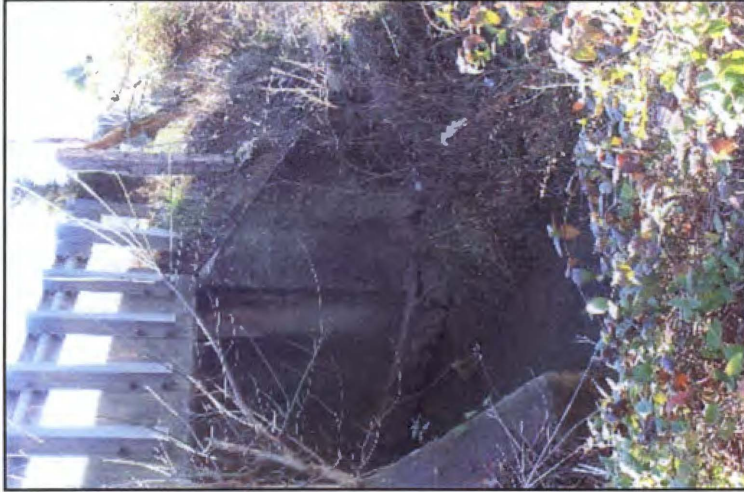
C. An exposed bridge footing at TS01.
