**The Use of Terrestrial Laser Scanning  
to Assess the Mobilization of  
Contaminated Creekbank Soils in Oak  
Ridge, Tennessee**

Tyler C. Musante

August 2025

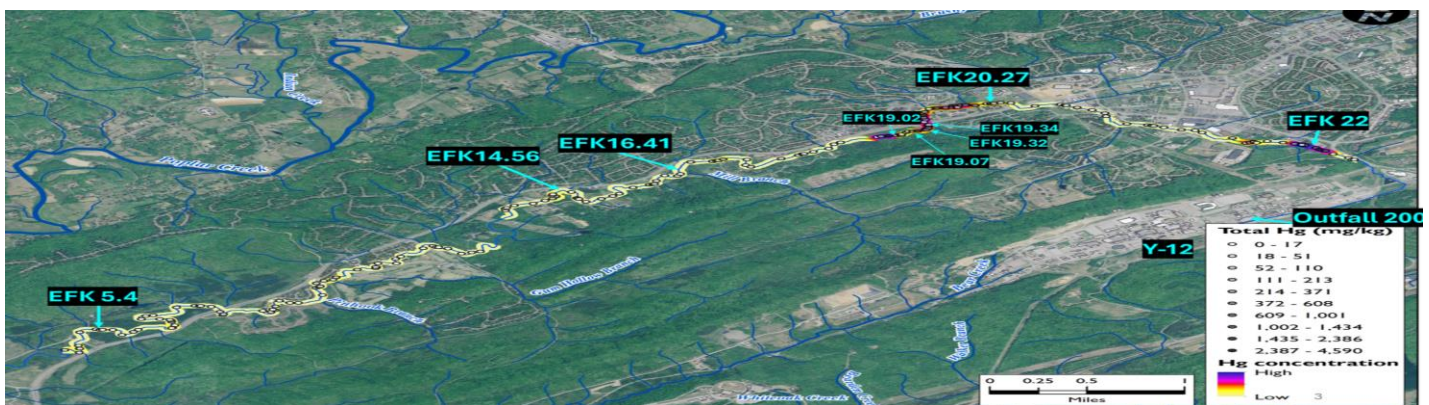
Figure 3: Map of the EFPC watershed. Total mercury concentrations in bank soils are indicated by a color gradient. East Fork Kilometer (EFK) markers show scanned field sites.

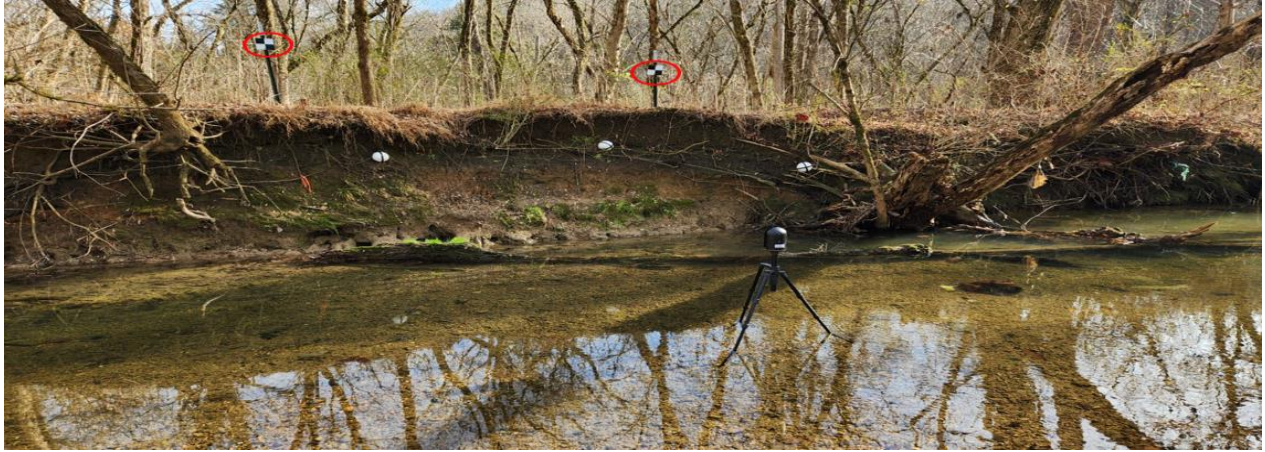
Figure 5: Photo of a regular field setup with georeferenced targets circled in red.
