**Investigation of Blade Stall from a H-46 Helicopter Dynamic  
Component Upgrade Test**

**A Thesis  
Presented for the  
Master of Science Degree  
The University of Tennessee, Knoxville**

Lieutenant Colonel Michael Adrian L'Heureux USMC

August 2001

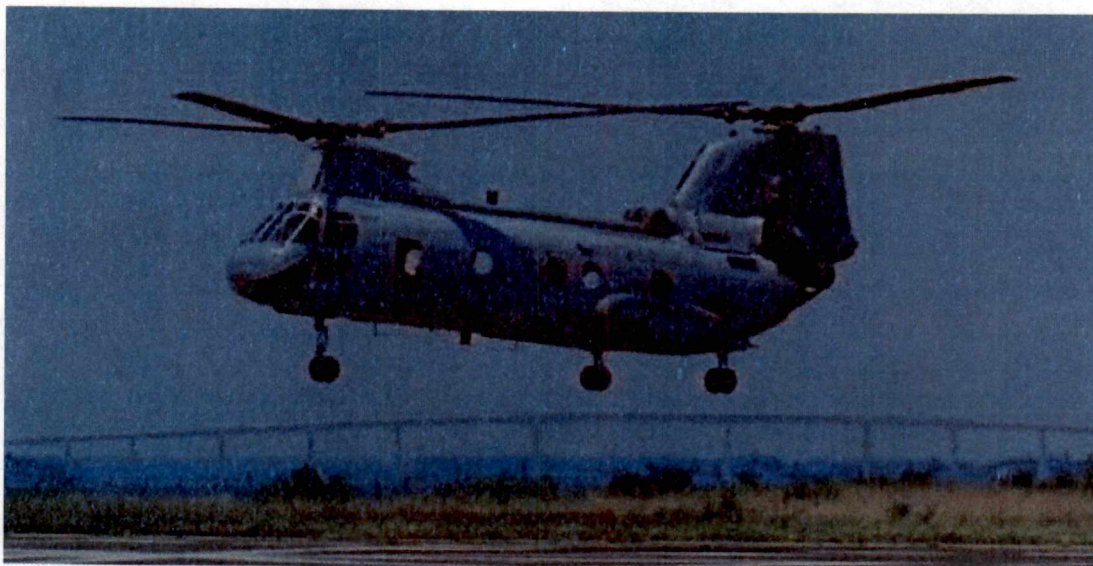
Figure 1 Boeing CH-46E Sea Knight Helicopter

This thesis investigates the results, conclusions, and recommendations revolving around a specific in-flight incident that occurred during the testing of a Boeing Sea Knight (CH-46E) helicopter (Bureau Number 153355) for the Dynamic Component Upgrade and Fuselage Strain Survey (DCU) testing Program. The Sea Knight, (figure 1) manufactured by Boeing Helicopter, is a tandem-rotor assault helicopter with a maximum gross weight of 24,300 lb. Two T58-16 turbo-shaft engines rated at 1,870 shaft horsepower each at military rating power the aircraft. Power is transferred through a transmission system consisting of a combining gearbox, an aft transmission, a synchronizing shaft, and a forward transmission. Each transmission drives a three bladed 51-foot diameter, fully articulated rotor system.
