A STUDY OF THE HYDROLOGY OF THE CANE CREEK WATERSHED

A THESIS

by  
Bernard High Zellner

June 1952

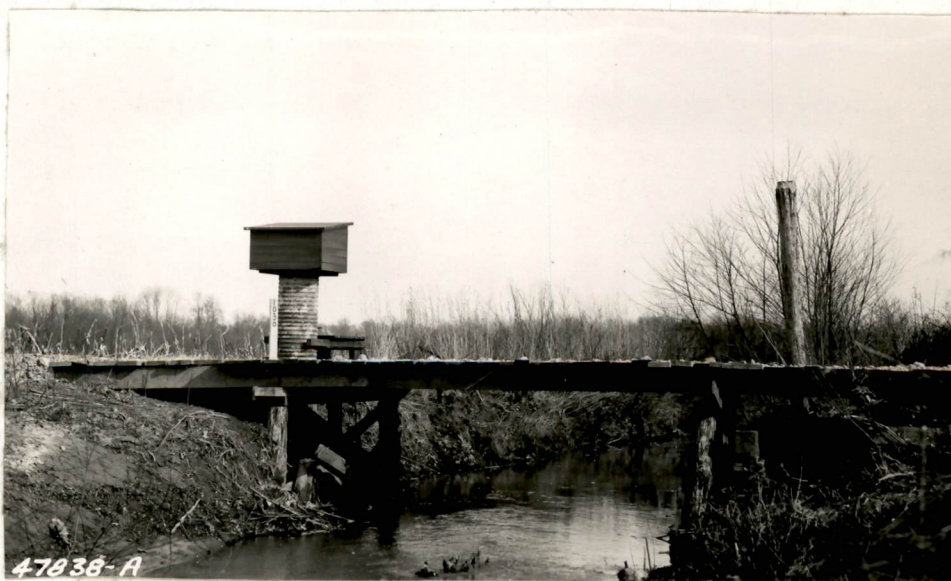
Figure 1. Cane Creek Gaging Station

This view, taken January 22, 1951, shows the stream gage on Cane Creek along the road leading south from Chesterfield, Tennessee.

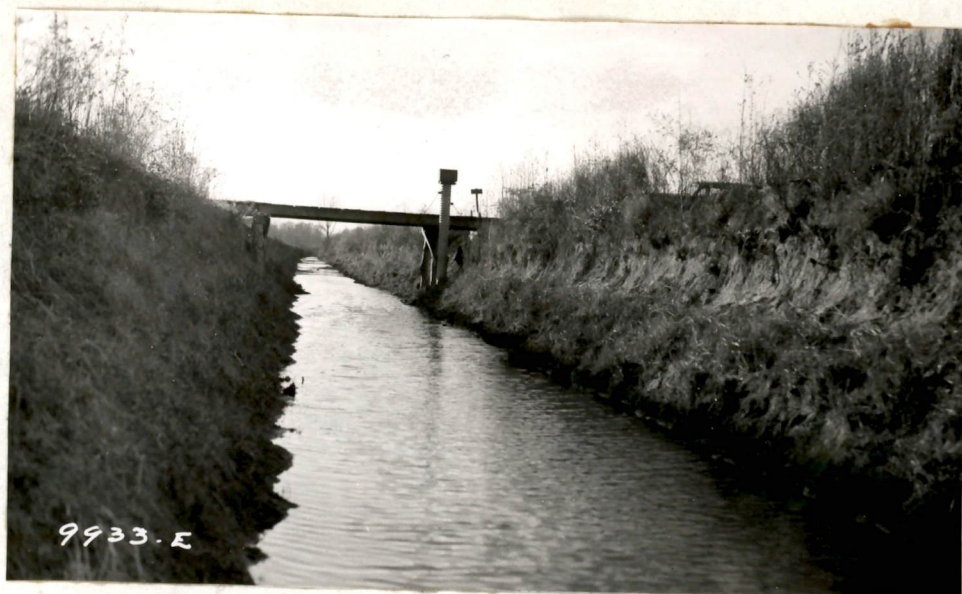
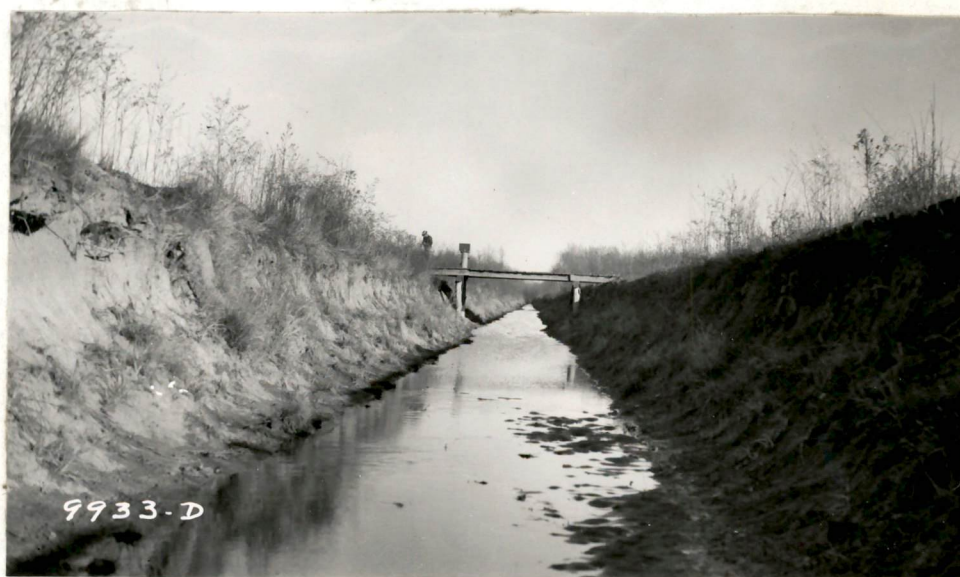
Figure 2. Cane Creek Drainage Canal in December 1939

The Cane Creek canal, shown here in the vicinity of the Chesterfield Road, was in very good condition when these pictures were taken on December 19, 1939.

The lower two miles of the Cane Creek channel was still in good condition in 1939 and early 1940 after the work that was done in 1937. The period beginning in the summer of 1940 and extending through 1941 was the driest period in more than 50 years of record. Between June 1 and October 31, 1941, there was no flow in Cane Creek and during this

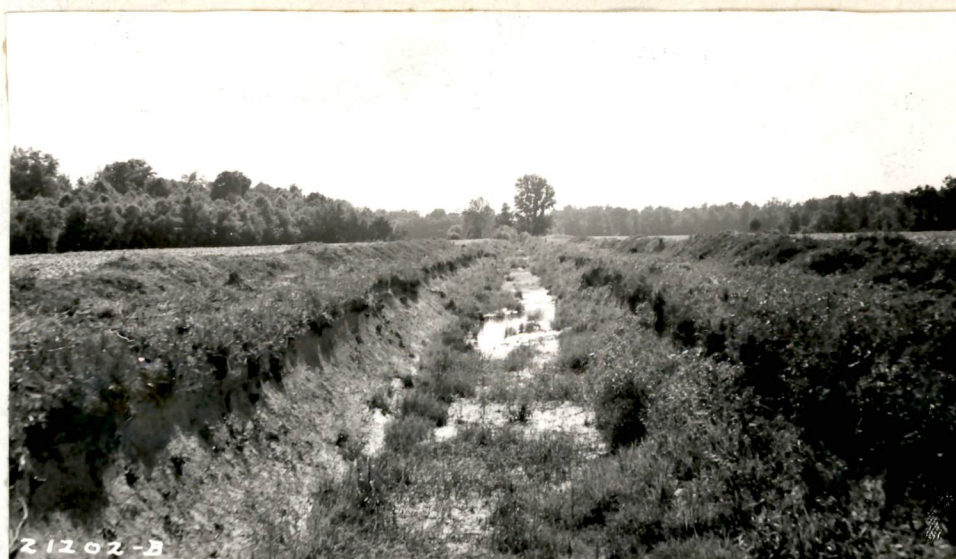
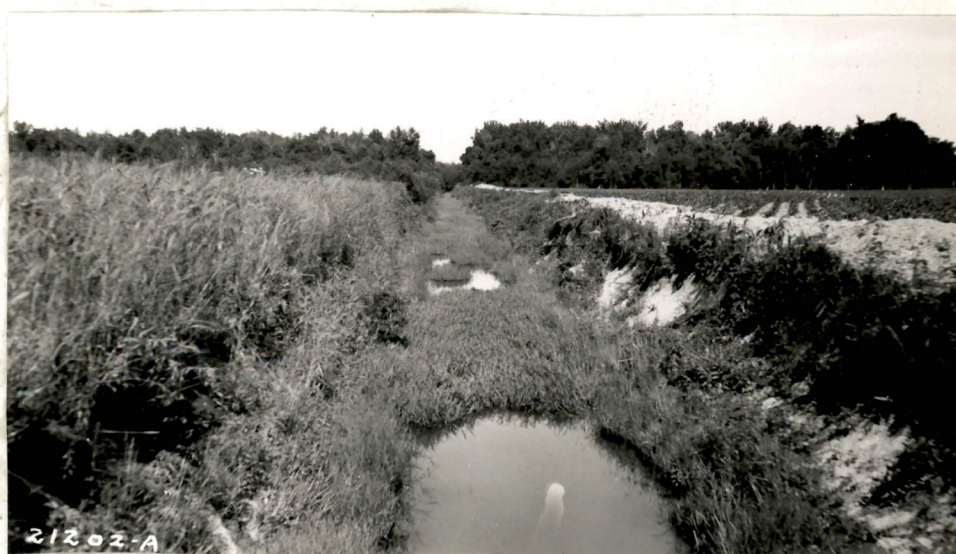
Figure 3. Vegetation in Cane Creek Canal in June 1942

During the summers of 1941 and 1942 there was no flow in Cane Creek for long periods, and vegetation began to grow up in the channel. These views are looking up and downstream from the Chesterfield Road bridge. Taken on June 24, 1942.

time grass and weeds grew in the bed of the stream. Figure 3 shows the vegetal cover in 1942. The interference to flow caused by this vegetation and the accumulation of sediment in the stream resulted in a very sharp reduction in channel capacity. Discharge measurements made in 1941-1942 showed that in those years a flow of 360 cubic feet per second filled the channel to bankfull stage as compared to 510 cubic feet per second in 1940. The growth of vegetation and the accumulation of sediment continued through 1943 and 1944 but with a reduced rate. The channel capacity in 1943-1944 was 320 cubic feet per second.

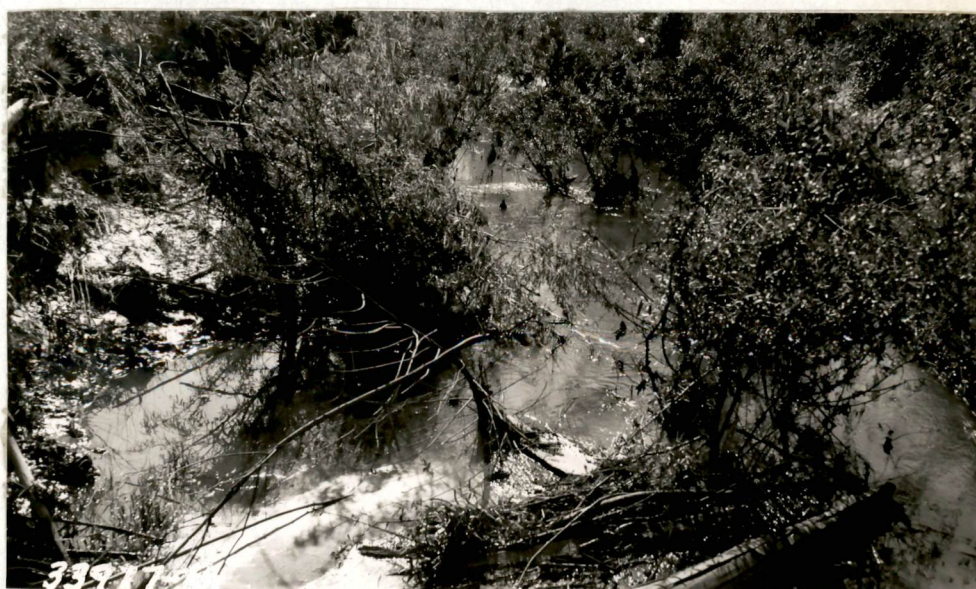
Figure 4. Brush and Debris Above Cane Creek Bridge

By April 18, 1946, when this picture was taken, brush had nearly filled the channel of Cane Creek at the Chesterfield Road bridge.

In 1944 or 1945, Mrs. Ada Rogers, whose property is on the old Cane Creek drainage canal about one mile downstream from the gaging station, sold the timber on her land to outside interests (4). In cutting the timber, tree tops and logs were allowed to fall into the channel. They were never removed. This condition contributed greatly to the drastic reduction in channel capacity that occurred during this period. Between the spring of 1944 and the spring of 1945, the capacity of the Cane Creek channel at bankfull stage dropped from 320 cubic feet per second to 160 cubic feet per second. From 1945 to 1951, as shown by Figures 4 to 6, the channel has continued to deteriorate but at a greatly reduced rate. The 1951 rating table shows a channel capacity at bankfull stage of 140 cubic feet per second, 27 percent of the 1940 discharge at this stage. Table VIII shows channel capacities for various periods of stream flow record.

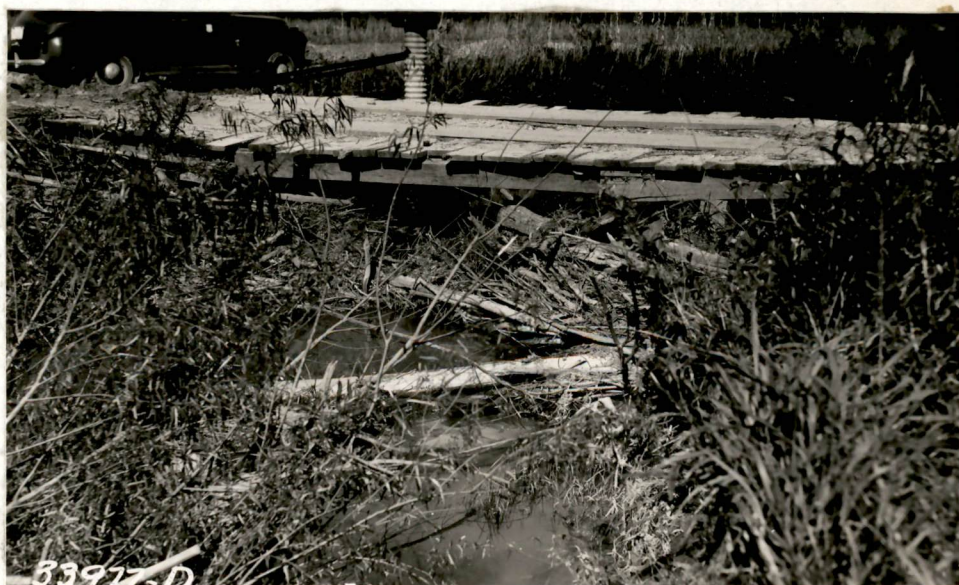
Figure 5. Cane Creek Bridge Blocked by Drift

The waterway under the bridge was almost completely blocked with drift when this picture was taken on April 18, 1946.

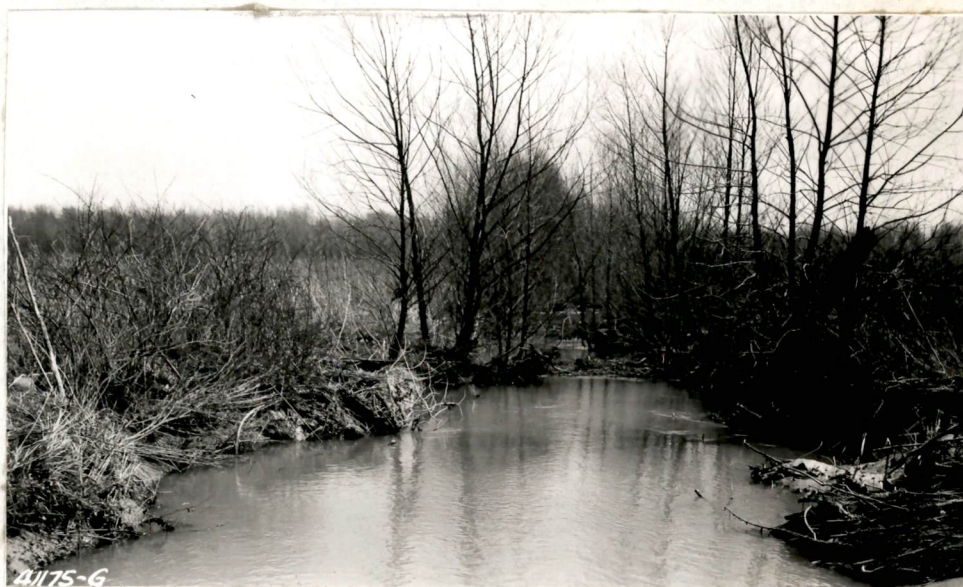
Figure 6. Trees and Drift Hindered Flow in March 1949

By 1949 the Cane Creek canal was badly choked with vegetation, sediment, and drift. This view looking downstream from Chesterfield Road bridge was taken on March 10, 1949, with a flow of about 100 cubic feet per second.

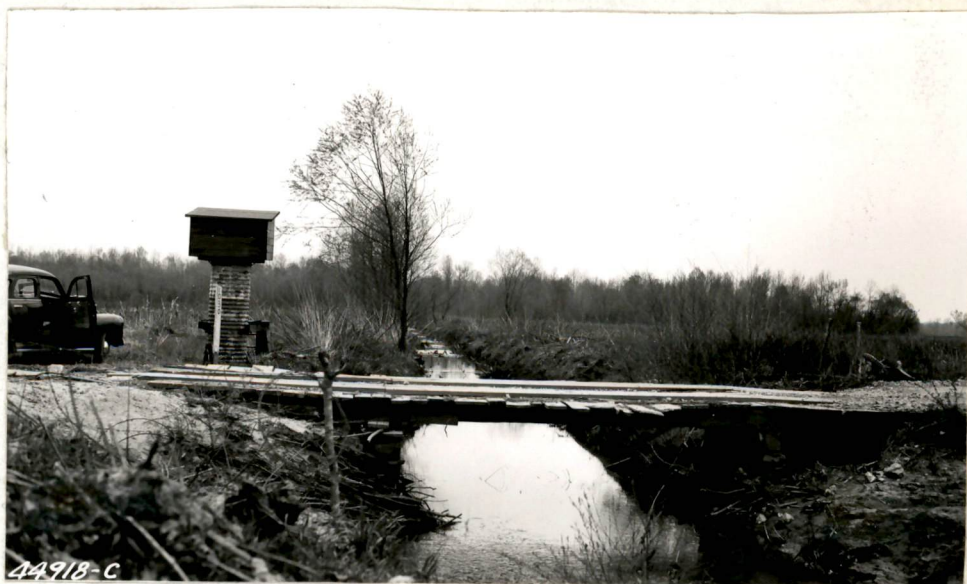
Figure 7. After Channel Clearing in April 1950

In April 1950, farmers along Cane Creek near Chesterfield cleared brush and trees and dynamited drifts and sediment deposits from a 1200-foot reach of the creek. This view taken on April 17, 1950, is looking downstream at the Chesterfield Road bridge.

1950, farmers spent \$350 in clearing brush and trees from the canal and its banks for a distance of 600 feet above and below the gaging station. Drifts and heavy sediment deposits were dynamited (4). Figures 7 and 8 show Cane Creek after this work was completed. Apparently nothing was done on the Rogers property and the work near the gage had little effect. By summer the vegetation was again growing, and by the spring of 1951, conditions in the reach were nearly as bad as before. This condition is shown by Figure 9.

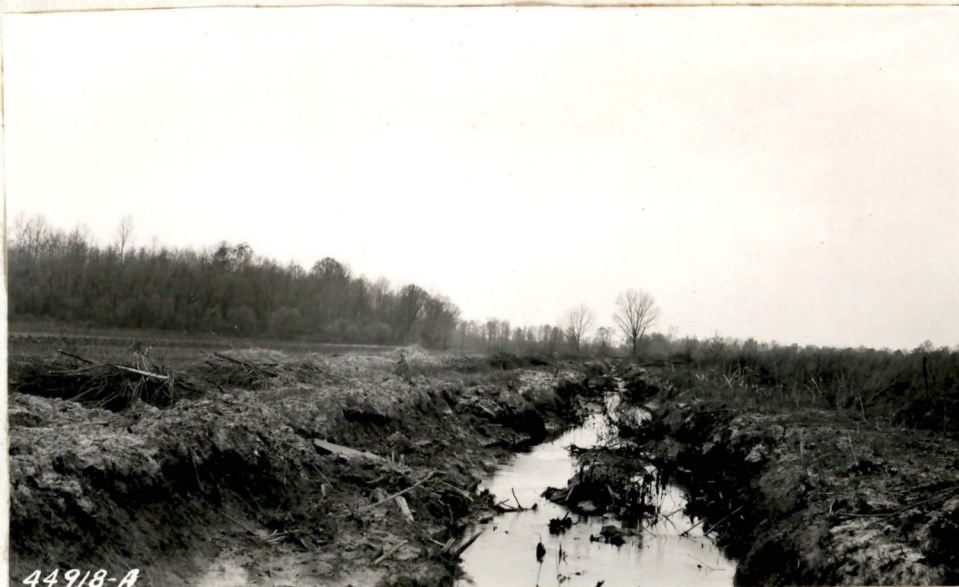
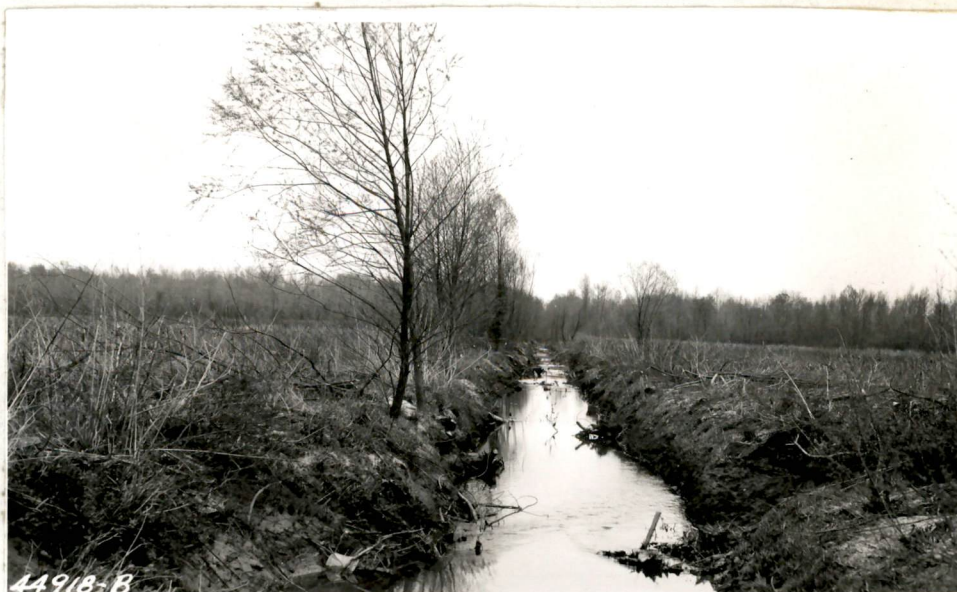
Figure 8. Dynamiting Partially Cleared Cane Creek in 1950

These two views from Chesterfield Road bridge show the reach extending 600 feet upstream and 600 feet downstream from the bridge that was cleaned out in April 1950. Taken on April 17, 1950, after most of the work had been completed.
