# STRUCTURAL BEHAVIOR OF A PILE FRAMED TIE BACK RETAINING WALL

A Thesis  
Presented for the  
Master of Science Degree  
The University of Tennessee, Knoxville

Mieah Dee Turner  
December 2009

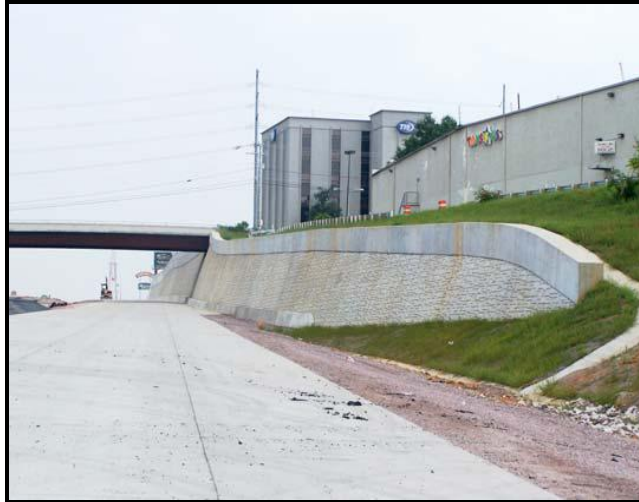
**Figure 1-1. Pile Framed Tie Back Retaining Wall at West Hills  
(Pate and Haddad 2007)**

A similar land limitation site challenged TDOT during the widening project of I-40/75 a few years earlier. The site was located at the West Hills eastbound exit ramp. Due to the pre-developed land surrounding the interstate, the major cost of land limitations was a concern to TDOT. In order for a typical cantilever retaining wall to be constructed the right-of-way behind the wall requires a minimum distance of the height of the wall. The required right-of-way was not possible without spending millions of dollars to acquire the land where an office building and commercial shopping center stood. Figure 1-1 shows the completed retaining wall and the limited right-of-way. The engineers at TDOT created a new retaining wall concept that used a top-down construction technique and H-pile framing called a pile framed tie back retaining wall. The wall is heavily reinforced to compensate for unknown forces that the wall experiences.

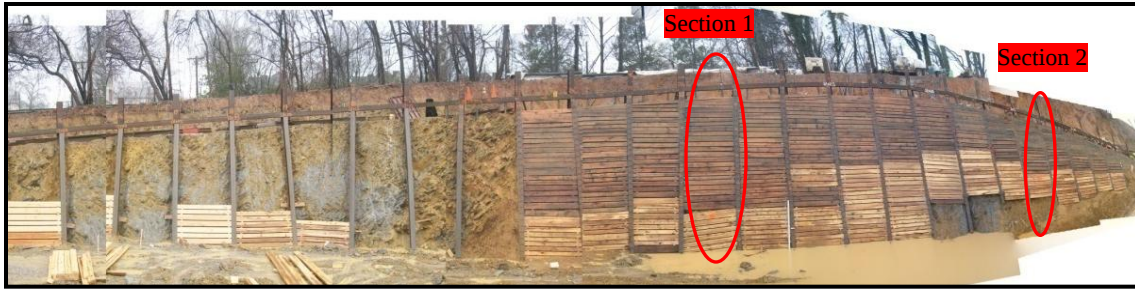
**Figure 1-4. Soil Profile of Excavated Wall**

The geotechnical investigation was performed by Wilbur Smith Associates, Inc. Overall the soil conditions consisted mostly of 5 feet of clay fill followed by interbedded calcareous sandstone and calcareous shale. The report also indicates a variety of areas with weathered rock and rock. (Wilbur Smith Associates, Inc. 2006) Figure 1-4 shows the excavated retaining wall and the two instrumented sections.

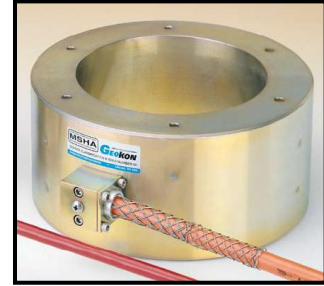
**Figure 2-1. Instrumentation**  
([www.geokon.com](http://www.geokon.com))

The strains at selected points along the steel piles are measured using the Model 4000 Arc Weldable Strain Gage from Geokon. The six inch strain gage is made up of a steel bar with two support blocks located on each end, with the support blocks welded to the steel piles. The frequency in the strain gage changes with the pile loading. An increase in strain reading indicates tension and a decrease indicates compression.

Geokon Model 4900 Load cells are installed on each of the two anchors located between the vertical piles. The load cells are cylindrical steel devices that are placed around each anchor. The load cell consists of three sensors that each contain six vibrating wires. The sensors are averaged together to find a more accurate reading and overcome any eccentricity that the bearing plate causes. As the anchor takes on loads an increase in reading occurs when the anchor rod is in tension.

Soil pressures that build up on the wall are measured by the Geokon Model 4800 Earth Pressure Cells. The earth pressure cells are constructed of two attached steel plates with hydraulic fluid between them. As the plates are compressed by the soil pressure, the hydraulic fluid is pressurized and converted to an electrical output using the vibrating wire technology. Compression of the earth pressure cell is indicated by an increase in reading from the initial value on the GK 403 Readout Box.
