**MICROBially INFLUENCED CORROSION  
OF AUSTENITIC STAINLESS STEEL WELDMENTS**

**A Dissertation**

**The University of Tennessee, Knoxville**

**Ping Li**

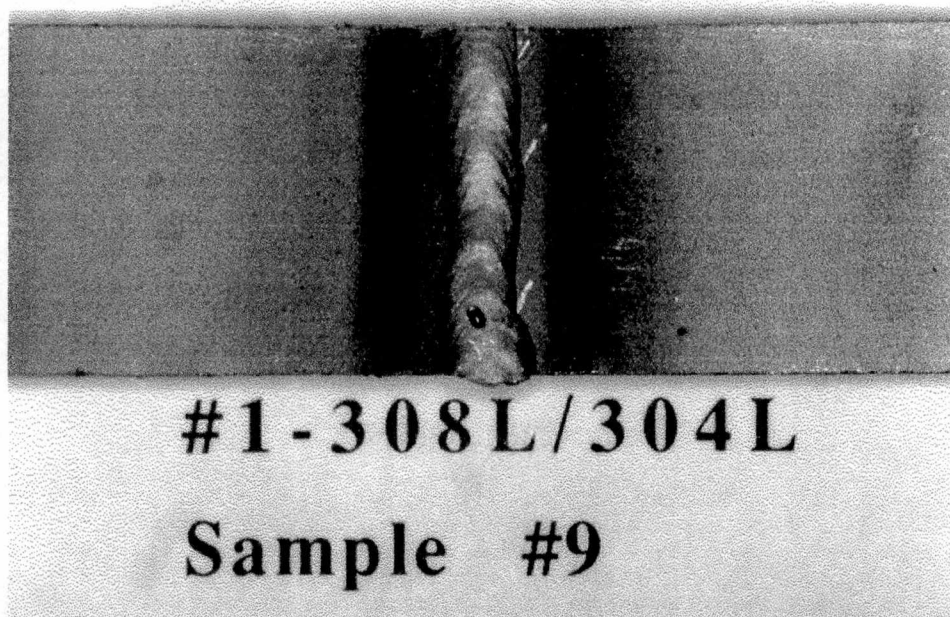
Figure 2-4. Coupon No. 1 having an as-welded surface prior to corrosion test.

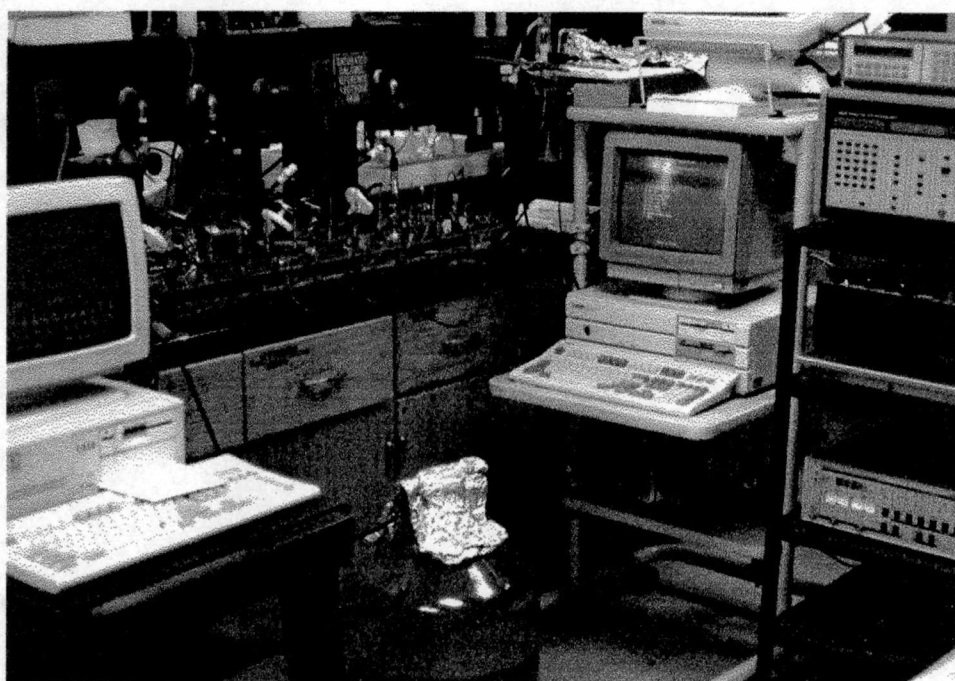
Figure 2-10. Laboratory experimental setup showing corrosion cell, solution supply system, and electrochemical measurement system.

A experimental setup (Figure 2-10) including a corrosion cell, a solution supply system, and an electrochemical measurement system, was designed for the MIC laboratory tests. The corrosion cell having dimensions of 2 x 2 x 48 inches was fabricated from Plexiglas. Thirteen corrosion coupons with ID weld surfaces exposed were mounted on the bottom of the cell and sealed with silicone. The solution system consisted of the medium reservoirs, as well as a waste vessel, to provide continuous culture conditions for

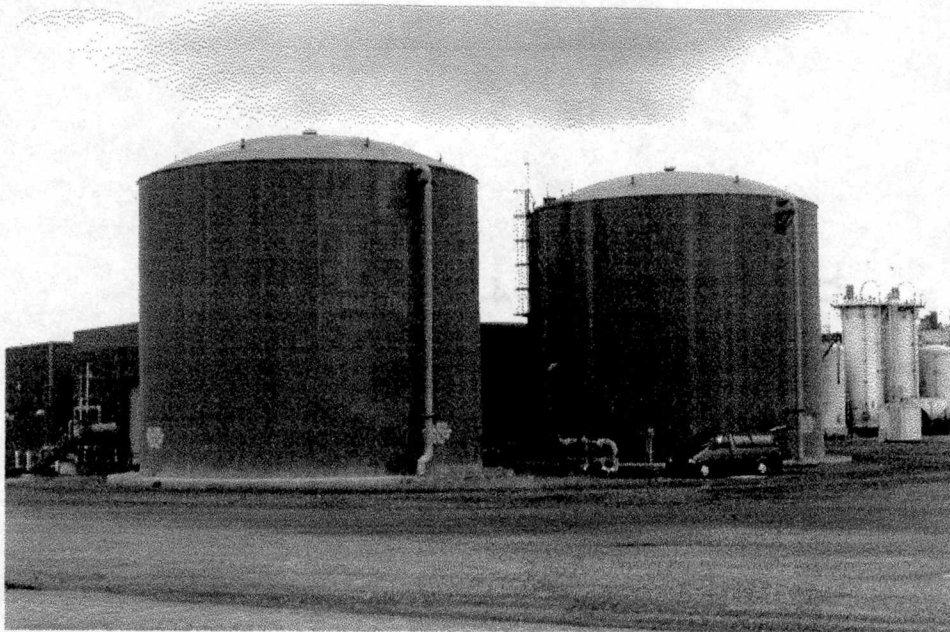
Figure 2-13. The field site at the Palo Verde Nuclear Generating Station near Phoenix, Arizona.

The coupons were exposed to the well water (pumped directly from the underground source) at the field site for 140 days, as shown in Figure 2-13. The temperature of the well water varied from 15 to 23°C. Chlorides were 126-635 ppm and oxygen was 1.0 ppm. Table 2-4 gives the inorganic chemical analysis of the water flowing through the test system. The volumetric flow rate was controlled by a needle valve at approximately 10 liters per hour, corresponding to a flow velocity of  $1.08 \times 10^{-3}$  meters per second ( $3.54 \times 10^{-3}$  feet per second). Periodically, open circuit potential data were collected with a portable electrometer and a saturated Ag/AgCl reference electrode from all thirteen weldment coupons and the platinum electrode for each cell. At the end of the exposure, each coupon was photographed in the cell. Biological scraping samples were taken from typical corrosion coupons.

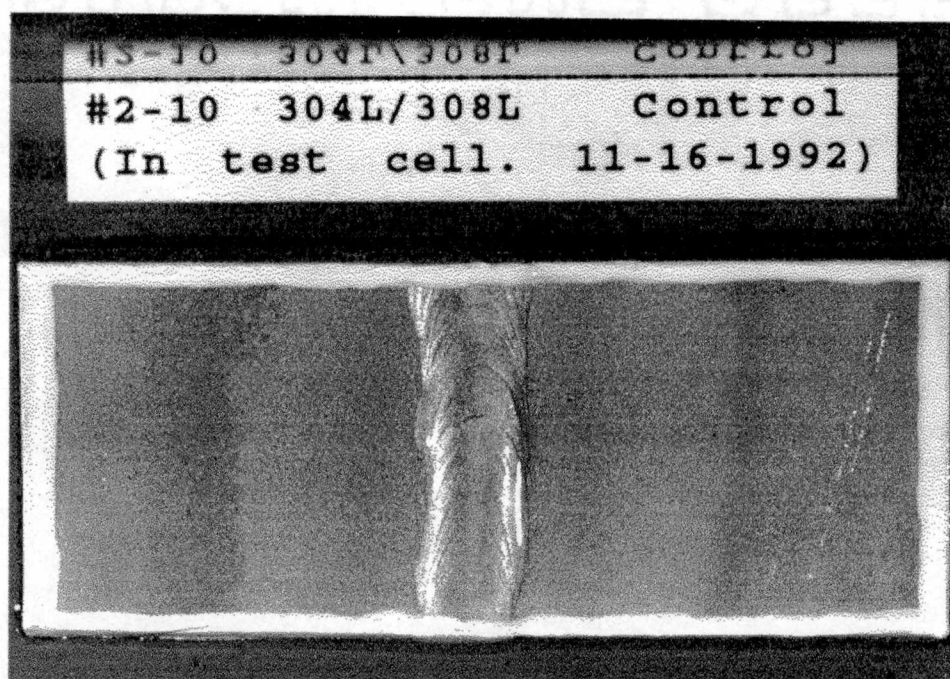
Figure 3-13. Photographs of 304L/308L, pickled, after the exposure: (a) Coupon #2 in Run 3; (b) Coupon #2 in Control Run.

After the 90-day exposure, the appearances of the weldments were photographed while in the corrosion cell. The weldments in order of the specimen's sequential number are shown in Figure 3-12 through Figure 3-24. The results of all bacterial runs and the control run, in terms of corrosion nodule number and size, are summarized in Table 3-1. Visual observation of the weldments after exposure showed that small corrosion nodules had formed at the epoxy interface in the weld region on all specimens except those for which the oxide layer had been removed by either chemical or electrochemical means. It is seen that specimens #2 (pickled, Figure 3-13), #3 (electropolished, Figure 3-14), and #4 (solution annealed + pickled, Figure 3-15) clearly showed corrosion resistance. Nodule formation was observed in all three runs with the bacteria inoculation after about 30 days exposure and in the control run without the bacteria inoculation. However, as shown in the Table 3-1, the numbers of nodules on each coupon for the control run was less, and the size was much smaller, compared to that for the bacterial runs. This result indicates that either the bacteria assisted the attack on the coupons or the environmental history exacerbated the corrosion since the bacteria had altered the environment before the nodule was observed. The corrosion nodules occurred at the metal/epoxy interface on the specimen surfaces in the heat tint area, as opposed to the base metal, suggesting that the

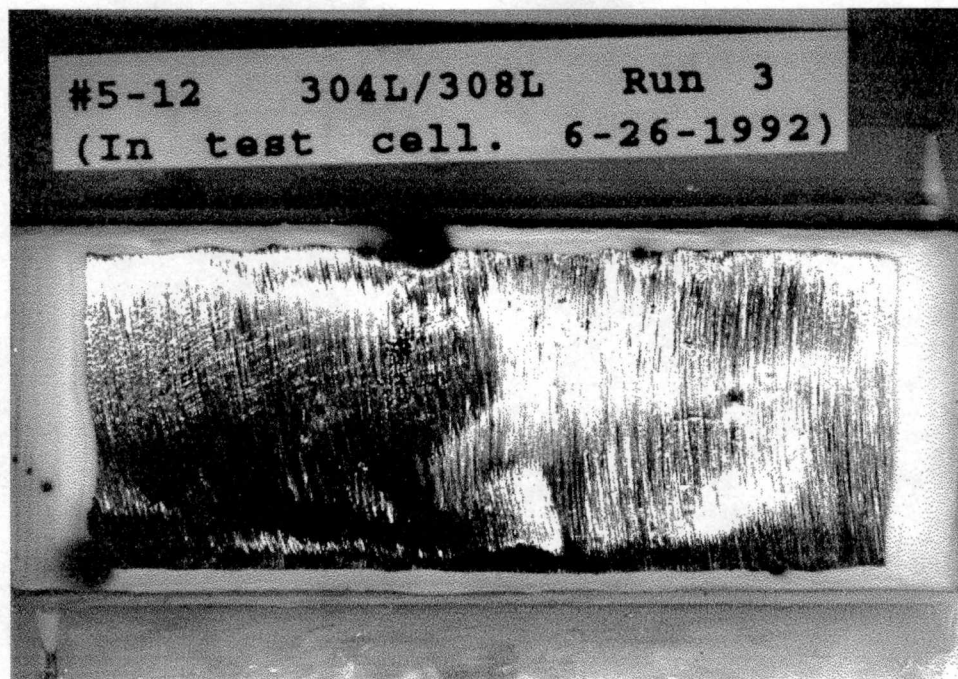
Figure 3-16. Photographs of 304L/308L, ground, after the exposure: (a) Coupon #5 in Run 3; (b) Coupon #5 in Control Run.

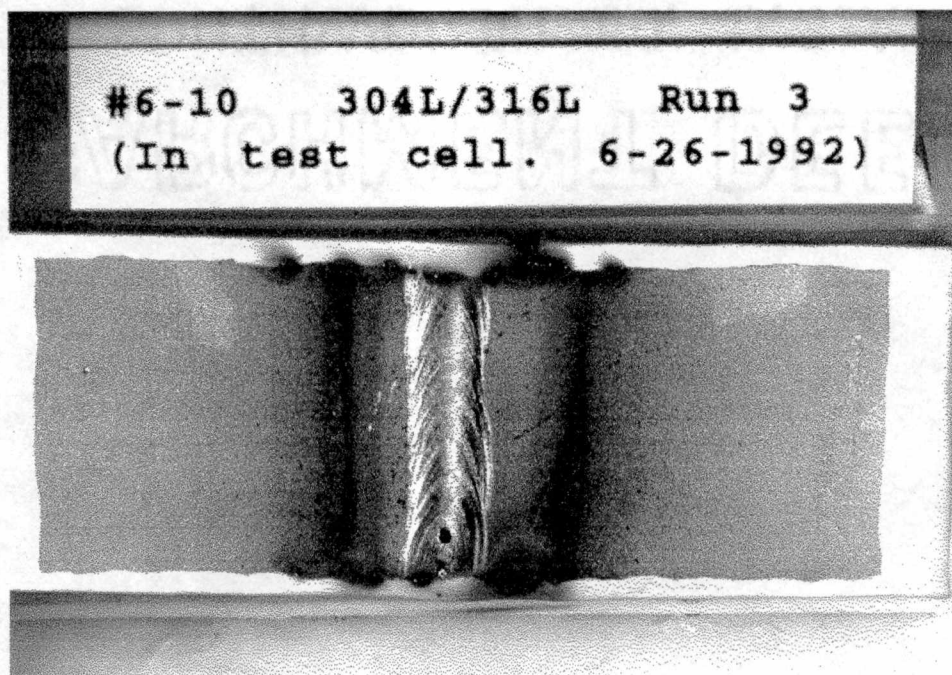
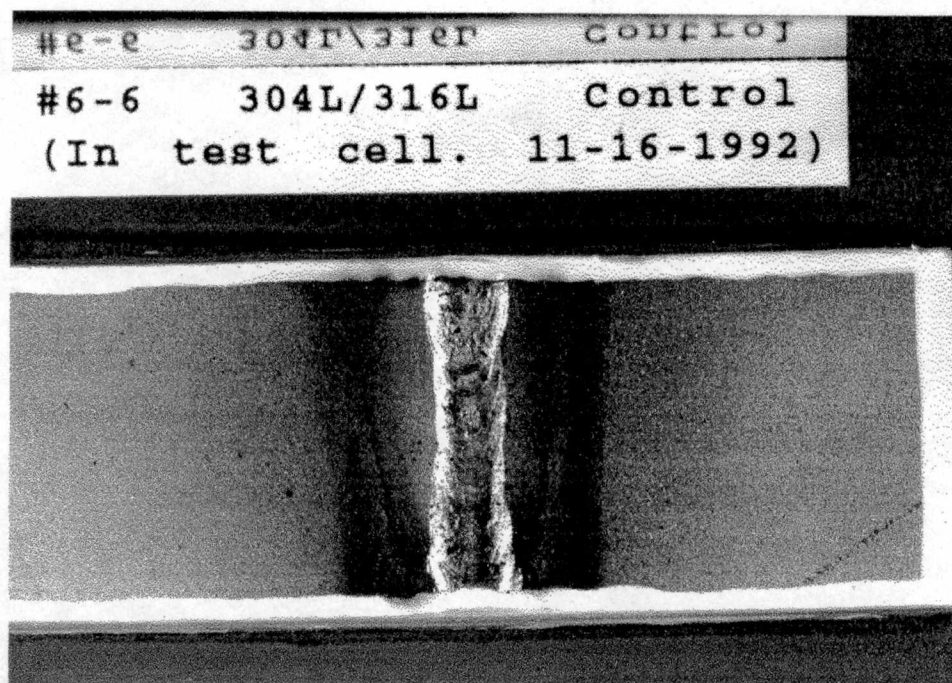
Figure 3-17. Photographs of 304L/316L, no treatment, after the exposure: (a) Coupon #6 in Run 3; (b) Coupon #6 in Control Run.

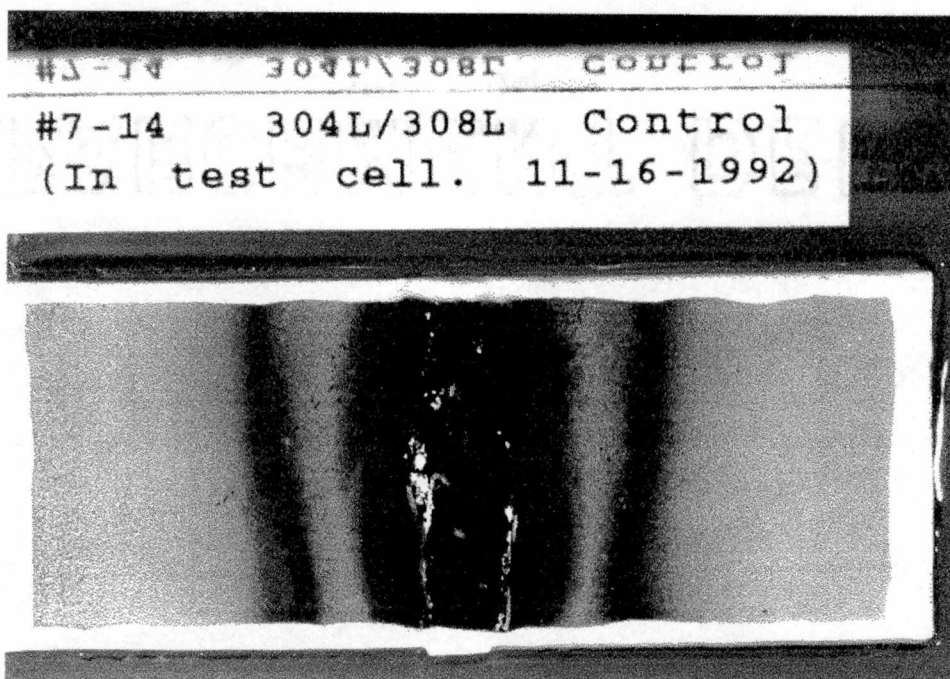
Figure 3-18. Photographs of 304L/308L, purge removal after root pass, after the exposure: (a) Coupon #7 in Run 3; (b) Coupon #7 in Control Run.

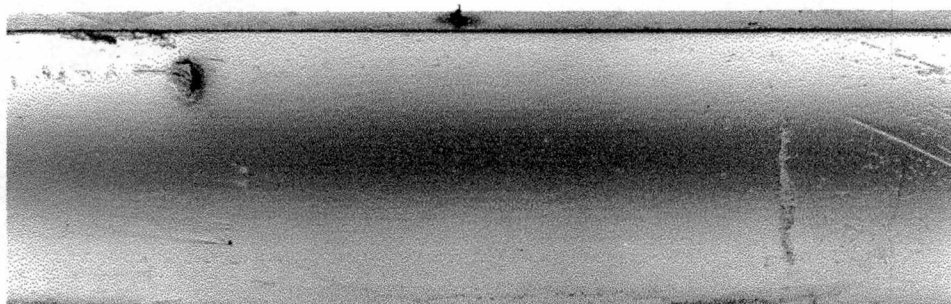
**The 800°F Gleeble specimen**

Figure 3-67. Photograph of the 800°F Gleeble specimen.

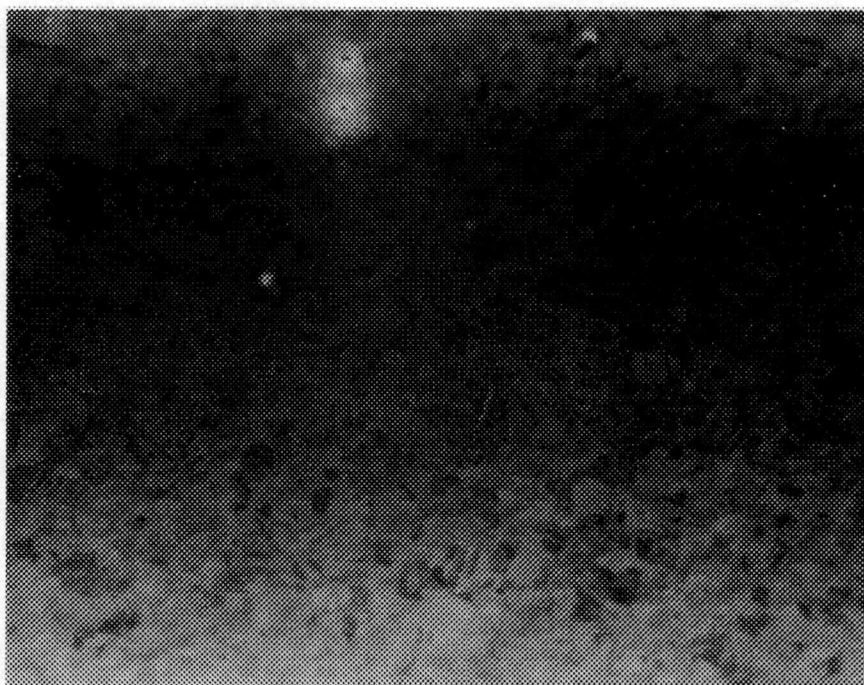
Figure 3-70. Photograph (30x) of the heat-tinted specimen showing grain boundaries at blue and straw-colored oxide regions after welding.

It is interesting to point out that a micro-grain structure after the welding was revealed from the surface at the blue and straw-colored oxide regions because of grain boundary movements (Figure 3-70). This grain boundary movements could have caused mechanical strain in the blue and straw-colored oxides.

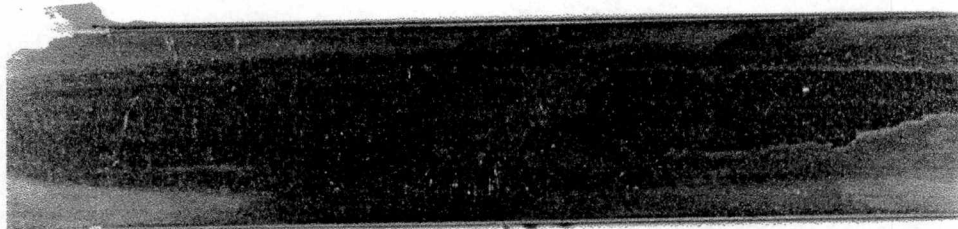
**SS GLEEBLE WELD SIMULATED  
IN ARGON , CREVICE SAMPLE IN  
BACTERIAL SOLN. (10-27-93)**

Figure 3-73. Photograph of the Gleeble specimen simulated in argon after the crevice corrosion test showing corrosion free surface.

two specimens almost had an identical potential profile although one specimen had oxide on the surface and the other one did not. The oxide specimen (Figure 3-72) experienced crevice corrosion attack at the oxide region while the non-oxide specimen (Figure 3-73) did not experienced crevice corrosion attack, indicating that the crevice corrosion was attributed to both the bacterial solution and the oxide.

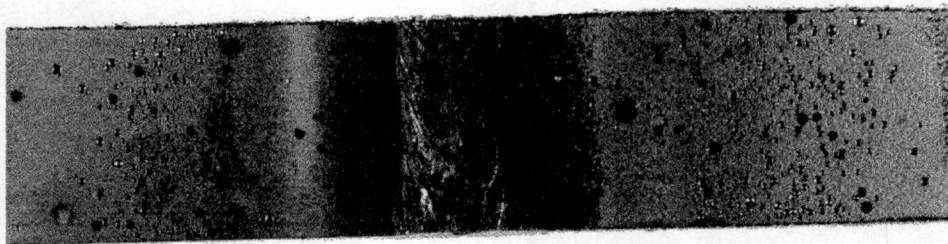
The as-welded 304L/308L weldment  
after pitting test

Figure 3-77. The as-welded 304L/308L weldment after pitting corrosion test per ASTM G48 specification.

An immersion test on the stainless steel weldments in Table 2-1 was carried out according to the ASTM G48 specification for the purpose of examining pitting resistance. The test was conducted in 6% ferric chloride solution at 50°C for 72 hours. After the test, it was found that pits were concentrated on the area away from weld bead, as shown in Figure 3-77 for the as-welded 304L/308L weldment. This area experienced lower temperatures during welding and was more susceptible to pitting corrosion. When the oxide was removed by pickling the 304L/308L weldment (Figure 3-78), pits tended to be more spread out and also fewer pits were observed.

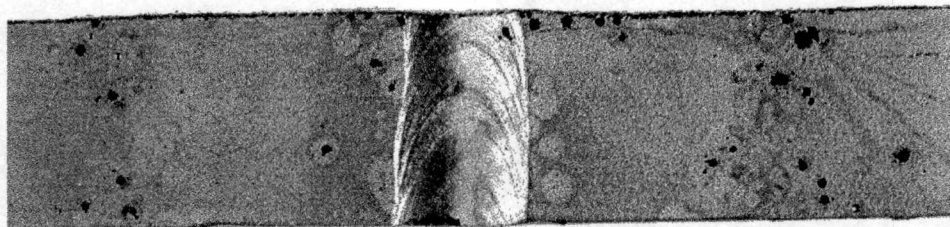
## The pickled 304L/308L weldment after pitting test

Figure 3-78. The pickled 304L/308L weldment after pitting corrosion test per ASTM G48 specification.

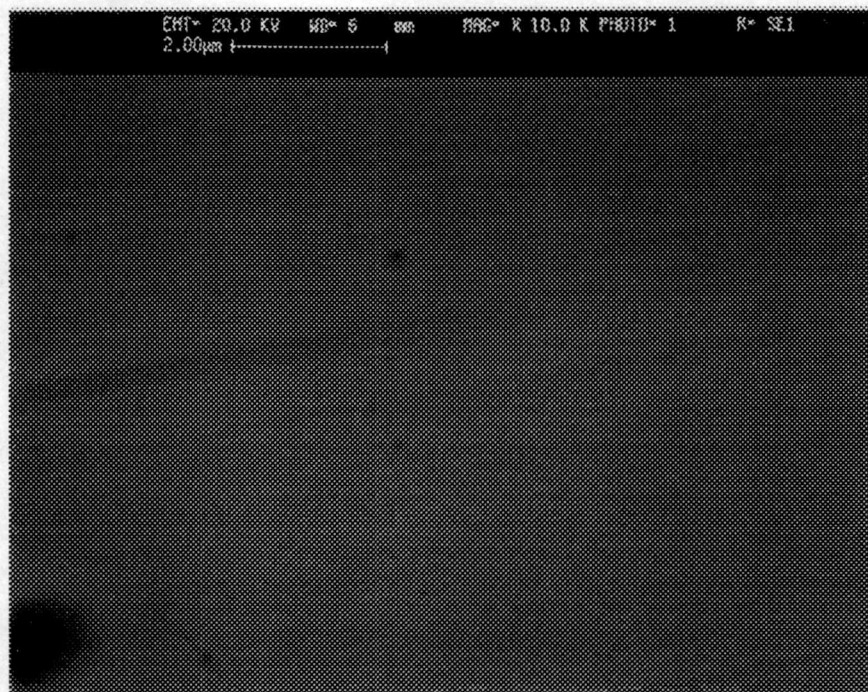
Figure 3-106. SEM micrograph of light yellow oxide of the 800°F Gleeble specimen showing oxide morphology.
