**AN INVESTIGATION INTO HOT GAS INGESTION**  
**BY AN HH-65A HELICOPTER**

A Thesis  
Presented for the  
Master of Science  
Degree  
The University of Tennessee, Knoxville

John Bradley Westerbeke  
August 1993

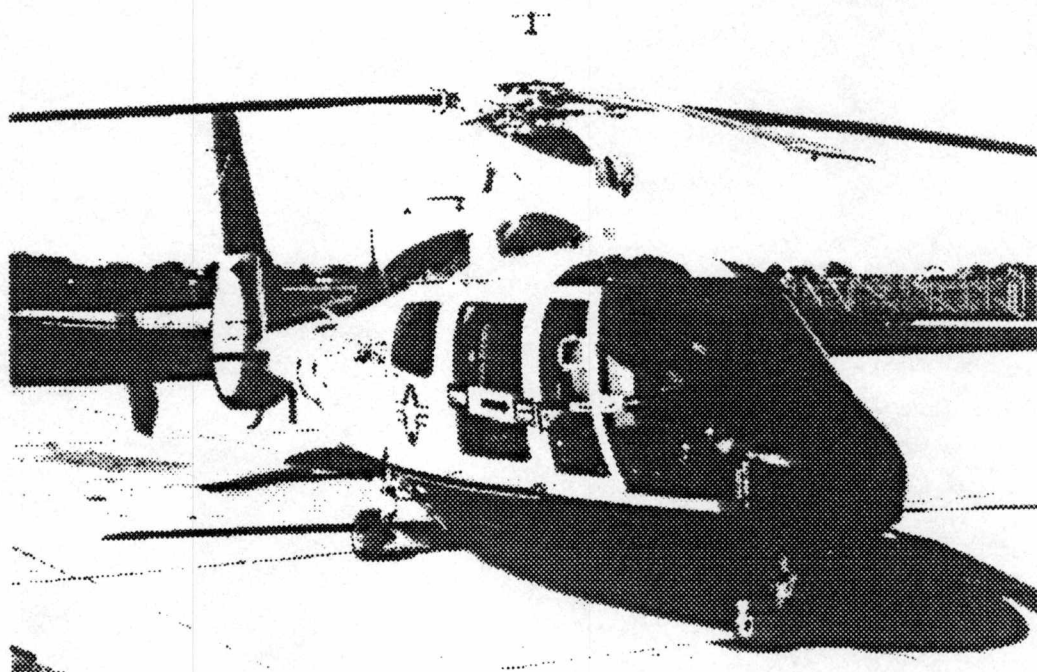
Figure 7. The HH-65A "Dolphin" Helicopter.

The HH-65A helicopter is used by the Coast Guard primarily for search and rescue operations originating from both shore based locations as well as from ships. This helicopter is configured with a four blade single main rotor and a single tail rotor for anti-torque control. It's maximum gross weight is 8,900 pounds, it has a maximum forward airspeed limit of 165 knots and a maximum sideward and rearward airspeed limit of 35 knots. The HH-65A is powered by two Lycoming LTS-101 gas turbine engines which produce a total output of 1,360 shaft horsepower. The main rotor diameter is 39.2 feet which results in a disk area of 1,204.8 square feet. Subtracting out the center portion of the main rotor disk where the blades are attached to the hub and in which no useful lift is produced, the main rotor disk area ( $A_D$ ) becomes 1,197 square feet. A diagram of the HH-65A is presented in figure 7. (HH-65A, 1992)

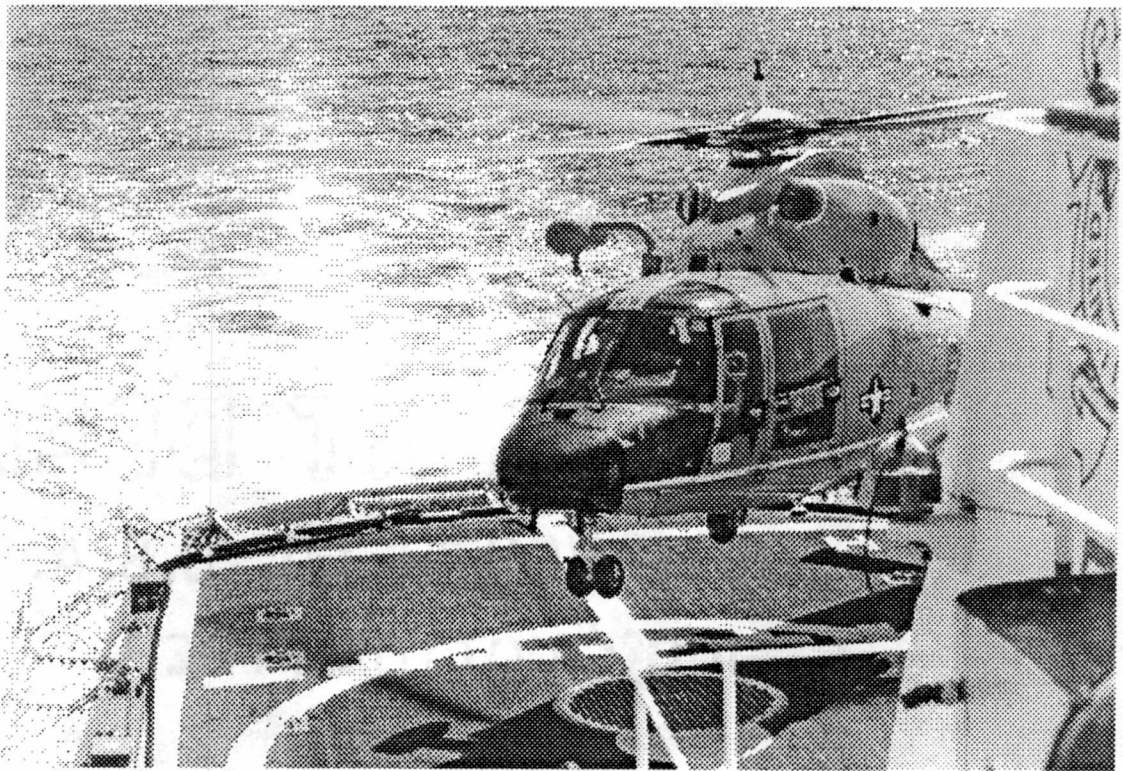
Figure 24. The HH-65A Conducting A Shipboard Hover Ladder.

Shipboard hover ladder main transmission torque data was compared to the HH-65A Flight Manual predicted values in a manner identical to that of the previous section. The results are presented in figure 23. Again, the results show that in general, the flight manual tends to underpredict the actual torque required to perform the hovers. The same trends that existed in figure 22 are present in the shipboard environment with one important exception. On average, the flight manual would underpredict the actual torque required to a greater degree than occurred during the land based hovers. The only two situations in which the flight manual significantly overpredicted the actual torque was during the out of ground effect hover with the helicopter heading 0 degrees and 315 degrees relative to the windline. A photograph of the HH-65A conducting a shipboard hover ladder is presented in figure 24.

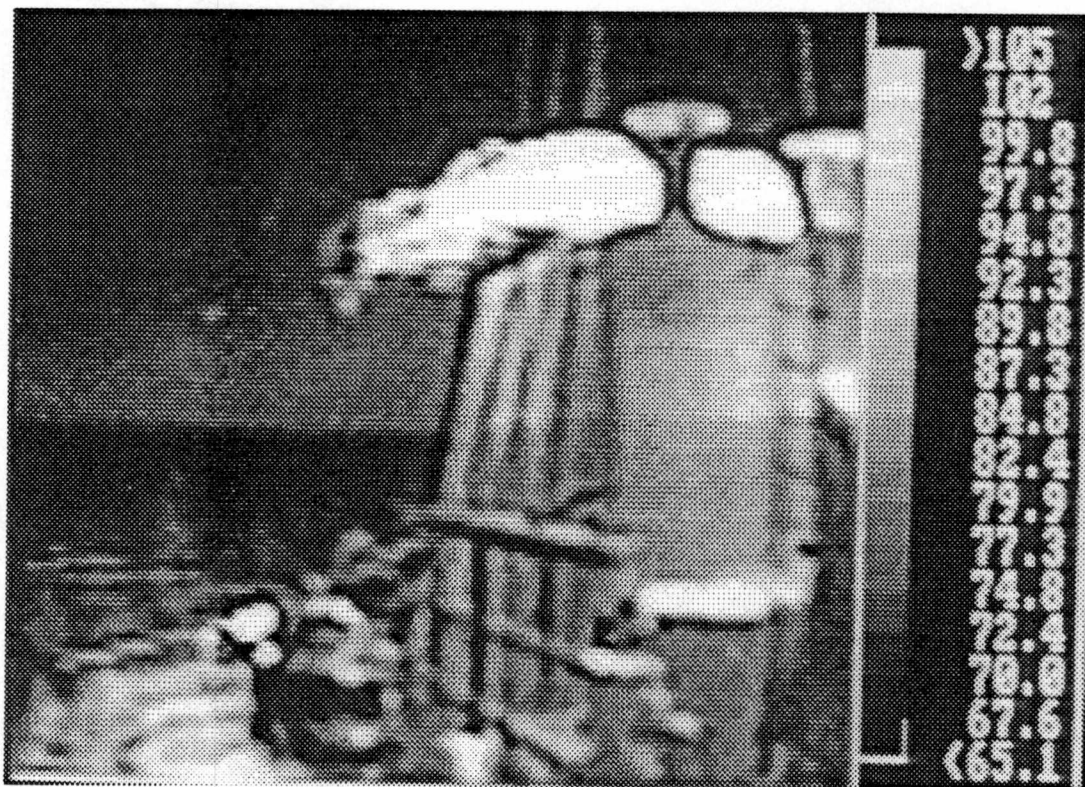
Figure 34. IR Thermography Image Of Exhaust Gas With Helicopter On Deck After Landing With Relative Winds 000 degrees at 22 knots.

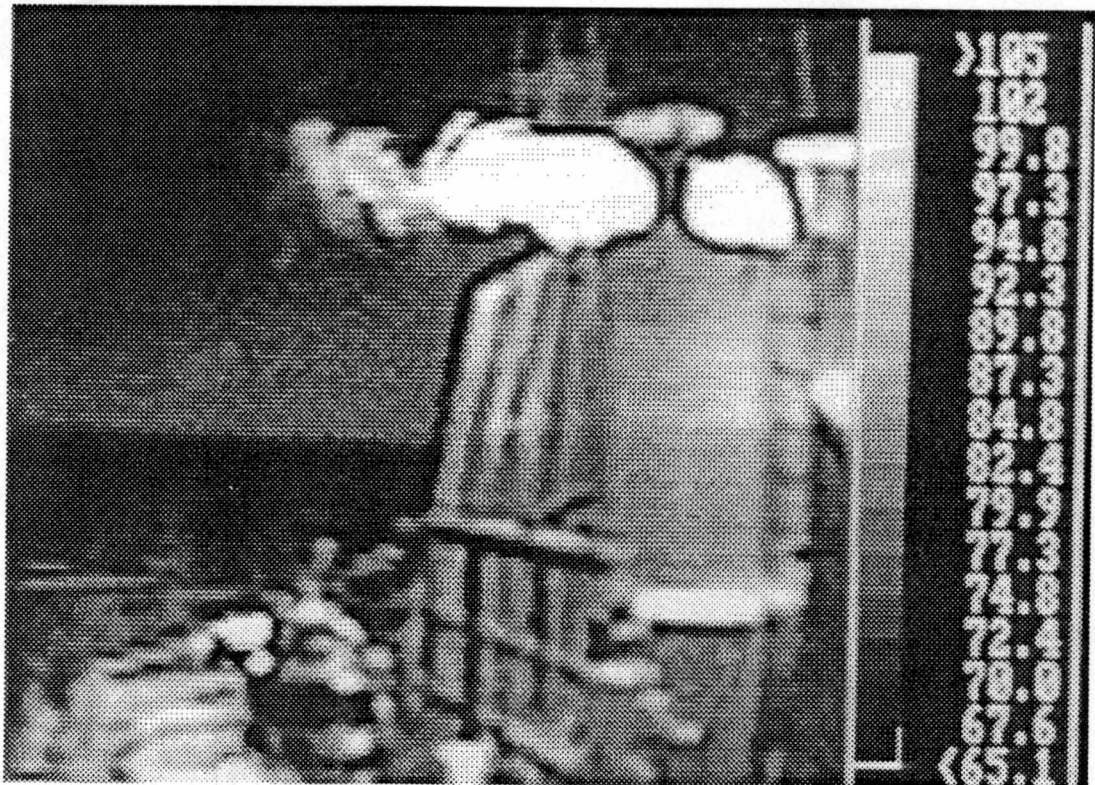
Figure 36. IR Thermography Image Of Exhaust Gas With Helicopter On Deck Prior To Launching With Relative Winds 000 degrees at 22 knots.

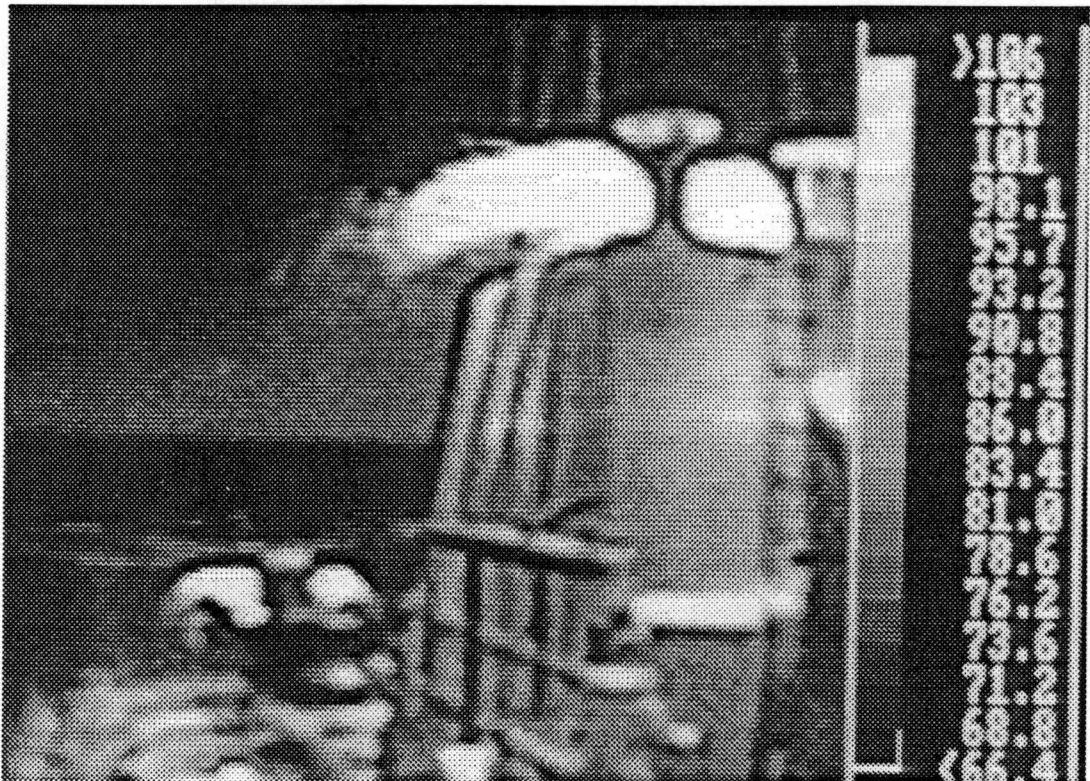
Figure 37. IR Thermography Image Of Exhaust Gas During Launching Evolution With Relative Winds 000 degrees at 22 knots.
