Interface Behavior of Water Saturated Limestone Rock Joints Using  
Hollow Cylinder Testing  
and  
A Case History Regarding Mine Roof Stability:  
Fort Hartford Mine Superfund Site

A Thesis  
Presented for the  
Master of Science  
Degree  
The University of Tennessee, Knoxville

Part III is a case history regarding mine roof stability at the Fort Hartford Mine Superfund Site in Olaton, Kentucky. Specifically, mine roof instability at the Fort Hartford Mine Superfund Site has a number of potentially detrimental consequences including risks to mine personnel, subsidence damage, escape of hazardous gases from within mine, and contamination of the local groundwater system. Correspondingly, a

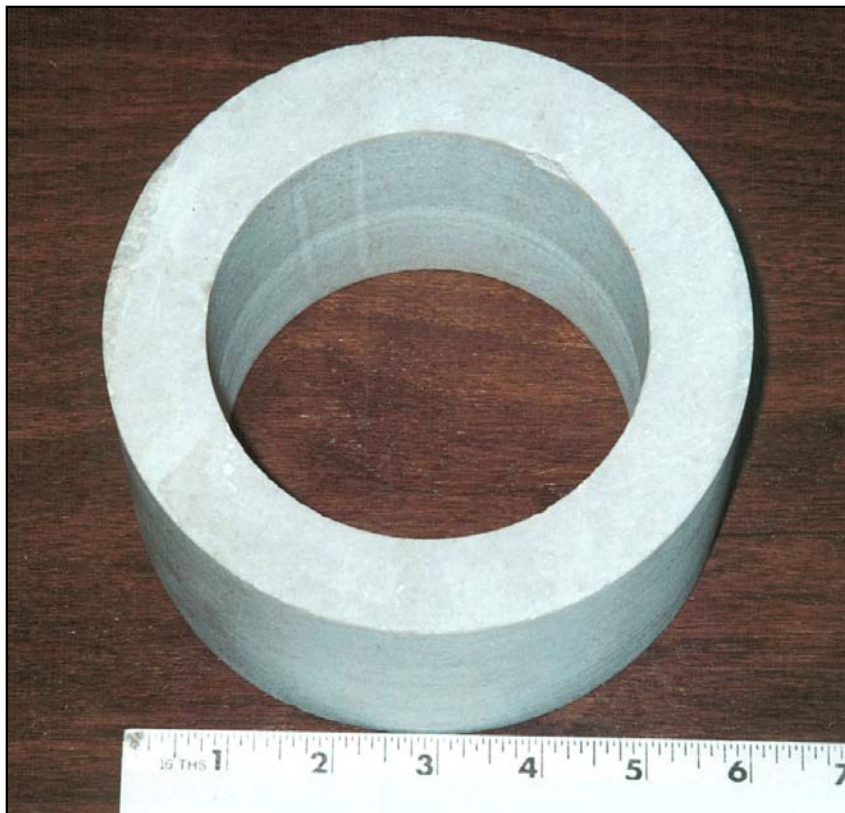
**Figure 3. Typical HCA Sample (Scale in Inches).**

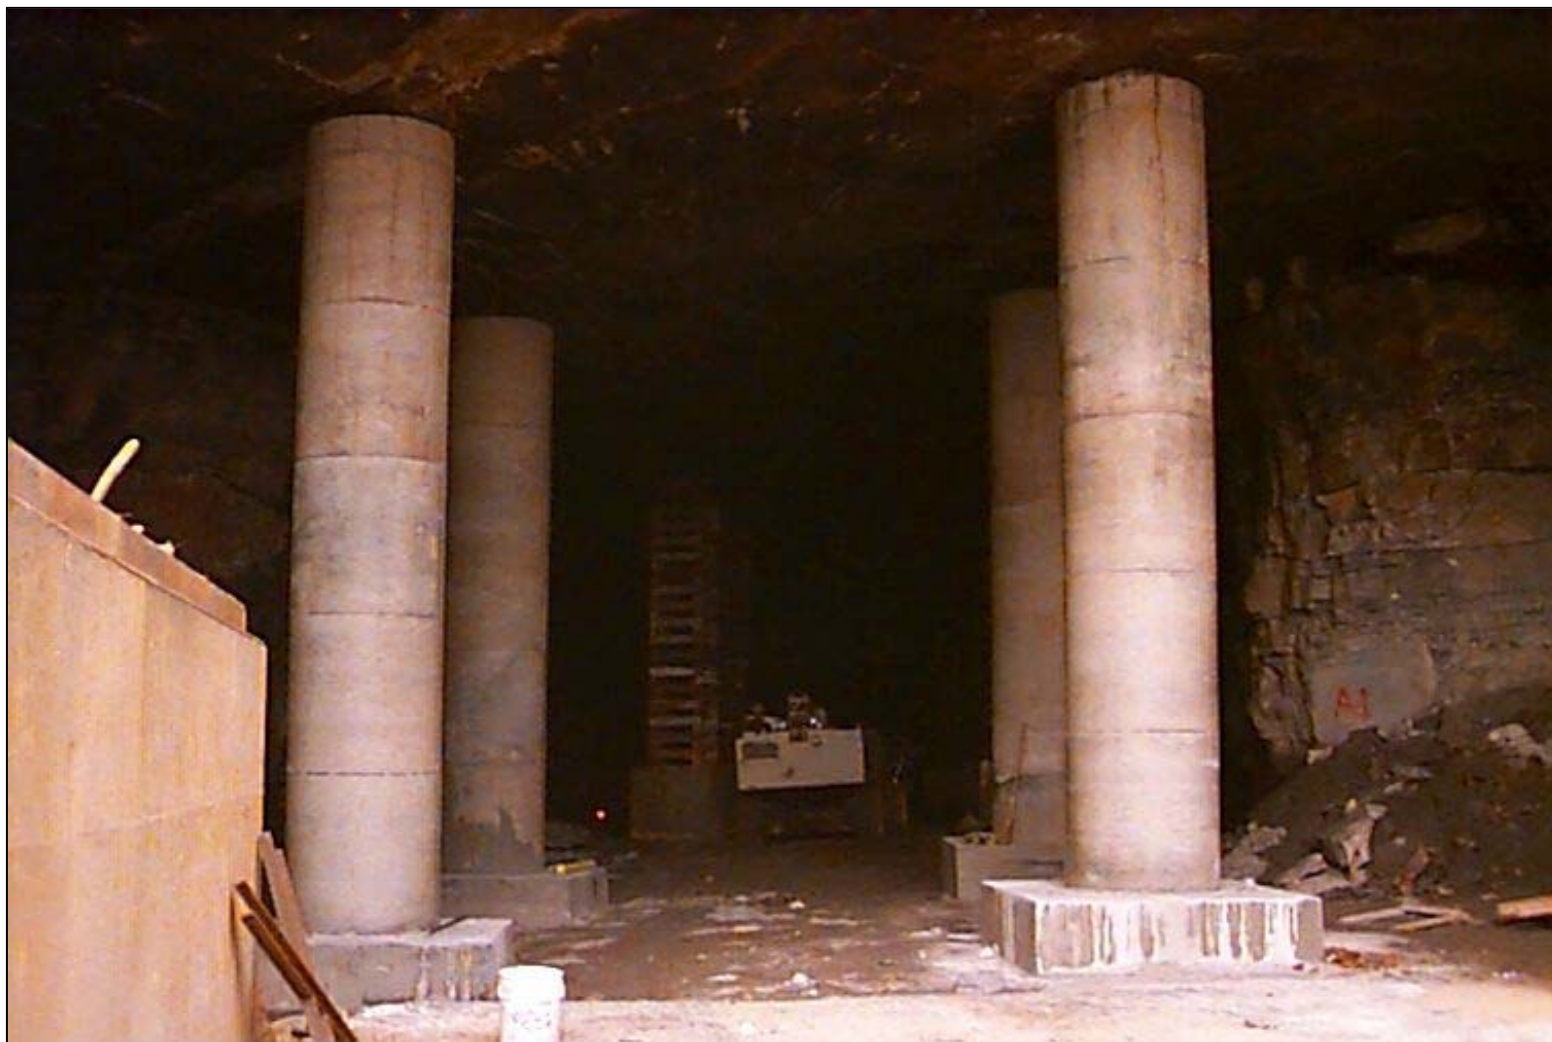
**Figure 14. Fort Hartford Mine Superfund Site Cast-In-Place Concrete Columns at “A” Portal**

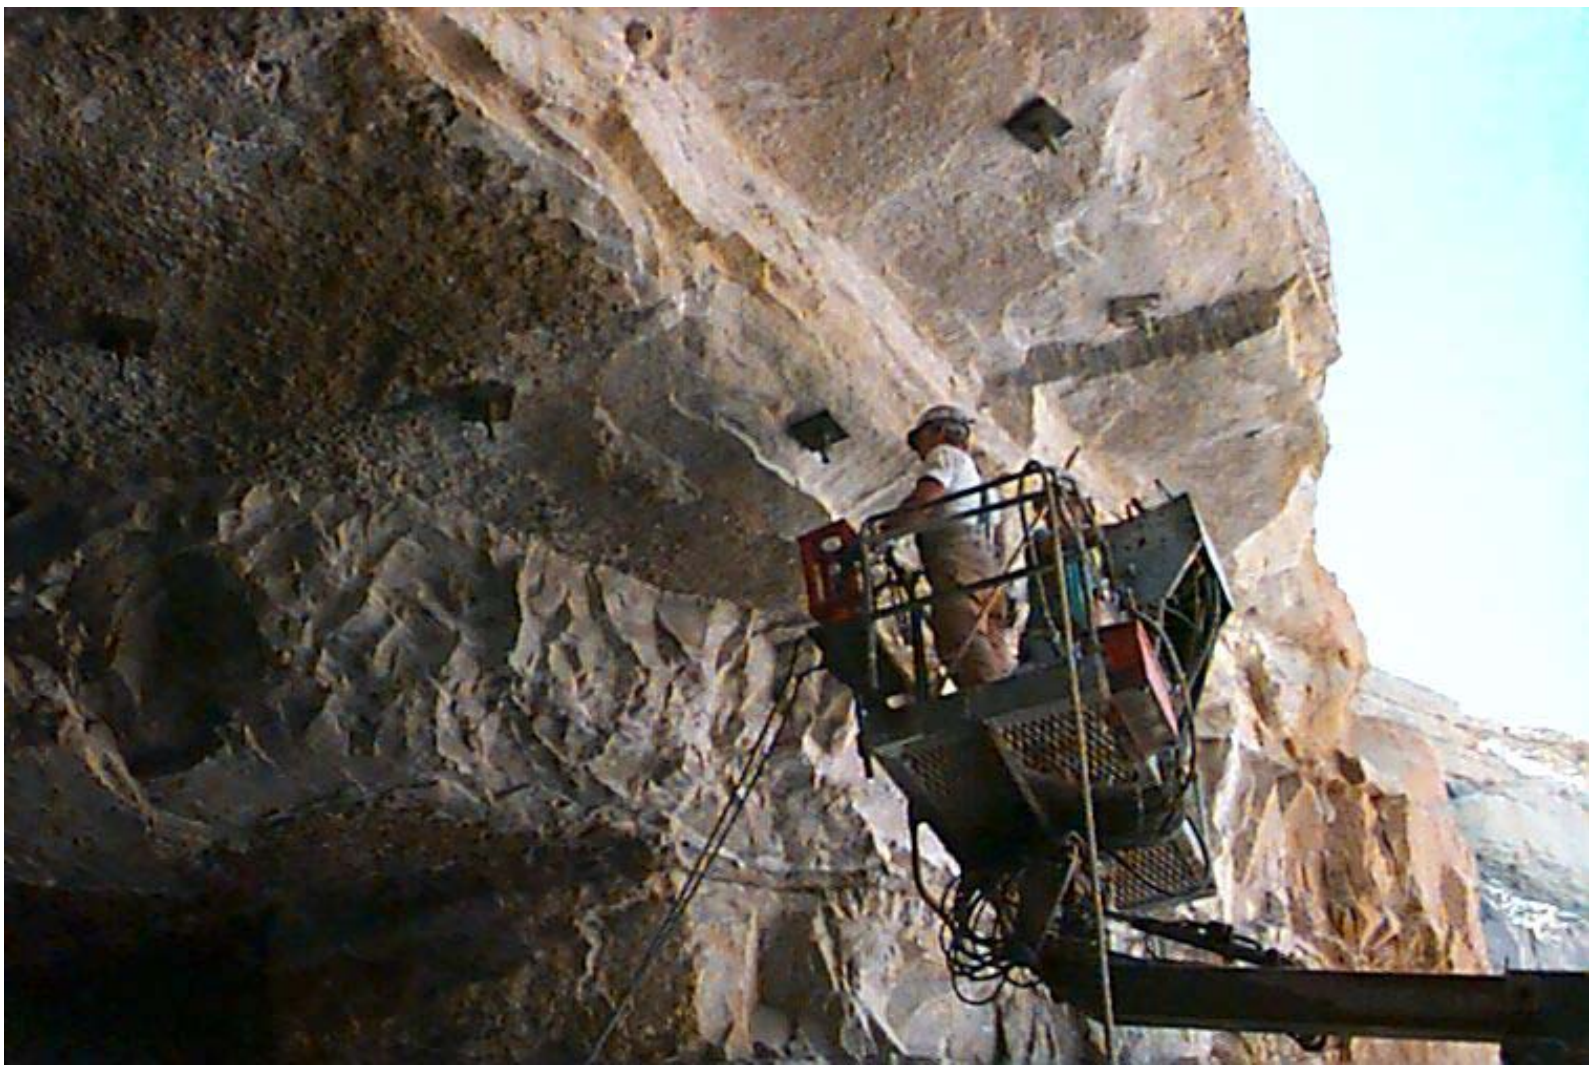
**Figure 15. Fort Hartford Mine Superfund Site Installation of Roof Bolts at “A” Portal**

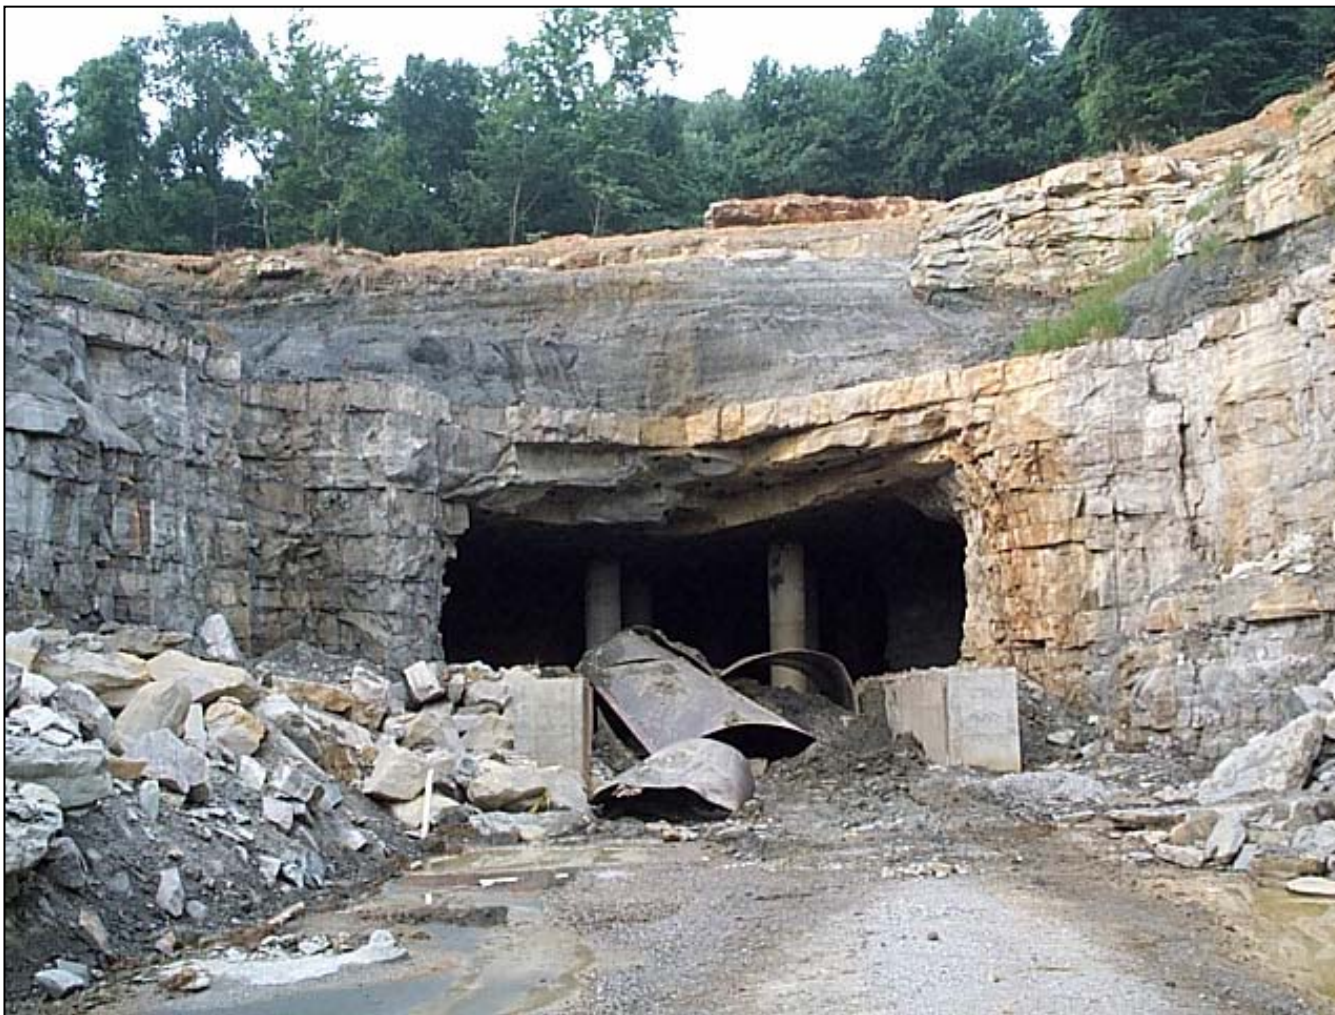
**Figure 16. Fort Hartford Mine Superfund Site “A” Portal Landslide**

In December 2001, a landslide occurred above “A” Portal, thereby blocking access to the Caney Creek Lobe of the mine (See Figure 15). As shown in Figure 15, the landslide crushed the steel canopy at “A” Portal. Although the landslide was not directly related to the mine roof stability per se, it was a function of the complex geologic conditions previously discussed. Further, the landslide presented an obvious safety hazard for maintenance personnel.

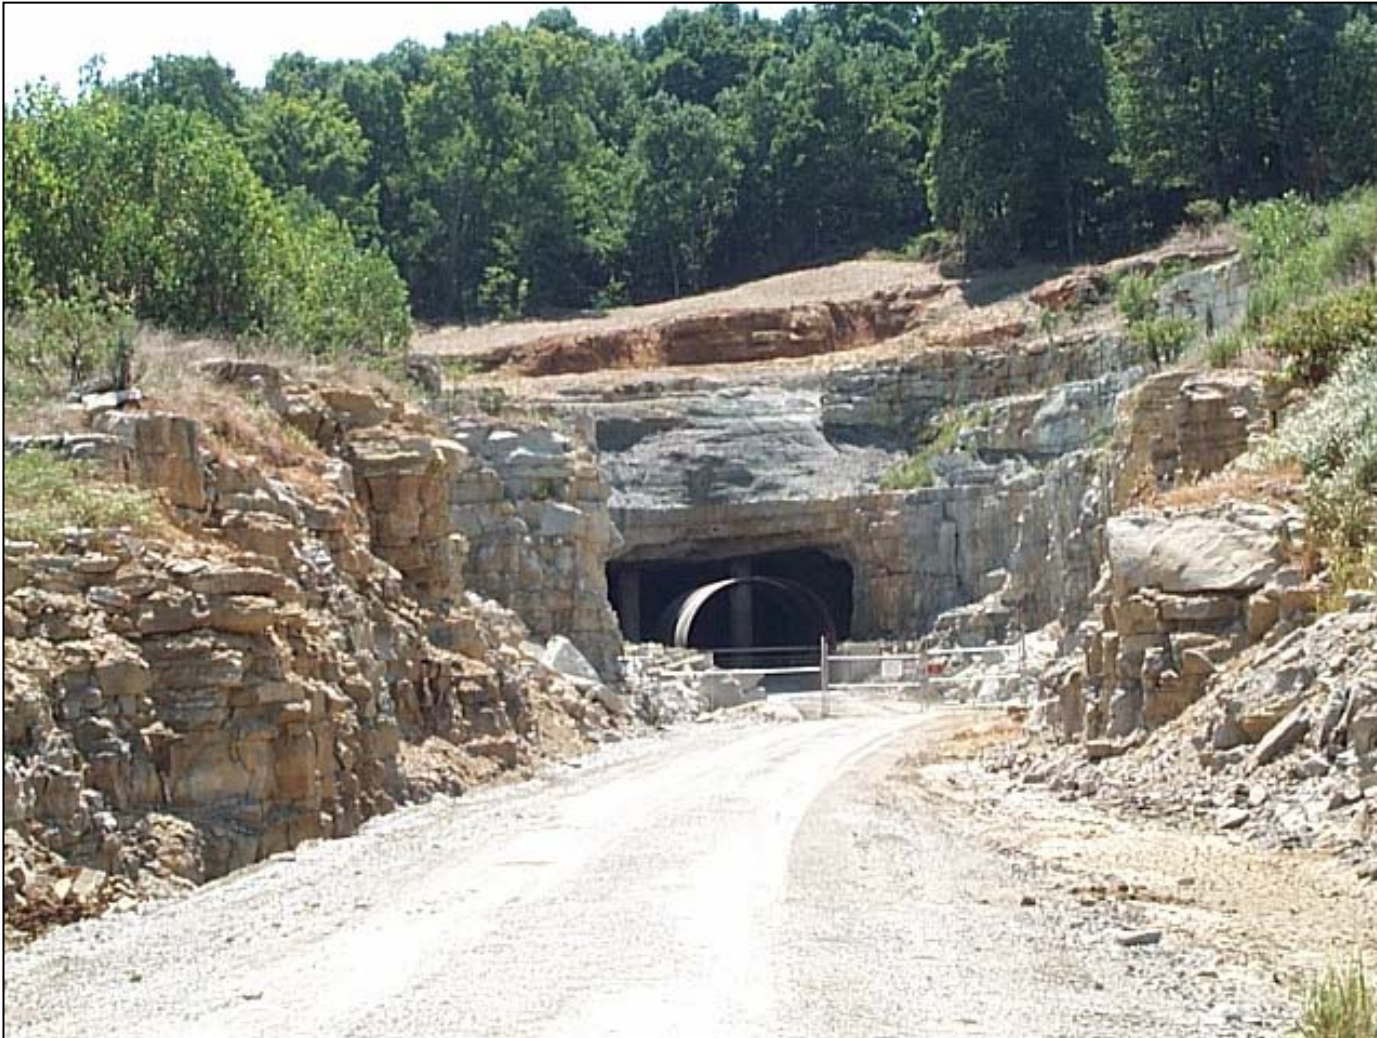
**Figure 17. Fort Hartford Mine Superfund Site Repaired Slope at “A” Portal**
