**Terrestrial laser scanning technology for measuring streambank retreat along  
East Fork Poplar Creek and calculating the effect on mercury release.**

A Thesis Presented for the  
Master of Science  
Degree  
University of Tennessee, Knoxville

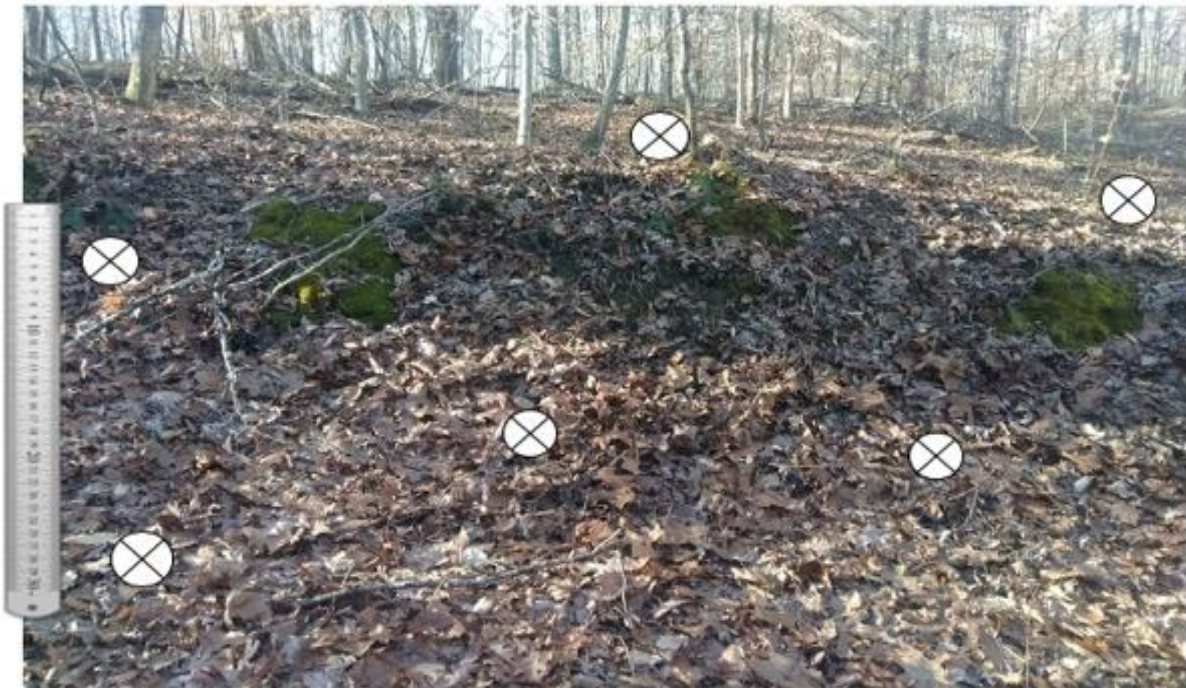
*Figure 9: Control Site reference target positioning*

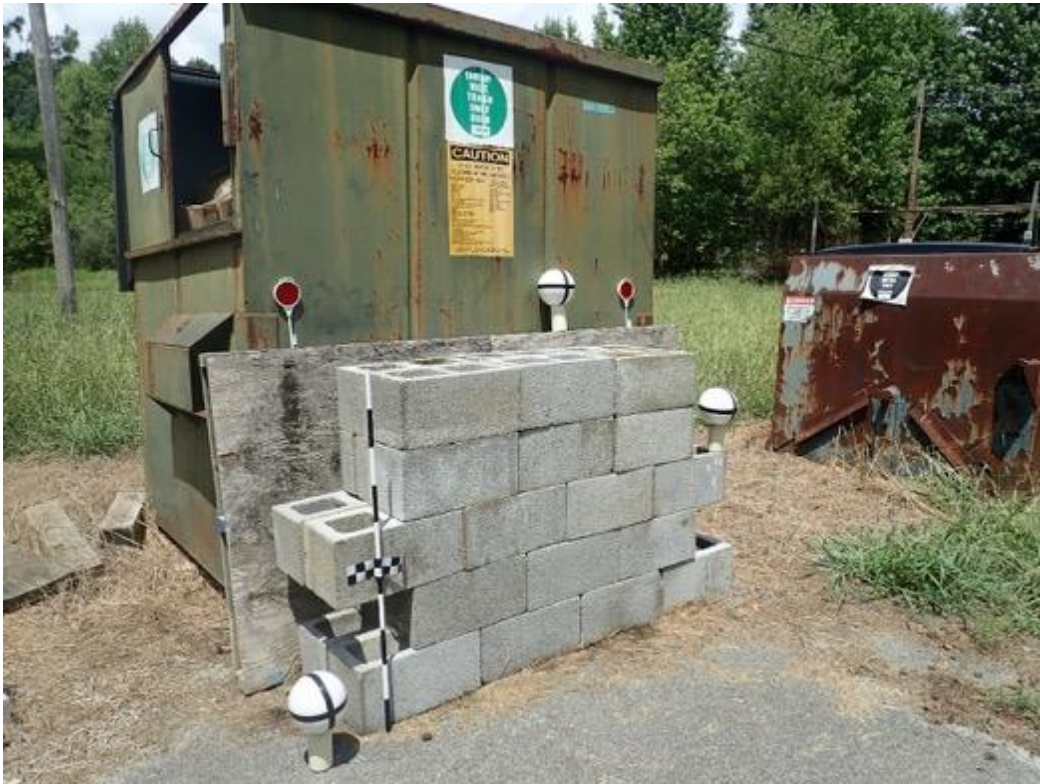
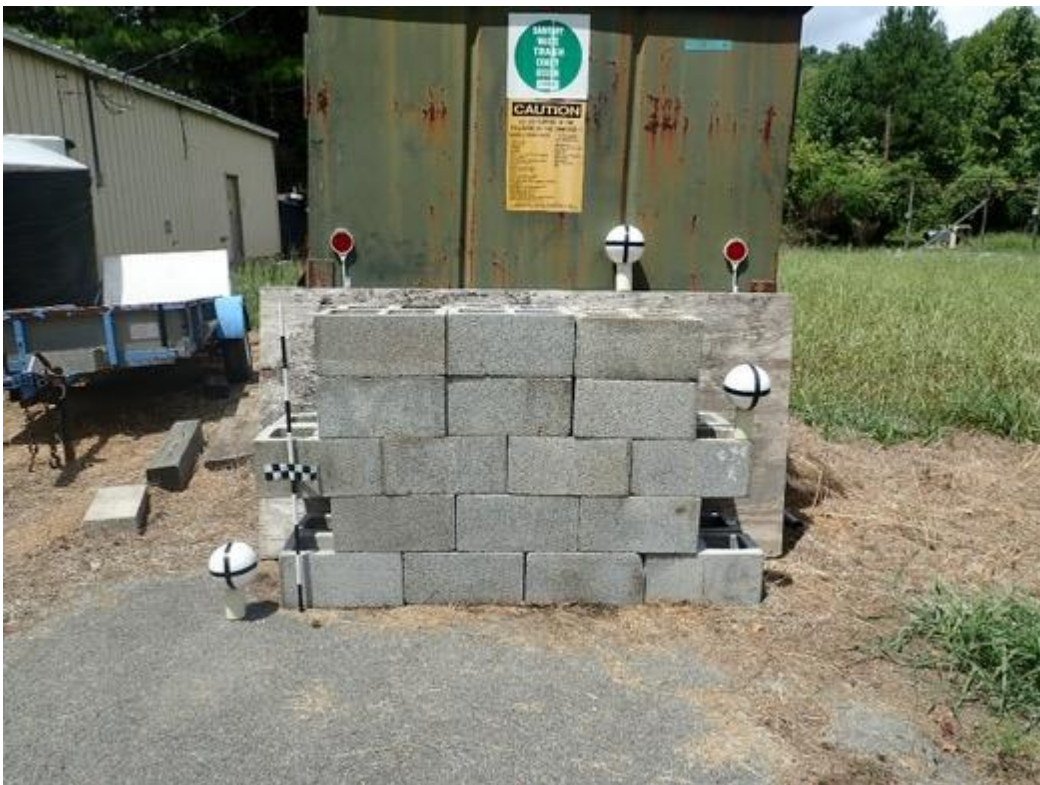
*Figure 12: Double-layer brick wall simulating a creek bank surface*

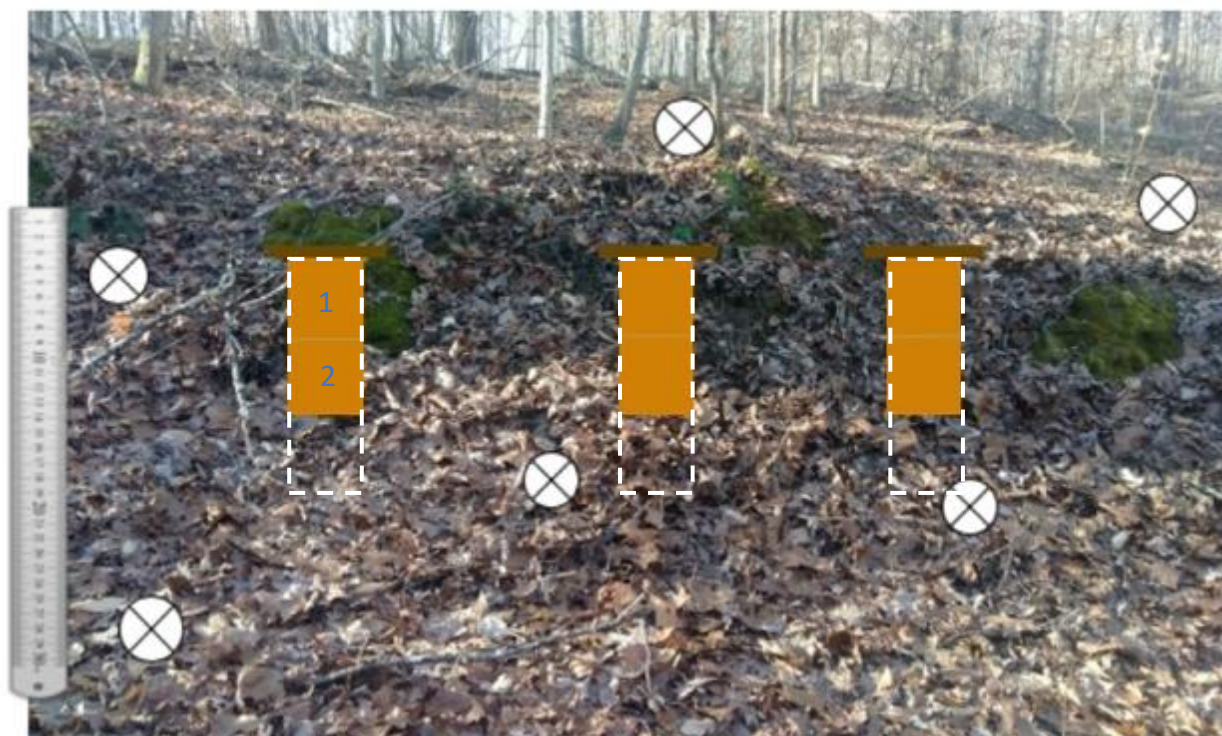
*Figure 14: Diagram of the artificial zone after the second erosion event.*

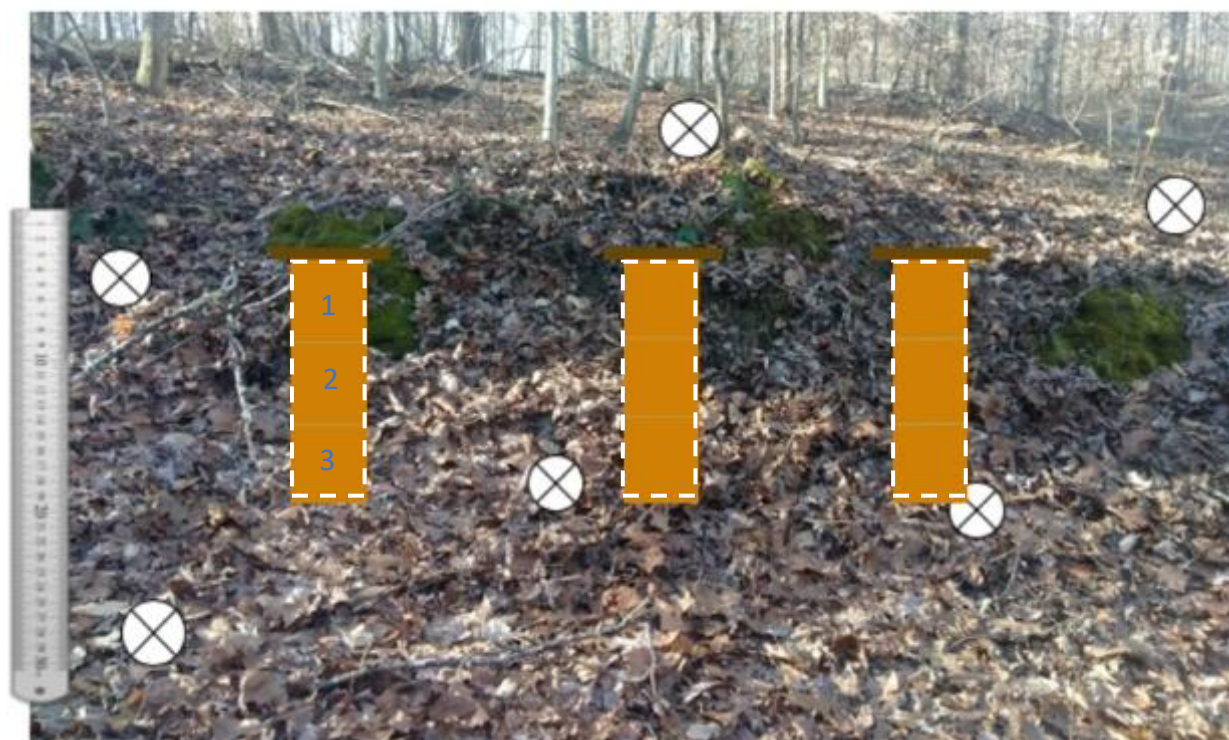
*Figure 15: In this diagram, the third erosion zone was added to the delineated area.*

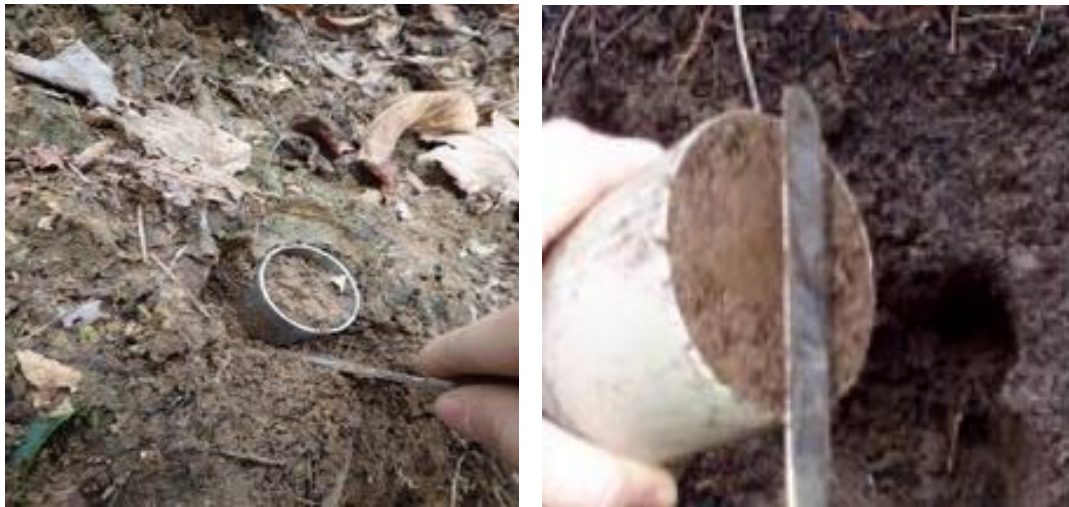
Figure 17: (a) the soil around the core was removed, then (b) the excess soil from the bottom was detached from the cylinder's surface.

To remove the cylinder and avoid losing soil, I dug the soil around the cylinder's outer surface until it was mostly exposed (Figure 17 a). Once the cylinder was loose and easy to remove, I ensure that the soil at the bottom was flat with the bottom part of the cylinder. With the help of a small knife and spatula, I carefully removed the excess soil from the bottom (Figure 17 b). To conclude the sample collecting, each of the core samples were placed inside a labeled plastic bag.
