Compatibility Evaluation of Glass/Epoxy  
Insulation for Use in ITER's Central Solenoid  
Superconducting Electromagnets

A Thesis Presented for the  
Master of Science  
Degree  
The University of Tennessee, Knoxville

Carolyn Grace Kidwell  
May 2012

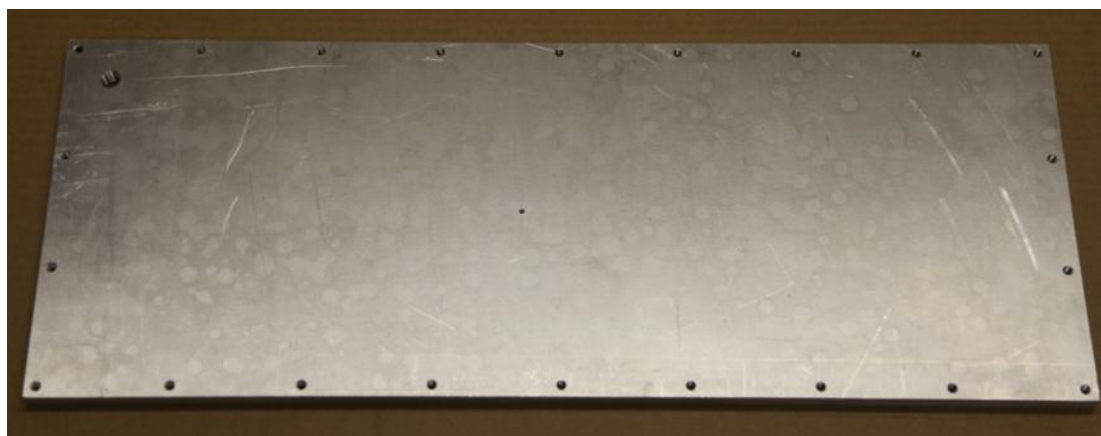
**Figure 6.** The outside of plate A.

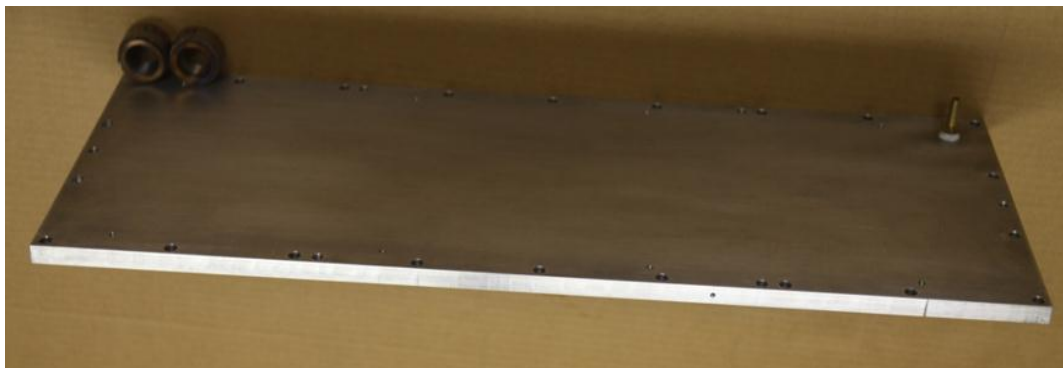
**Figure 8.** Plate B.

The other plate (plate B) was flat on both sides. Plate B had the same outside dimensions as plate A (Figure 7). The outside of plate B had another  $\frac{1}{4}$  in pipe tap thread hole for the resin entry. The resin outlet port (Figure 5) and the inlet port (see Figure 7) were at diagonally opposite ends of the assembled mold such that the inlet port was the bottom most point and the outlet port was the top most point of the mold. Plate B also had a recess machined on its side for a thermocouple attachment (see Figure 8). This thermocouple would monitor the heater temperature. There were additional holes drilled in plate B for help in the alignment of plates A and B and to help in separating the two plates after the part has been cured.

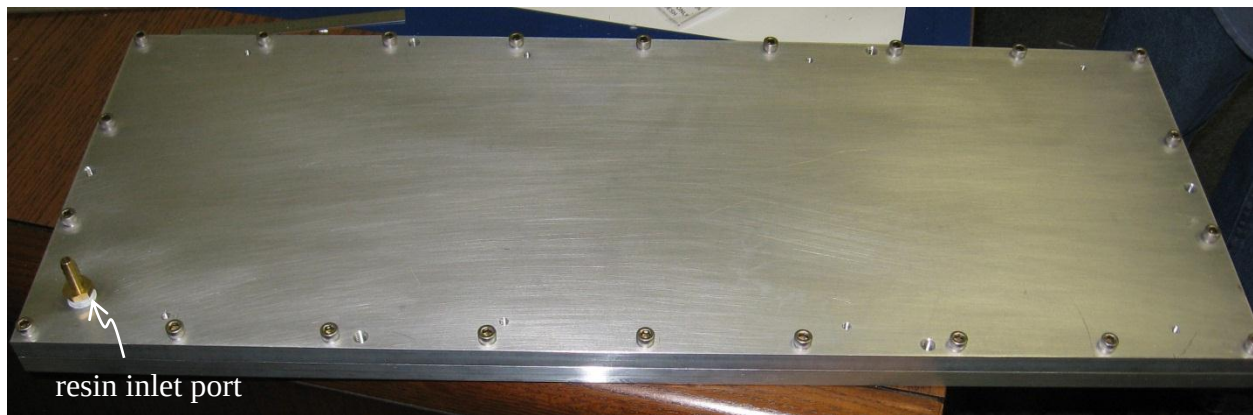
**Figure 11.** Mold plates containing glass cloths.

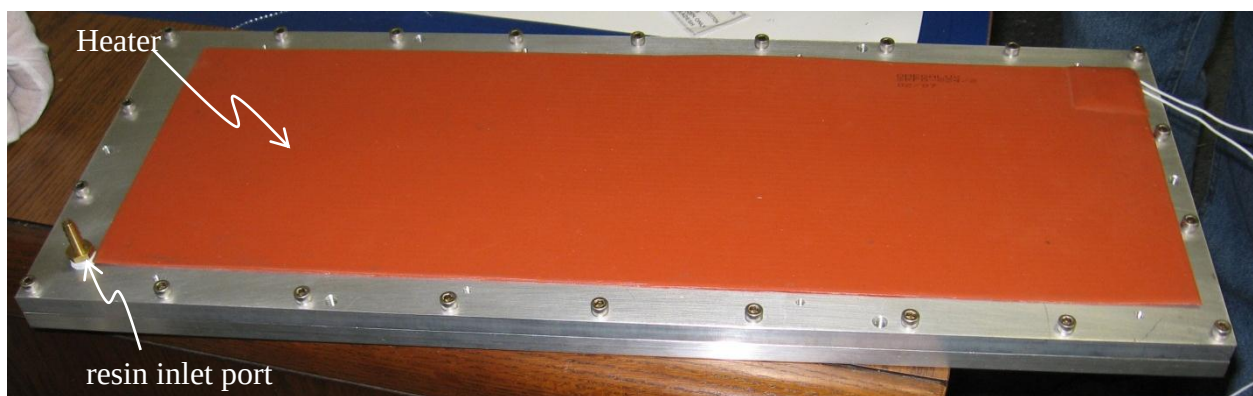
A 20 cm x 61 cm rectangular flexible silicone rubber fiberglass insulated heater (Omega SRFG-824, 100 volt, 480 W) was placed on top of the mold plate, Figure 12. The flexible heater was secured into position by bolting another flat plate on top of the heater, Figure 13. In order to monitor the sample temperature two thermocouples were attached – one located in the middle and outside of the mold plate with the rectangular cavity, and other one located on the side of the other mold plate, Figure 14. Tygon tubes were connected to inlet and outlet ports by means of compression fittings.

**Figure 12.** Mold plate with flexible heater placed on top.

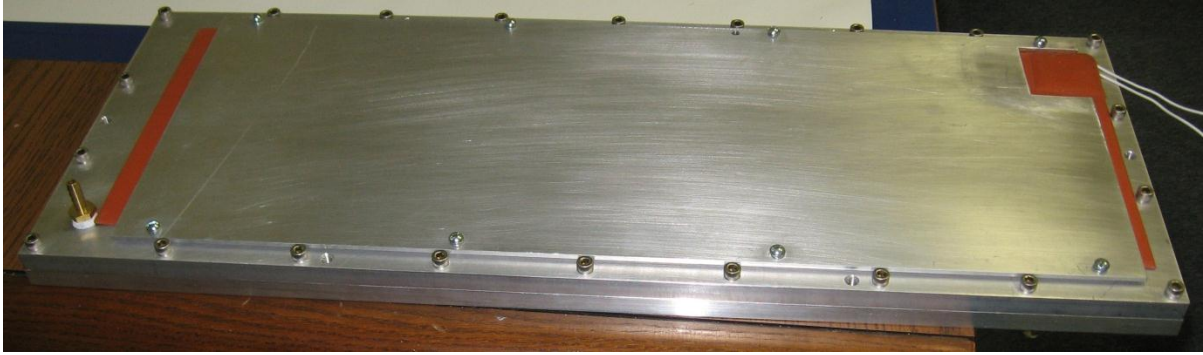
**Figure 13.** Flat plate used to secure flexible heater.

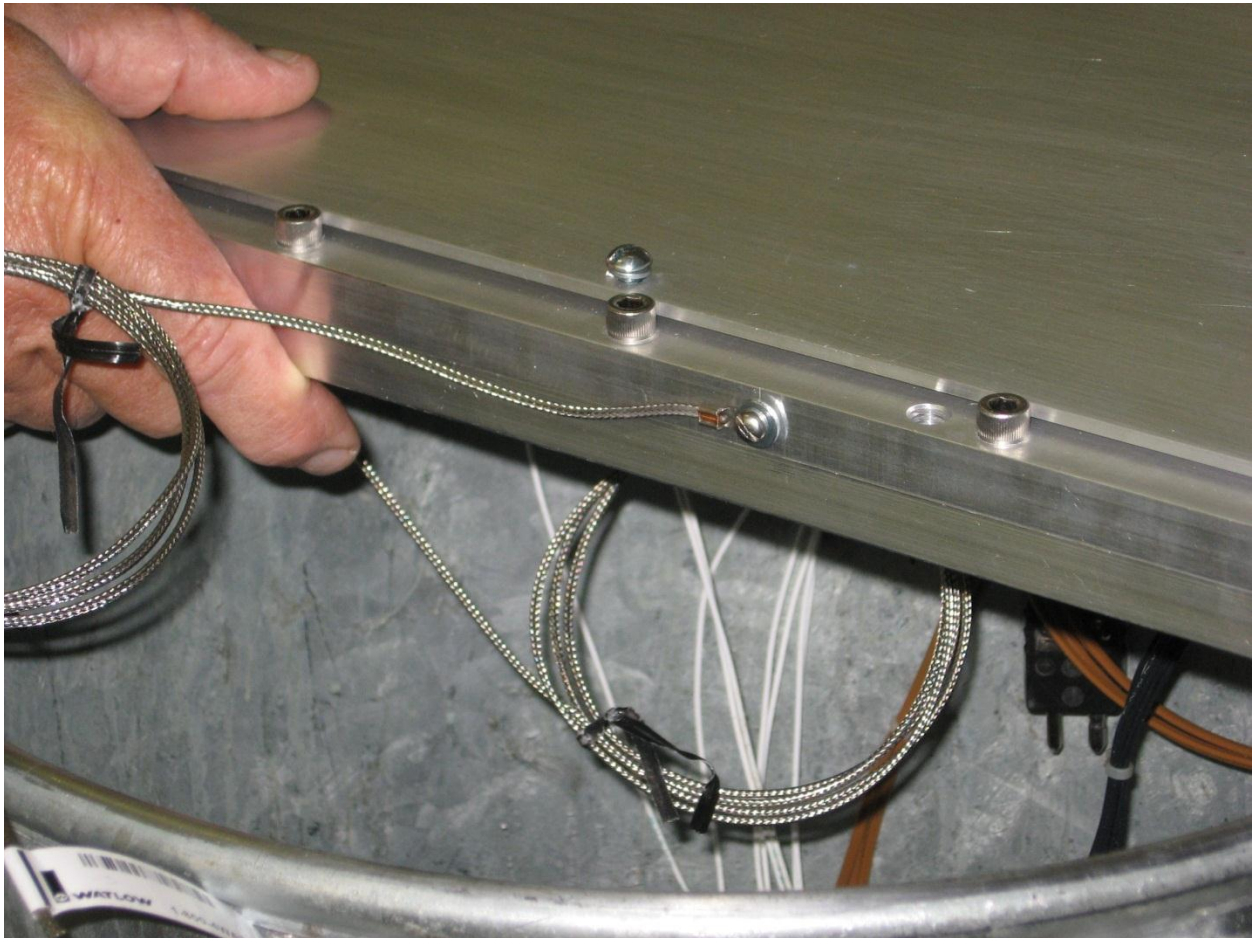
**Figure 14.** Thermocouple connected to side of mold plate.

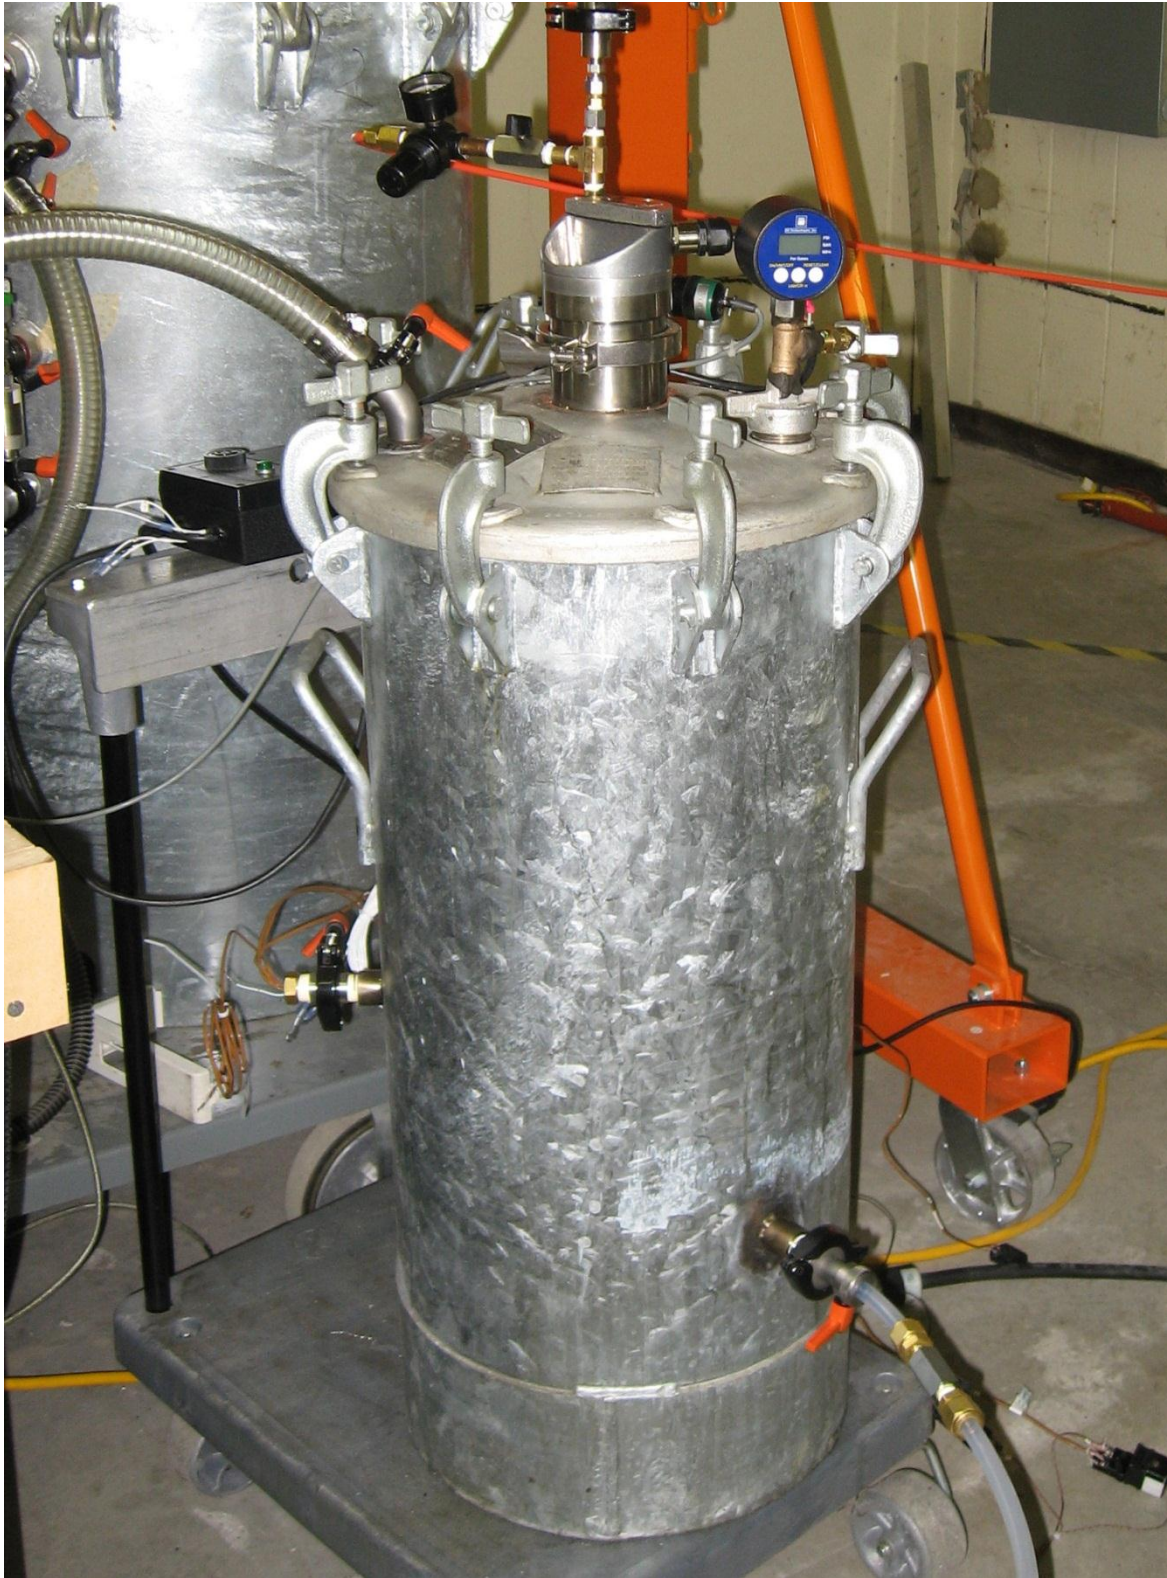
**Figure 16.** Photograph of the sealed mold tank.

The mold tank was a cylindrical vessel 400 mm tall and 800 mm in diameter having a capacity of about 25 gallons. The mold was positioned in the middle of the mold tank, Figure 15. The mold tank was capable of sustaining a vacuum of less than 5 millitorr. A photograph of the sealed mold tank is shown in Figure 16. The mold tank was instrumented with several sealed ports accessible from the outside to connect a heater, thermocouples, vacuum pump, dry nitrogen, resin inlet port, and a view port, Figure 16.

The vessel used for the resin preparation was 1016 mm (40 inch) tall and 610 mm (24 inch) in diameter. Inside the vessel there was another cylindrical container that was 711 mm (28 inch) tall and 457 mm (18 inch) in diameter, Figure 17. This inner container is normally used for VPI jobs requiring about 25 gallons of resin. Since the volume of mixed resin required would be much smaller (not more than 1 gallon), another smaller container (resin tank) of height 381 mm (15 inch) and diameter 305 mm (12 inch) was used for resin mixing and heating. This resin tank was wrapped with two silicon rubber drum heaters (Type OMEGALUX SHDH698 120) having a wattage of 698W each. To minimize the heat loss from the drum heaters, they were tightly wrapped with several layers (approximately 3) of glass fiber insulation tape, see Figure 16.

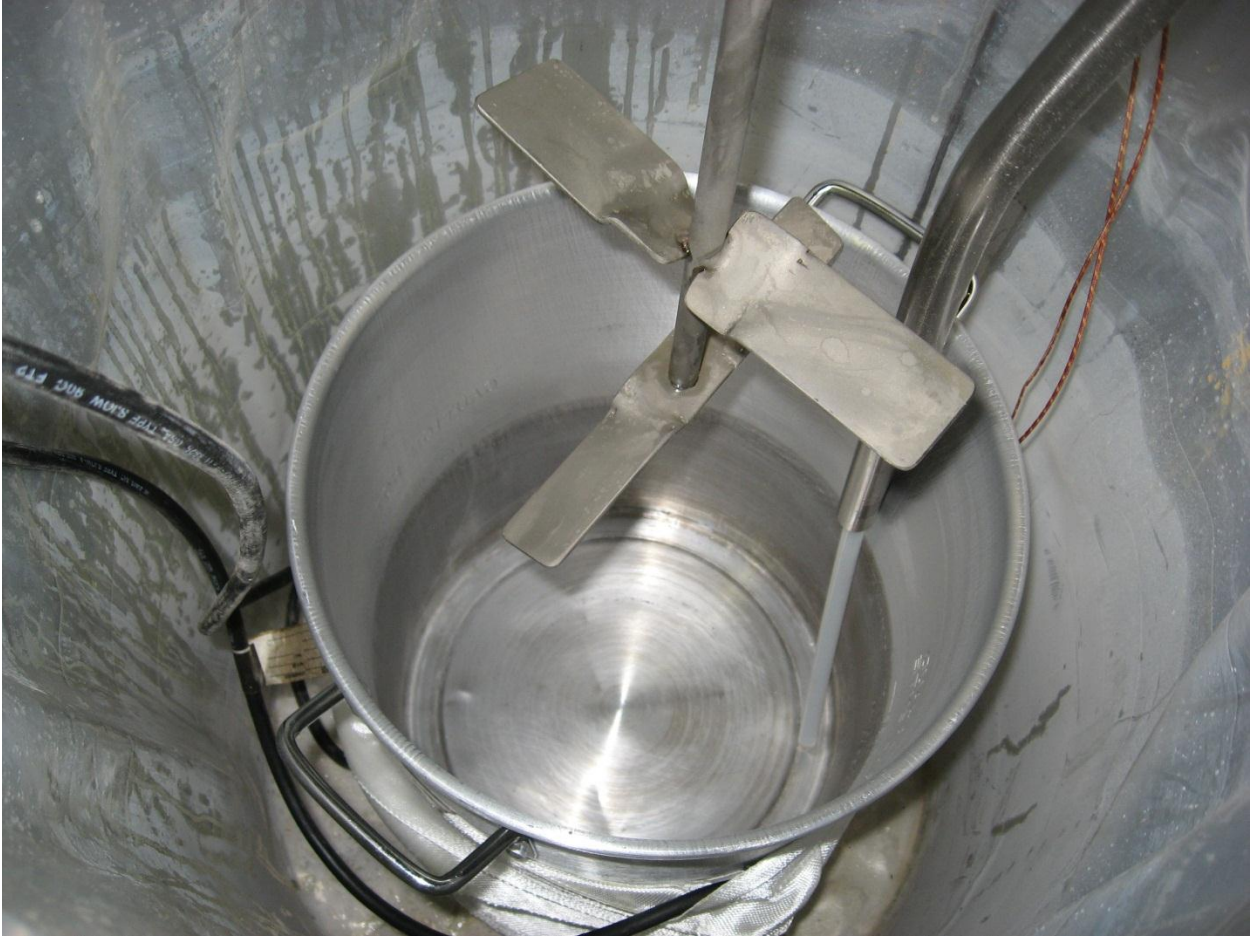
**Figure 17.** Inner container where mixing of resin occurred.

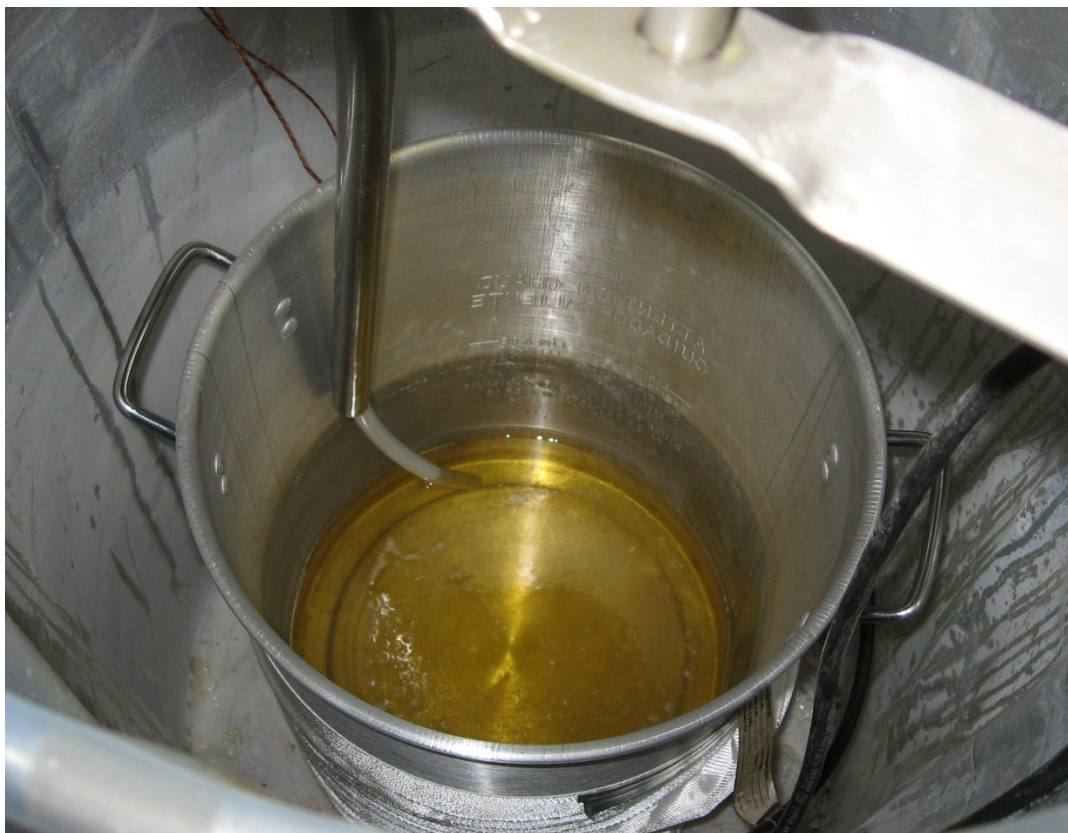
About 1.5 gallons of resin mixed in the weight ratios given in Table 3 was poured into the resin tank, Figure 18. The main vessel is also capable of sustaining a vacuum in the millitorr range. The main vessel's lid was bolted tight and the plumbing for resin transfer from the resin tank to the mold tank was completed.

**Figure 18.** Tank containing premixed resin.

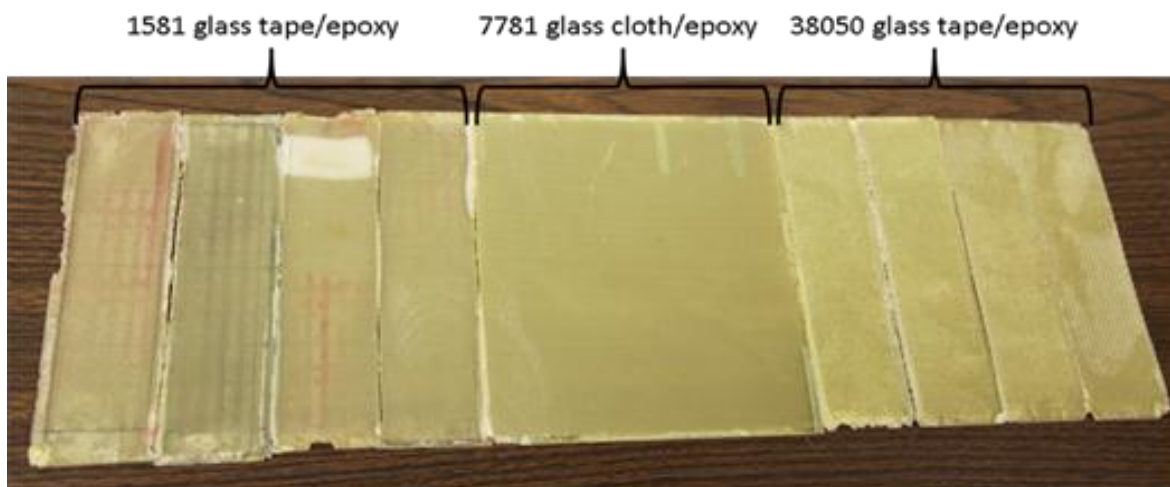
After the completion of the cure cycle, the heater was turned off and the mold was allowed to cool. The three types of composite plates were removed from the mold cavity (Figure 20). The average thickness of the three types of composite plates was 2.15 mm. A diamond-coated wheel cutter was used to cut rectangular samples for 3-point bend testing that were 55 mm long and 6.2 mm wide (see Figure 21). The span length (S in Figure 22) was 45 mm to provide an S/t ratio of about 20. However, it is necessary to note that about  $\frac{3}{4}$  of the 1581 laminate plates were cut to a sample length of 45 mm before the mistake was caught. The samples were cut in a way such that the sample's lengths were parallel to the warp direction of the weave pattern. With plain weave patterns (such as in 38050), both directions have the same pattern, but with 8-harness satin weaves the properties are different in warp and fill directions.

**Figure 20.** The three types of composite plates fabricated using the VPI process.

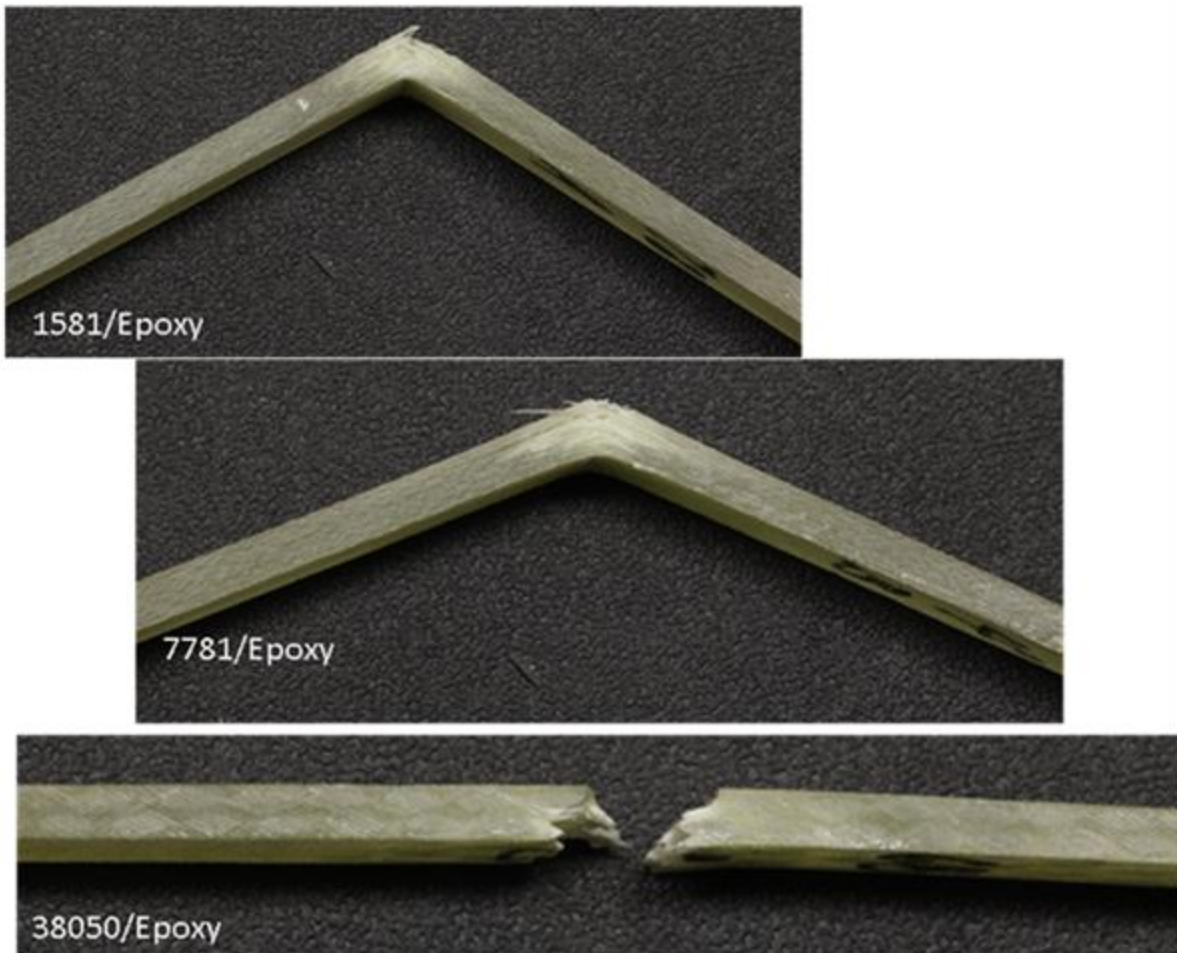
**Figure 31.** Photographs of the side view of the failed samples' middle sections tested at 295K showing the failure pattern.

In contrast, type 38050 specimens fractured completely. The fractures were brittle, perpendicular to the plane of the specimen and parallel to the loading direction. No specimen bending and limited delaminations were observed. Macro-dimensional, interior cracking along the entire length of these specimens was present. Localized debonding was also observed, indicating a lack of bond strength between the glass fibers and resin. This was not observed in the 1581 and 7781 specimens.

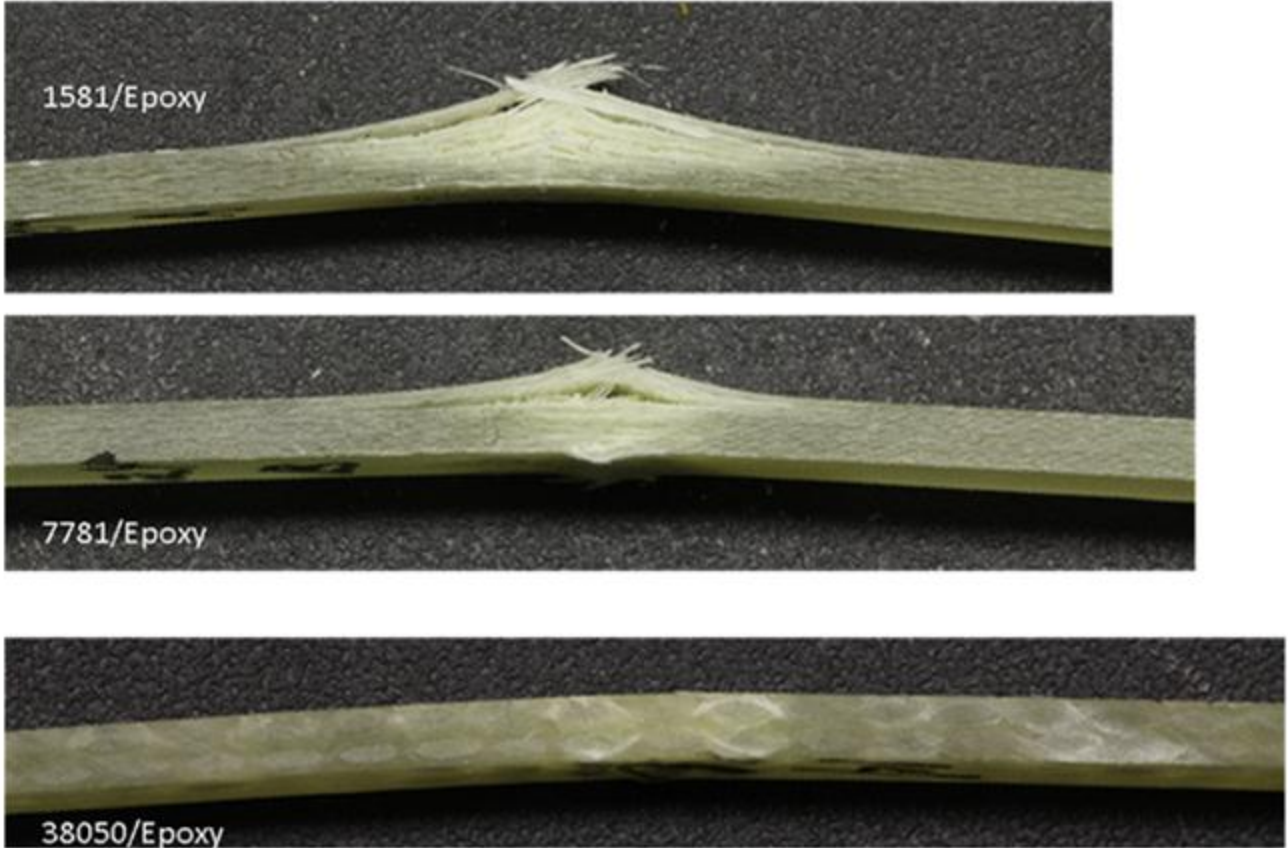
**Figure 32.** Photographs of the side view of the failed samples' middle sections tested at 77K showing the failure pattern.
