A STUDY OF DECARBURIZATION IN SAE 1042 STEEL: ITS  
EFFECT ON FATIGUE LIFE, TENSILE PROPERTIES,  
AND FATIGUE FRACTOGRAPHY

A Thesis  
Presented for the  
Master of Science  
Degree  
The University of Tennessee, Knoxville

Daniel A. Bales

August 1977

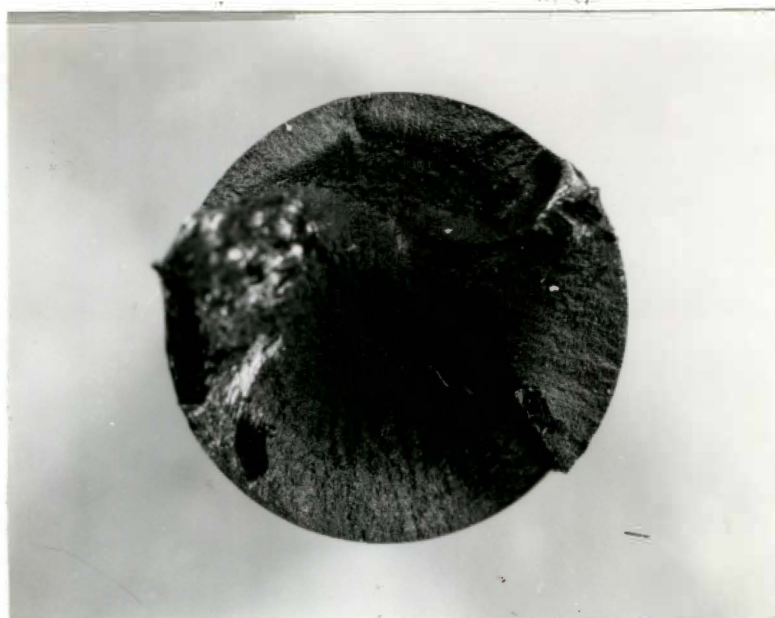
Figure 19. Photomicrograph of a D-1 Fracture Surface. Specimen Failed after 6800 Cycles; Applied Stress, 71004 psi ( $490 \text{ MN/m}^2$ ) (106% of the YS). 8x.

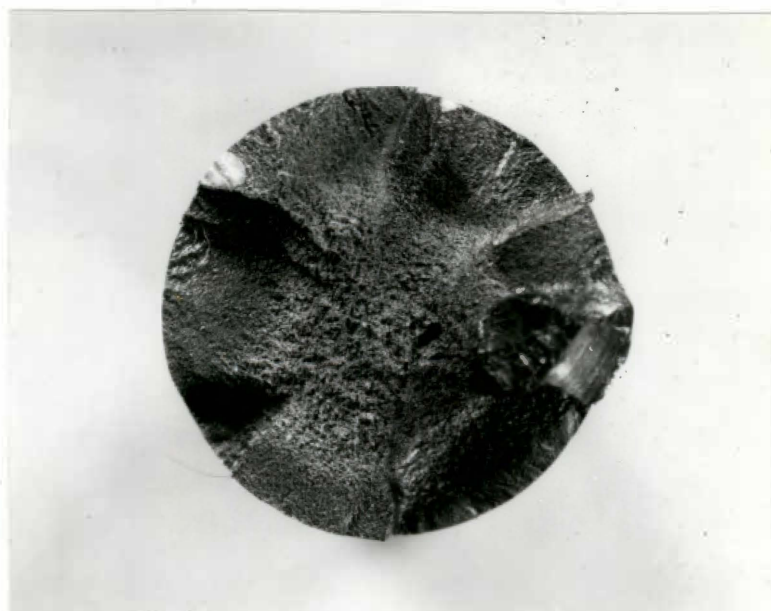
Figure 20. Photomicrograph of a D-1 Fracture Surface. Specimen Failed after 24700 Cycles; Applied Stress, 56211 psi ( $388 \text{ MN/m}^2$ ) (84% of the YS). 8x.

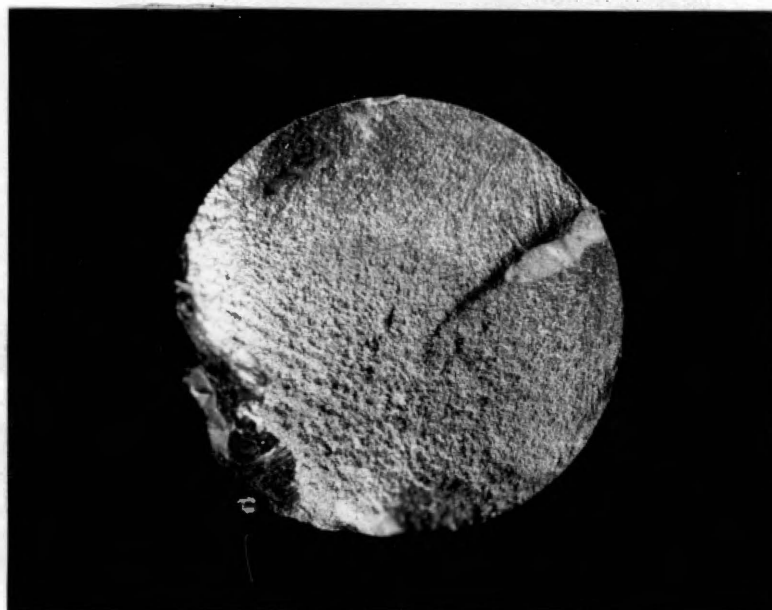
Figure 21. Photomicrograph of a D-1 Fracture Surface. Specimen Failed after  $3.34 \times 10^5$  Cycles; Applied Stress, 44821 psi ( $309 \text{ MN/m}^2$ ) (67% of the YS). 8x.

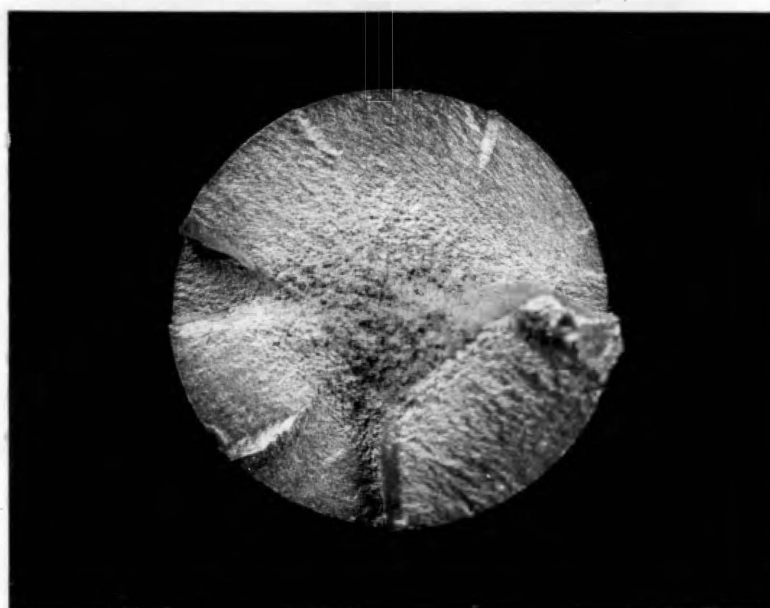
Figure 23. Photomacrograph of a D-8 Fracture Surface. Specimen Failed after 33300 Cycles; Applied Stress, 49199 psi ( $339 \text{ MN/m}^2$ ) (74% of the YS) . 8x.

At high stress levels the first crack which initiates will most likely result in the fracture of the specimen, due to the short initiation stage and high crack propagation rate. The result is a highly irregular, or "jagged," surface appearance (see Figure 18). The term "jagged" refers to the large variation in the maximum and minimum points of the fracture surface if measured from an arbitrary datum line drawn circumferentially about the specimen's longitudinal axis. Although the fracture surface may appear, at first, to be "ratcheted" (see Figure 19), there are few actual ratchet marks when compared to specimens which fracture at medium stress levels (see Figures 22 and 23). At medium stress levels multiple

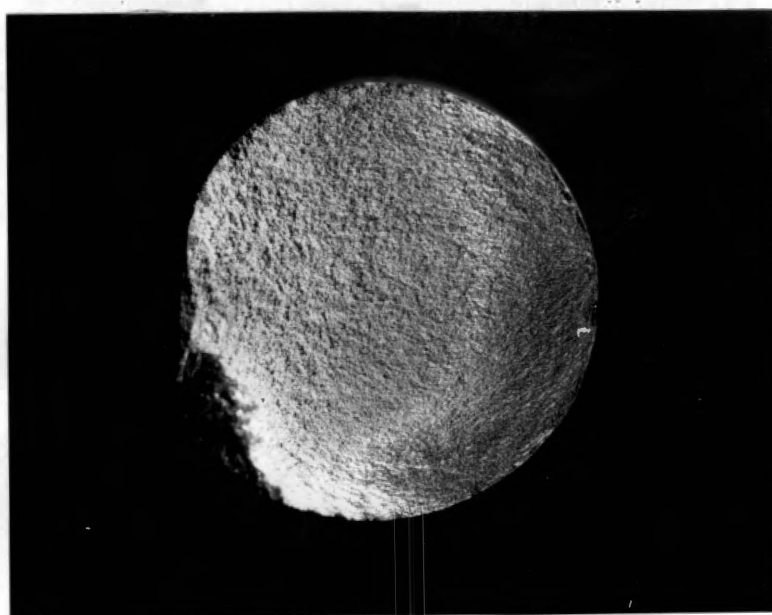
Figure 24. Photomicrograph of a D-8 Fracture Surface. Specimen Failed after  $4.32 \times 10^6$  Cycles; Applied Stress, 32730 psi ( $226 \text{ MN/m}^2$ ) (50% of the YS). 8x.

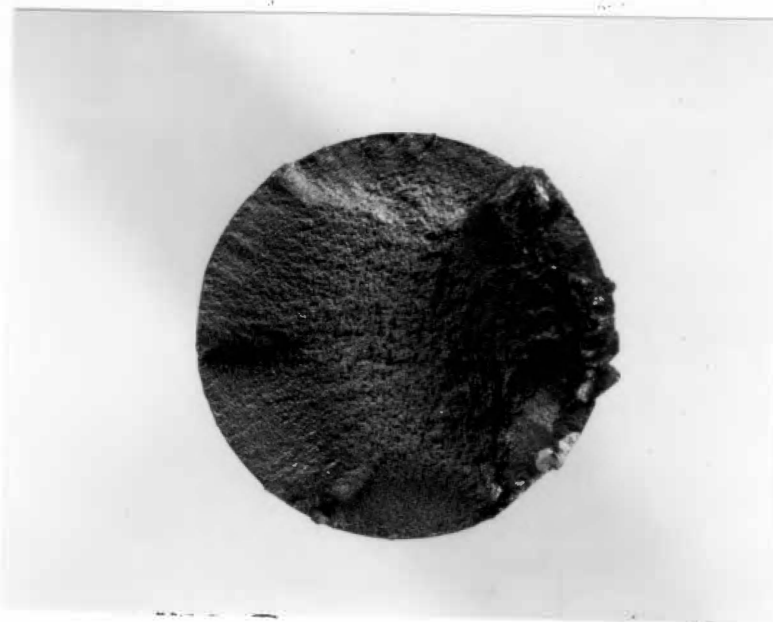
Figure 26. Photomicrograph of a D-24 Fracture Surface. Specimen Failed after 14200 Cycles; Applied Stress, 54995 psi ( $379 \text{ MN/m}^2$ ) (91% of the YS) . 8x.
