# **Innovation of Driving Gear Train System for Developer Unit of Lexmark Home Printers**

Final Report

Seniors in Mechanical Engineering

University of Tennessee, Knoxville

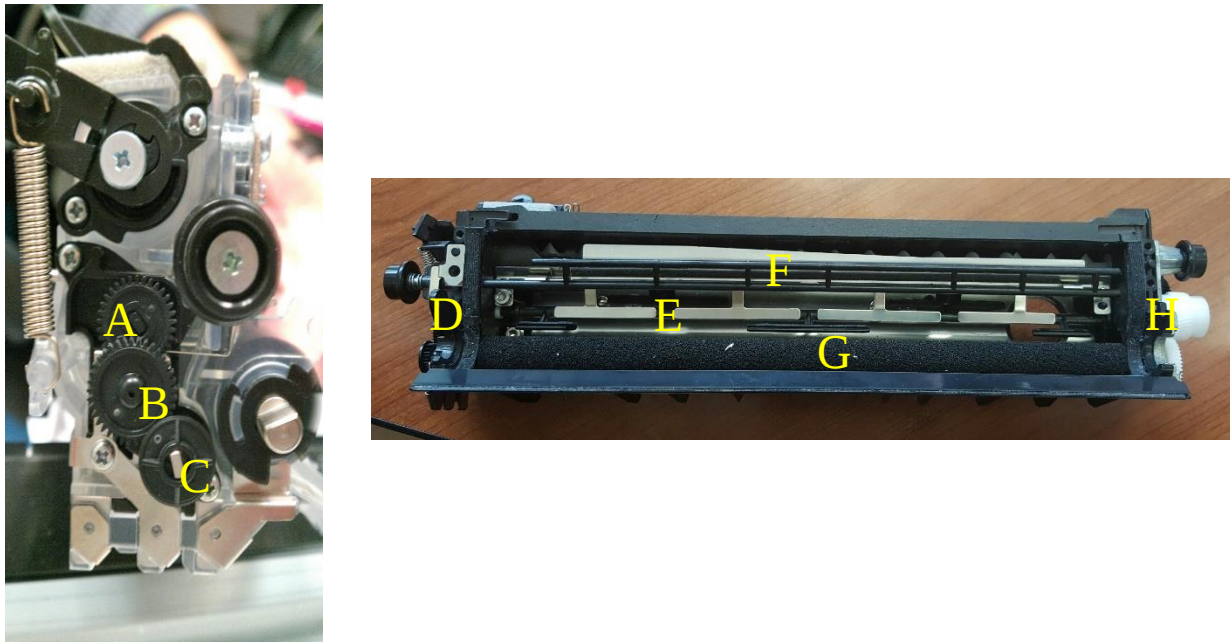
**Figure 1** Setup of Developer Unit with (A) Agitator Driving Gear (B) Compound Idler Gear (C) Agitator Driving Gear Train Input Gear (D) Gear Face Plate and Agitator Shaft Bearing (E) Agitator Shaft (F) Auxiliary Paddle (G) Toner Roller (H) Input Driving Gear

Lexmark presented a problem in the design of their printers concerning the gear train that drives the agitator shaft in the developer unit. This unit is the housing for the toner that is used to create the print on the paper; this setup can be seen in **Figure 1**. The problem was further investigated and was determined to be that the resistance load provided by highly compacted toner in the developer unit was much too high at around 350 mN-m, leading to both tooth disengagement, or cogging, and teeth breaking off of the agitator driving gear and off of the small gear of the compound idler gear. This was defined to only occur during initial startup as the agitator shaft stirred the compacted toner, which would greatly reduce the load.

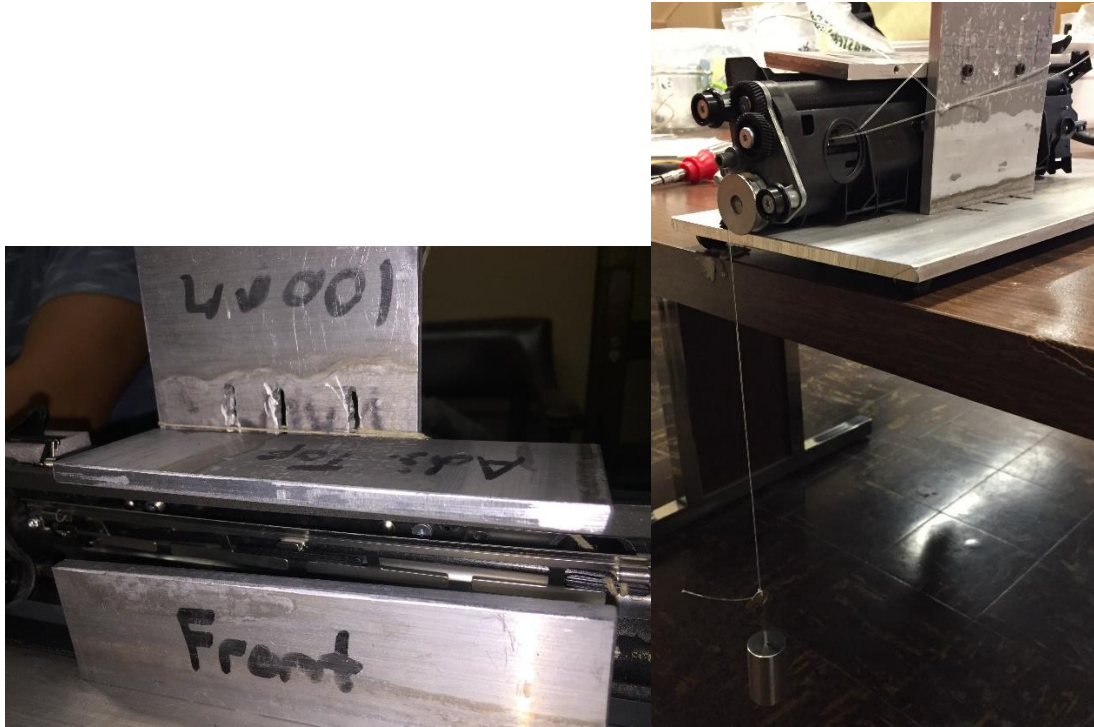
**Figure 5.** Gear Failure Test Apparatus and Loading Flywheel

The second test conducted was designed to determine the actual impact the change in gear face width had on the system by independently testing the gears. The paddle farthest from the gear train was tied with high strength twine to fix the agitator shaft, as can be seen in **Figure 5**. The developer unit without the front plate was used to represent the real system and allow for the assembly of the gear train. The developer unit was locked into place with a fixture designed to prohibit any movement or rotation of the housing. This fixture was stabilized by rubber feet to reduce any vibrations in the system. Similar to the first test, a flywheel was designed with a radius of 9.5 mm to attach to the input shaft with an insert made by Lexmark. Since the angle of the flywheel was irrelevant, the insert was glued in for more security than a set screw. Weights were tied to the flywheel with fishing line locked into the flywheel by a small hole. A 0.932 mN-m torque was incrementally loaded using the flywheel until failure occurred. A camera was set up to record the gears to attempt to measure the deflection in the system based on known measurements at different weights.

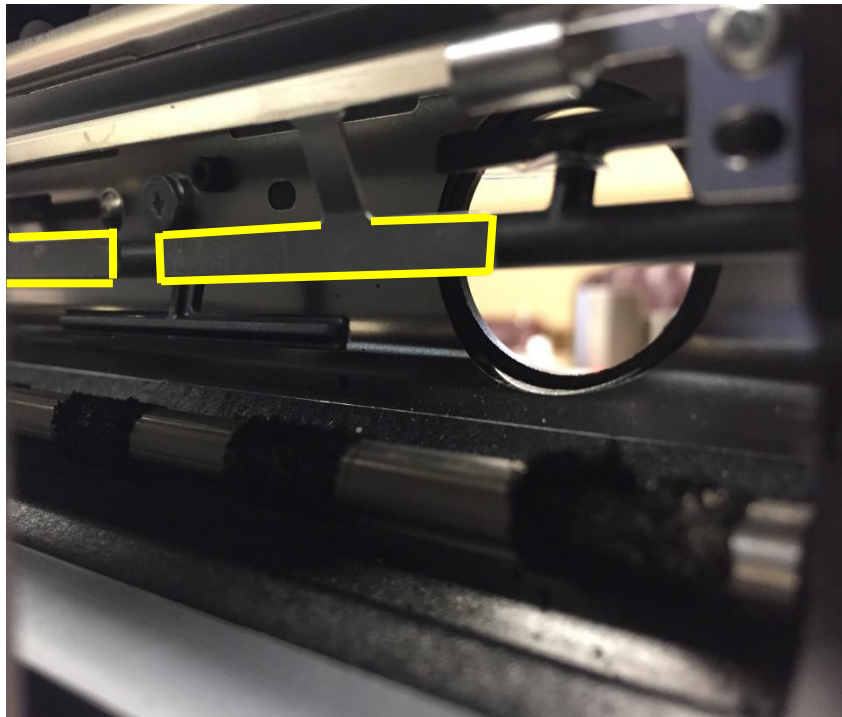
**Figure 7.** Developer Unit with Metal “T’s” Highlighted to Show What was Removed for the Alternative Test 4: Final Design Assembly Test

Upon completing the first four designed tests, an additional test was developed. The final design assembly test was redone with the metal “T’s” within the developer unit removed; these “T’s” are highlighted in **Figure 7**. This was done to attempt to discover the actual load of the toner alone without any potential interference from this alternative part of the system. Other additional tests were discussed but were not able to be run due to time constraints.

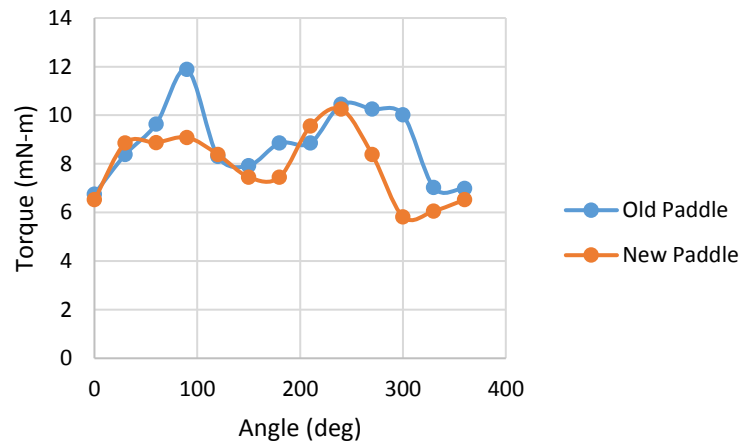
**Figure 8.** Load Reduction due to Agitator Shaft Paddle Shape Test Comparison Results for Old and New Paddle Shape Design

The first test was completed for all four machined agitator shafts with the old paddle design and all four machined agitator shafts with the new paddle design; the complete collection of data can be found in **Appendix A**. A summary of the data is presented in **Figure 8**. Statistical analysis done by Herman Smith and Kevin Kennedy from Lexmark was able to conclude that the new design of the agitator paddle reduced the load by 10% with 98% statistical confidence for the flour based systems. It was assumed that this load reduction was the same for a toner based system due to the similarity in compacting characteristics. The starting angle was also determined to play a noticeable role in the resistance of the flour due to the difference in moment of inertia for rotation based on the orientation.

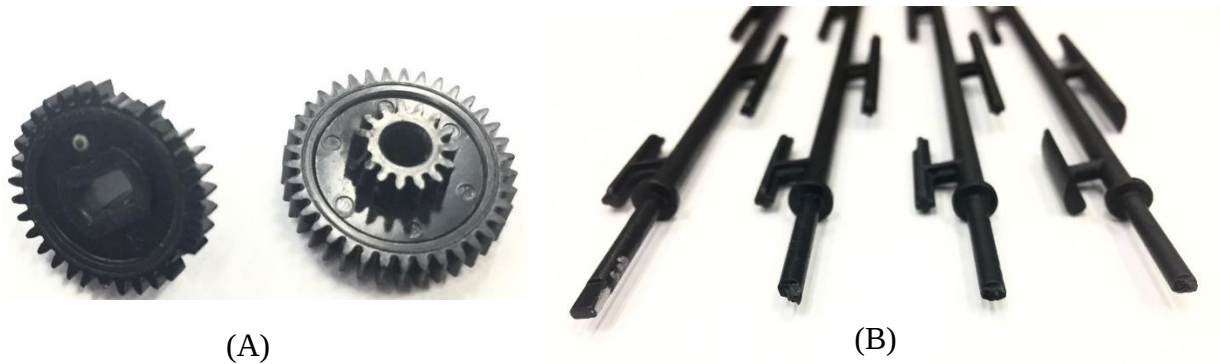
**Figure 9.** Gear Failure Test Failure Modes with (A) Molded Gear Failure and (B) Molded, Old Design Machined, and New Design Machined Agitator Shaft Failure

First, the molded gears were found to fail under the original setup at about 98 mN-m which was 26 mN-m more than predicted; this failure is depicted in **Figure 9**. Second, both systems with machined gears and shafts were found to exhibit a preloading phenomenon that manifested itself as a 90° to 120° visible rotation of the end of the agitator shaft that engaged with the agitator gear, along with a large vertical deformation of the central portion of the agitator shaft of about roughly 3.5 mm, calculated from images. Furthermore, the first new failure mode was discovered: shearing of the ends of the agitator shaft at the point of stress concentration where the shaft engages with the gear. This failure was found to occur in other tests and was explored further when combining all the shaft failures at the end of the final test. The second new failure mode was also discovered: shearing of the idler post from the gear face plate. This failure was found to occur more often in other tests and was explored further later.

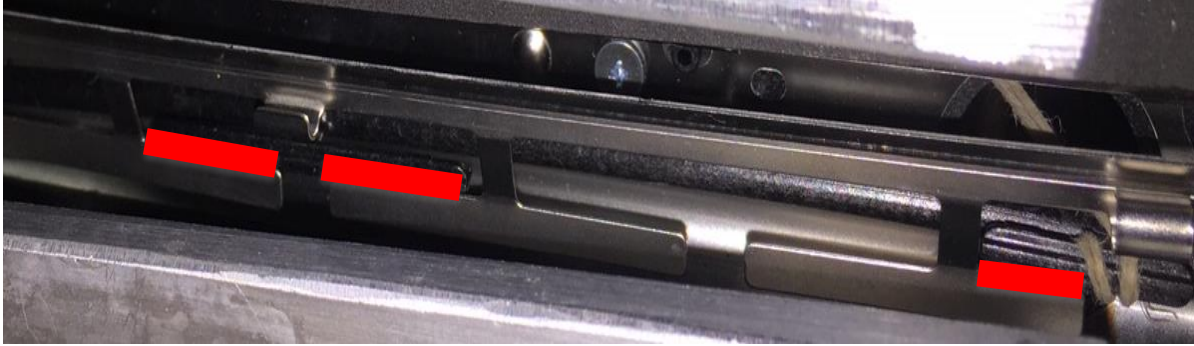
**Figure 10.** Additional Problem: Interference with Metal “T’s” Due to Extreme Deflection of Agitator Shaft (Marked by Red Zones)

Next, the agitator shaft deflection led to another unforeseen problem in the interaction of the system: after a load of 23 mN-m was applied to the system, at least one of the five agitator paddles became engaged with the metal “T’s” fixture within the system. By 46 mN-m, all of the paddles facing toward the front of the agitator shaft had engaged with the metal “T’s” fixture, depending on starting orientation. This provided a significant new problem because interference with this metal fixture drastically increased the torque required to turn the agitator shaft because

the shaft would not be able to rotate through this metal fixture. In fact, it was predicted that the agitator shaft would have to deflect away from this fixture to be able to move past it, which would require a load much higher than was capable before reaching the new failure mode of the shaft failure.

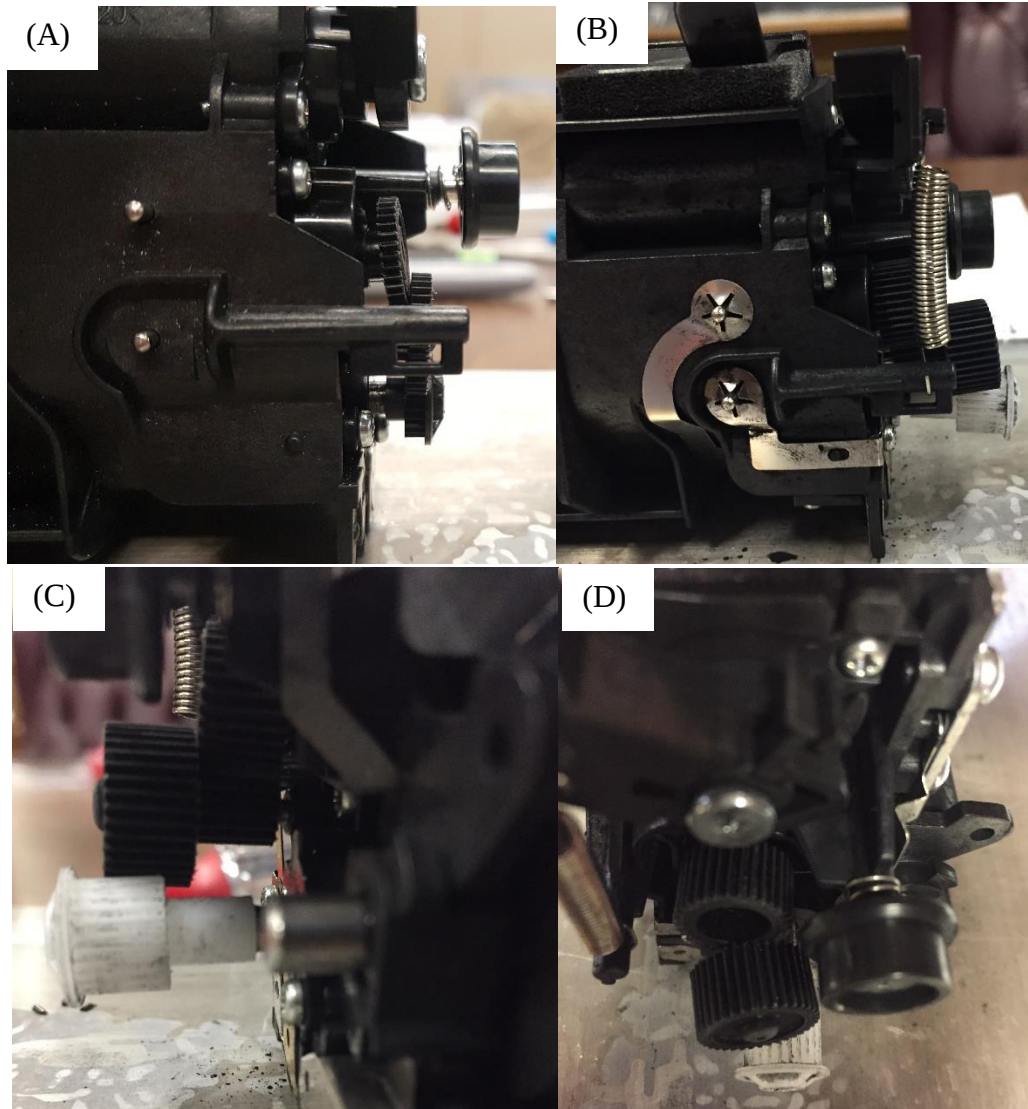
**Figure 11.** Example Deflection for (A) Original Design Output Gear at 137 mN-m, (B,C, and D) New Design Idler Gear at 158 mN-m

Finally, the deflection of the gears was observed for both the old and new design as is depicted in **Figure 11**. Note that the images for the deflection of the new gear train design were taken during a test run where the input gear was improperly assembled on the input shaft, resulting in a reduction of tooth engagement. However, these images clearly depict the observations made that the input gear had a low deflection in only the vertical direction; the idler gear had a high deflection in the vertical direction, horizontal direction, and rotationally about the vertical axis – around 1.1 mm, the horizontal was too small to be accurately measured, and 2 mm (8.5°), respectively; and the output gear had a moderate deflection in the vertical direction, around 0.6 mm (5.9°), and a large rotational deflection across the horizontal axis of about 1.5 mm (8.4°). Furthermore, it was observed that the outer surface of the output gear would get caught on the inner surface of the larger compound idler gear. This problem has been identified in gear trains before, and the solution would be to include a thin ring on the outer surface in the design for all gear surfaces to ensure that this contact never results in rotational failure.

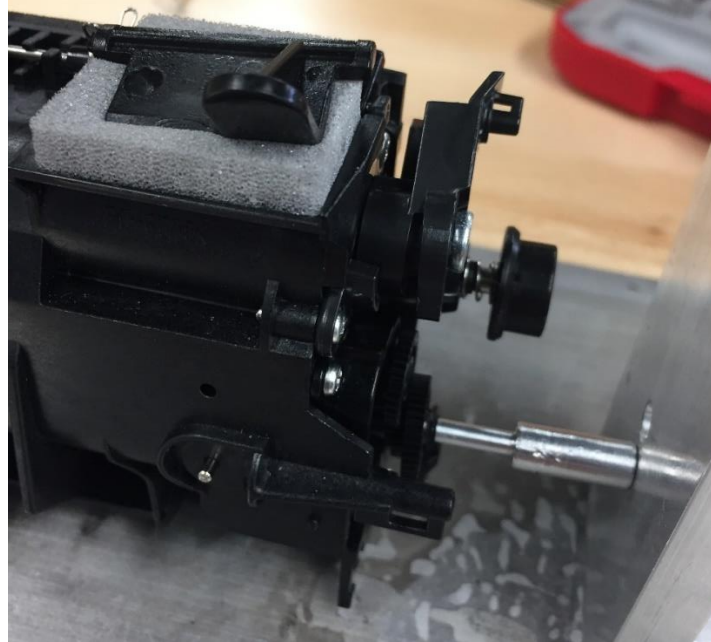
**Figure 12.** Gear Failure Test with Reduced Deflection Trial Run with Steel Shaft and One Aluminum Support Pin at 112 mN-m Load

The third test was also conducted with molded gears of the original design, machined gears of the original design, and machined gears of the new design. However, to avoid the agitator shaft failure found previously, a steel shaft was machined to fit in place of the agitator shaft and fixed from rotation; due to the increased strength of this shaft, deflection of this shaft was predicted to decrease greatly, so only one of the aluminum support pins was used, as can be seen in **Figure 12**. Note that the deflection of the system was significantly less than the original system, as intended.

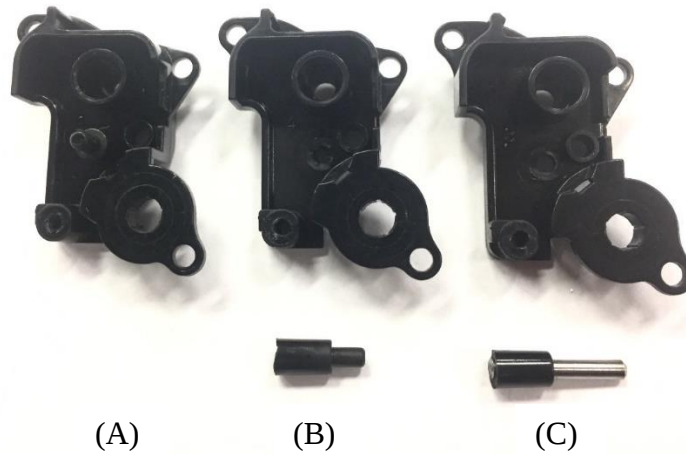
**Figure 13.** Depiction of Idler Post Failure with (A) Original Gear Face Plate Without Failure, (B) Original Gear Face Plate with Idler Post Failure, and (C) New Gear Face Plate With Idler Post Failure

The second observation was that another new failure mode was discovered: the base of the post attached to the gear face plate snapped in both the old and new systems, as is shown in **Figure 13**. The idler post was not expected to fail from initial estimations. However, the multi-

dimensional loading of the idler gear shown by the deflection from the second test was not specifically accounted for; so, the forces on the idler post were greater than the initial assumptions. Furthermore, both the old and new design visually appear to have broken at the connection between the idler post and gear face plate due to the bending moment; it can be reasonably concluded that this connection provided an impactful stress concentration that propagated failure.

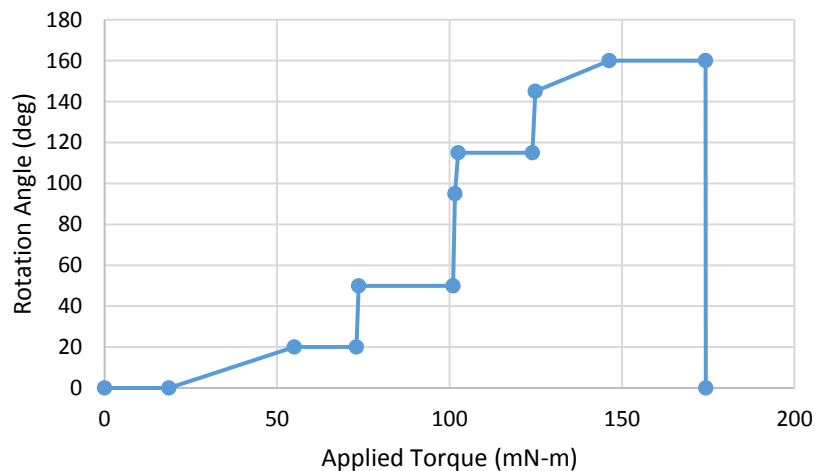
**Figure 14.** Example Rotational Loading Increments Used to Understand Preloading that Failed at 174 mN-m

Another observation made was in the described preloading of the system. As the load incrementally increased in the system, the visible end of the agitator shaft visibly engaged with the output gear would rotate along with the each of the gears within the gear train; a depiction of a load and angle measurement comparison can be seen in **Figure 14**. Similar to the second test, a rotation of between 90° and 150° was found to be a maximum rotation before shaft failure. However, this preloading rotation occurred incrementally and at higher loads compared to the second test. In attempting to understand this loading, the system was compared to a mass-spring system with multiple springs connected in parallel. A specific load, for example about 50 mN-m, was required to load the first spring to the point where the second spring would become loaded, and so on, leading to tiers of movement at higher loads. Different parts of the system that could be understood as spring resistances in the system were the rotation of the input shaft through the toner, the rotation of the paddle closest to the gear train, the rotation of the second paddle, and so on. This theory would need to be further tested in future work to determine its validity.
