PROJECT TITLE: Quantification and Standardization of Pattern Properties For Control of the Lost Foam Metal Casting Process.

# **QUANTIFICATION AND STANDARDIZATION OF PATTERN PROPERTIES FOR CONTROL OF THE LOST FOAM METAL CASTING PROCESS**

## **ABSTRACT**

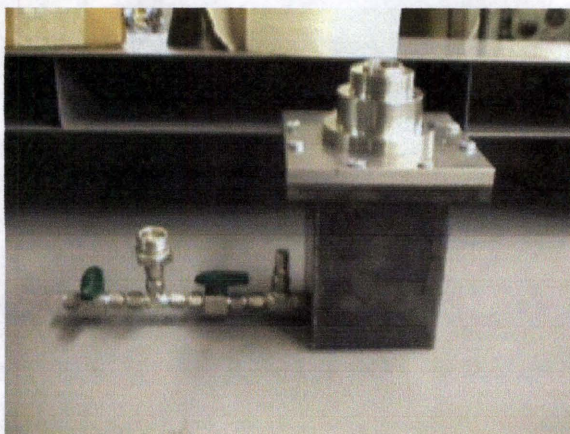
**Figure 1. Picture of the chamber and valve attachments**

In order to simulate the LFC process, a system had to be built that could accurately duplicate the procedure. The system consists of a chamber built to hold the sand and the EPS foam. The chamber was designed to be hermetically sealed in order to prevent gas to escape during the degradation process. The dimensions of the chamber are 4x4x6 inches. The chamber is displayed in the following figures.

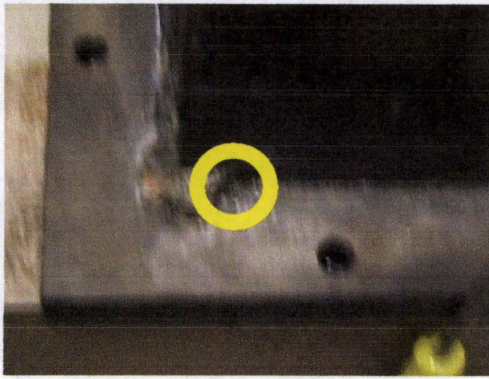
**Figure 13. Leakage area**

Now if the chamber had leaks the soap water would start bubbling and get sucked inside the chamber. And this is what exactly occurred. Water leakage was noticed in two specific areas of the chamber as shown in the figures below.

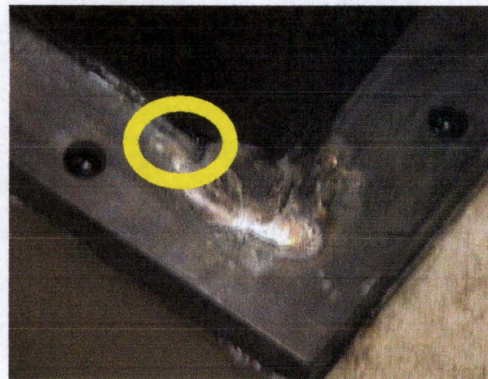
**Figure 14. Another leakage area**
