Measurement and Analysis of the Extreme Physical Shock Environment Experienced by Crane-Mounted Radiation Detection Systems

Boyd, Matthew; Erchinger, Jennifer; Marianno, Craig M.; and Kallenbach, Gene (2019) "Measurement and Analysis of the Extreme Physical Shock Environment Experienced by Crane-Mounted Radiation Detection Systems," *International Journal of Nuclear Security*: Vol. 5: No. 1, Article 1.

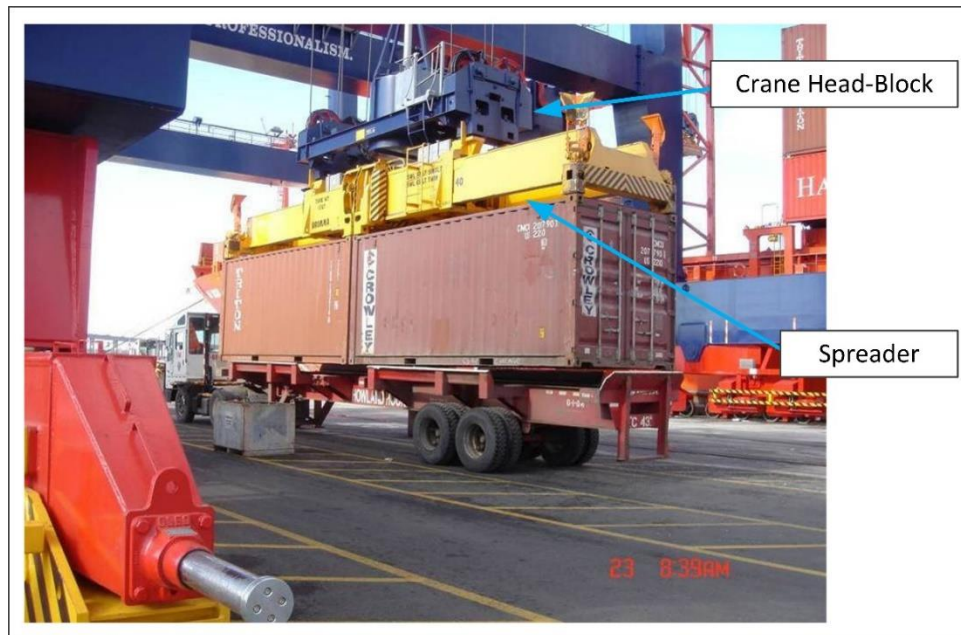
Figure 1. Container Crane Spreader

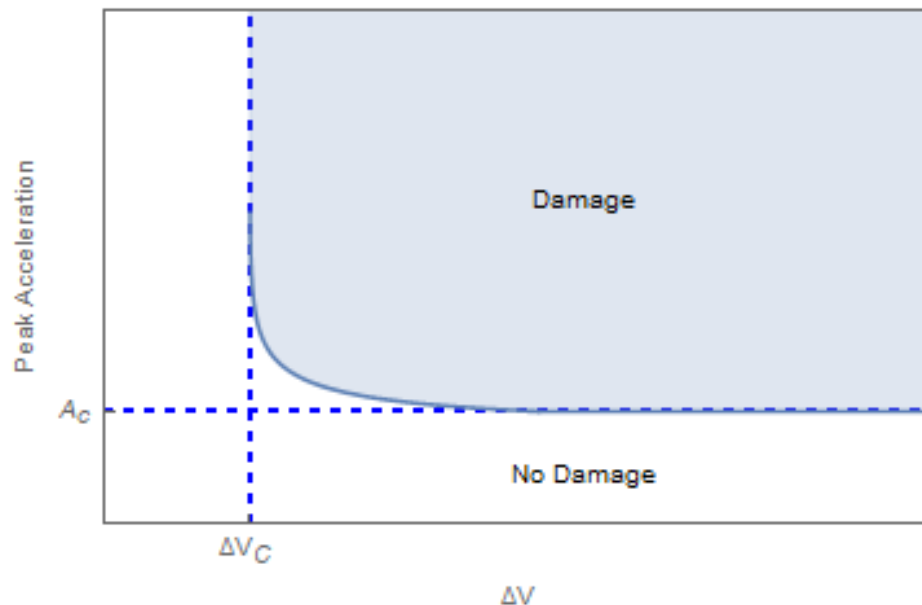
Figure 3. Theoretical damage boundary curve caused by a square waveform with arbitrary scaling. Product damage only occurs in the shaded region. A shock input above both the critical acceleration (A_c) and critical velocity change (ΔV_c) will cause damage.

System design for these conditions can be improved with direct observation of the physical shocks experienced by the spreader. Damage boundary theory is a testing protocol which determines which shock inputs will damage a product [8]. A combination of the acceleration level and velocity change, due to a shock, can cause product damage; however, there is a critical acceleration and critical velocity change, and both must be exceeded for damage to occur. A theoretical boundary damage curve can be seen in Figure 3. The shock environment of the spreader bar can be measured in advance for evaluation against the damage boundary curve for any proposed future instrumentation.

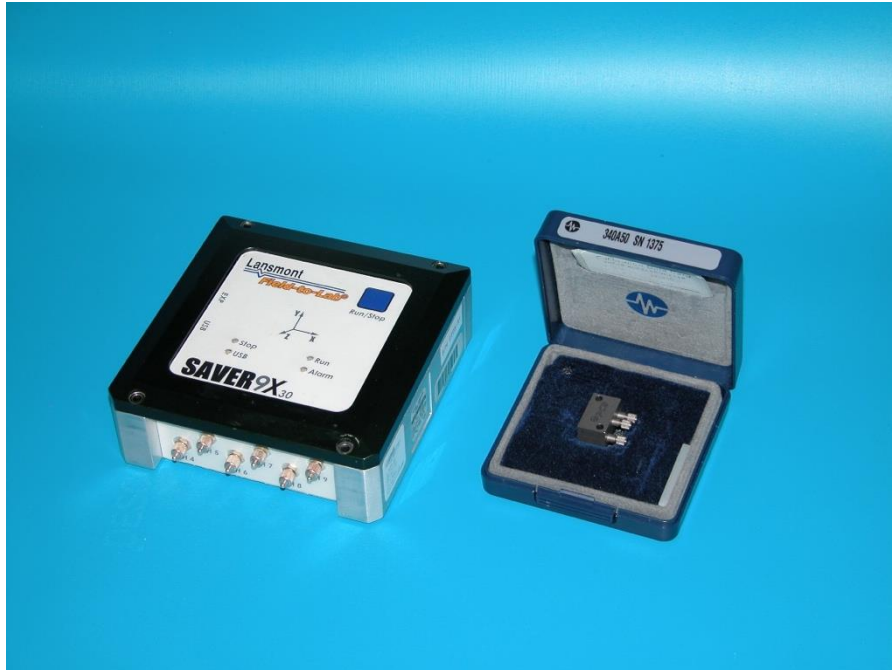
Figure 4. Lansmont SAVER 9X30 and Piezotronics Model 340A50

To measure physical shock, two self-contained accelerometer units were fabricated at Sandia National Laboratory, each consisting of a Lansmont SAVER 9X30 accelerometer/data recorder and a PCB Piezotronics Model 340A50 tri-axial accelerometer within an aluminum housing. The PCB accelerometer was attached directly to the aluminum housing while the Lansmont accelerometer was braced in the case by high-density polyethylene foam (Figures 4 & 5). The data from both accelerometers were stored by the Lansmont accelerometer. The Lansmont and PCB accelerometers were designated “internal” and “external” respectively, in accordance with their mounting location in the housing. The PCB accelerometers were previously calibrated by Sandia’s Primary Standards Lab and were in calibration during data collection. Calibration was checked on November 11, 2013 and found to be within specification. The Lansmont accelerometers were calibrated by the manufacturer. Sandia performed a subsequent shock table test which showed very good agreement between the Lansmont accelerometer and the reference accelerometer.

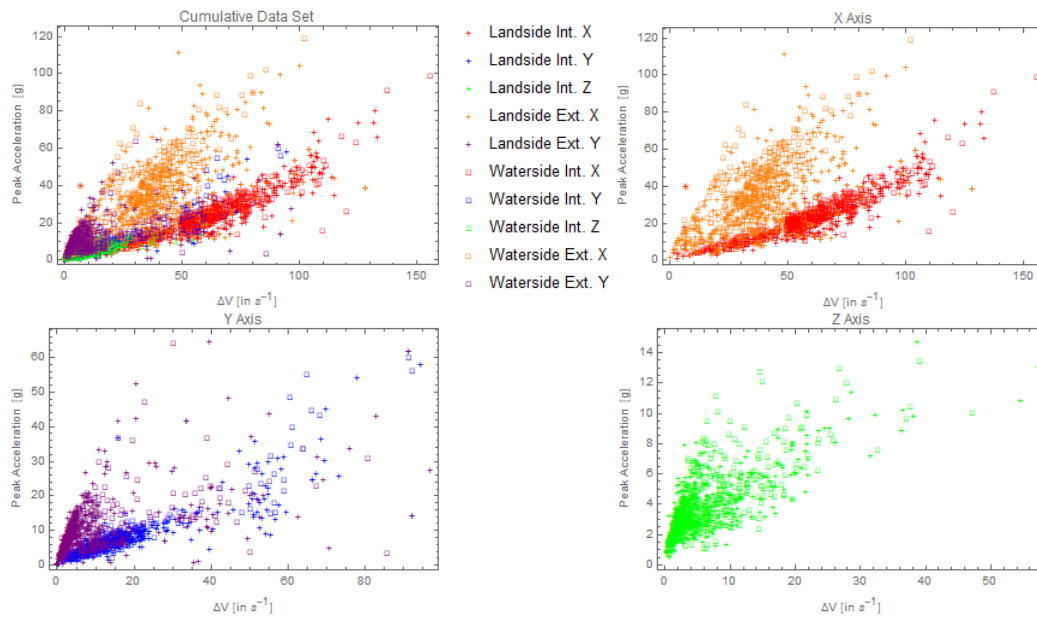
Figure 9: Peak acceleration [g] versus velocity change [in s⁻¹]. Landside values are plotted as + ; Waterside values as □. A cumulative data set and scaled plot for each axis is presented.

It is noted that the external accelerometers recorded larger mean and maximum shocks than the internal detectors with a greater spread in the data. It is unclear if this variance is due to differences in function between the accelerometer models used or a result of the padding used on the internal accelerometers. Additionally, the landside accelerometers show slightly more variance than the waterside ones. Despite this, the waterside units reported the largest maximum shock for both the internal and external accelerometers. However, peak acceleration alone will not cause damage; a sufficient velocity change, from a shock, must also occur. There is a critical acceleration and critical velocity change, and both must be exceeded for damage to result. The critical acceleration and critical velocity change required to cause damage will be instrument dependent. For example, Saint Gobian rates its 2" X 18"NaI(Tl) detectors for maximum shocks of 5g's at 10 ms in any direction while its PolyScin® NaI(Tl) are rated for 200g's at 5 ms. To aid in future instrumentation selection, a cumulative scatterplot of the observed peak accelerations and corresponding ΔV is provided in Figure 9, along with scaled plots of each axis for comparison with product damage boundary curves.

A few key observations can be made from these plots. First, the highest accelerations and ΔV values are observed along the X axis, while the lowest are observed along the Z axis. When designing a system, the weakest axis should be aligned parallel to the length of dock to minimize the possibility of damage. Additionally, there is not a significant difference between the maximum events for the landside and waterside units, though there is a noticeable difference between the external and internal accelerometers. The unpadded external accelerometers show higher shocks with lower velocity changes, while the padded internal accelerometers show lower peak shocks with larger velocity changes. This is believed to be due to small amounts of polyethylene padding present around the internal units, as the function of padding is to translate high acceleration events outside the packaging to lower acceleration events for the internal object. Any system designed to operate in these environments must be able to limit input accelerations below critical accelerations levels. Low Z padding is the suggested method to minimize attenuation and preserve detector sensitivity.
