Controlled Load Tests on a Four  
Girder Steel Bridge

A Thesis  
Presented for the  
Master of Science  
Degree  
The University of Tennessee, Knoxville

Michael David Sanders

May 1994

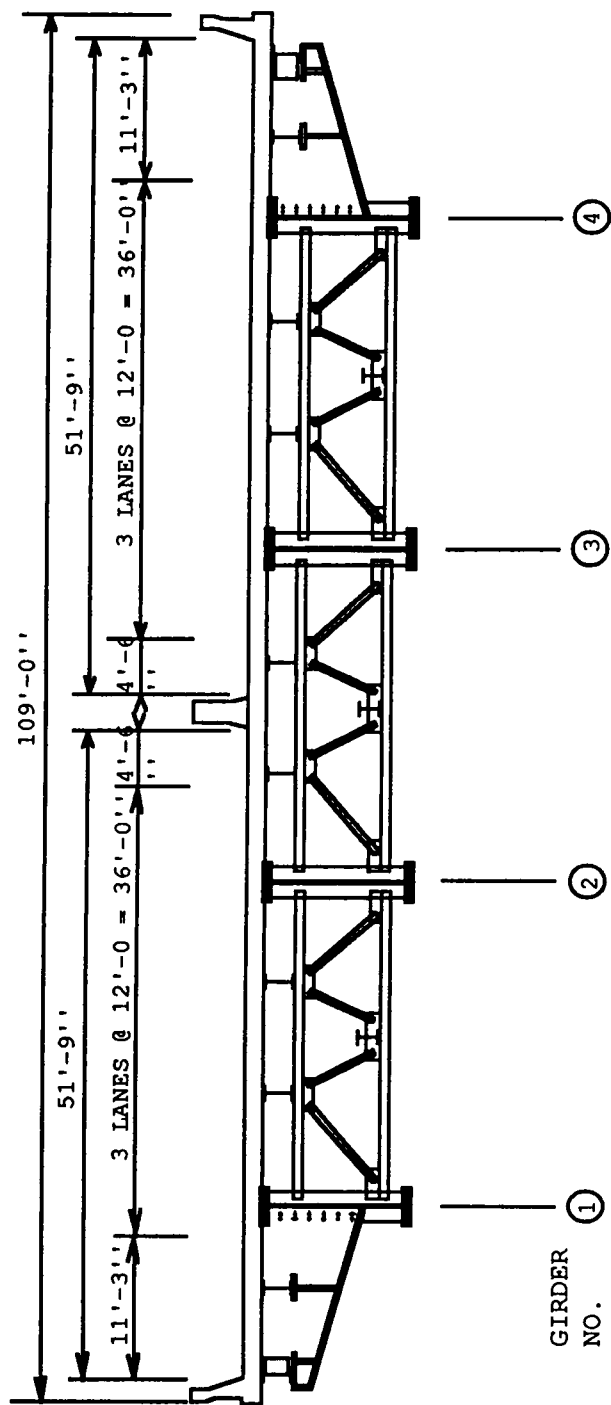
Figure 3.5 - Typical Cross Section in Span 2

frames span between the four girders within this span. These trusses support wide flange sections that serve as stringers for the bridge deck and transfer their loads into the main girders (Figure 3.5). All other spans use welded built up floor girders for this purpose (Figure 3.6). Several fatigue prone details were found to exist within these floor trusses and their connections to the girders.

The bottom connection of the floor truss to girder web connection is a major point of interest in this project. The lateral gusset plate that serves to connect the bottom chords of the truss and the bridge's diagonal X-bracing to the web of the girder is notched to accommodate the vertical stiffener located on the web (Figure 3.7). This detail solves the problem of intersecting welds at the gusset stiffener intersection. The gusset is bolted to tabs that are welded horizontally along the web of the girder on each side of the vertical stiffener. These tabs end four inches from the vertical stiffener. This forms a four inch web gap on each side of the vertical stiffener (Figure 3.8). This web gap is a length of unstiffened web that is subject to out of plane distortion. Forces introduced by the floor truss tend to pump the girder web in and out. When out of

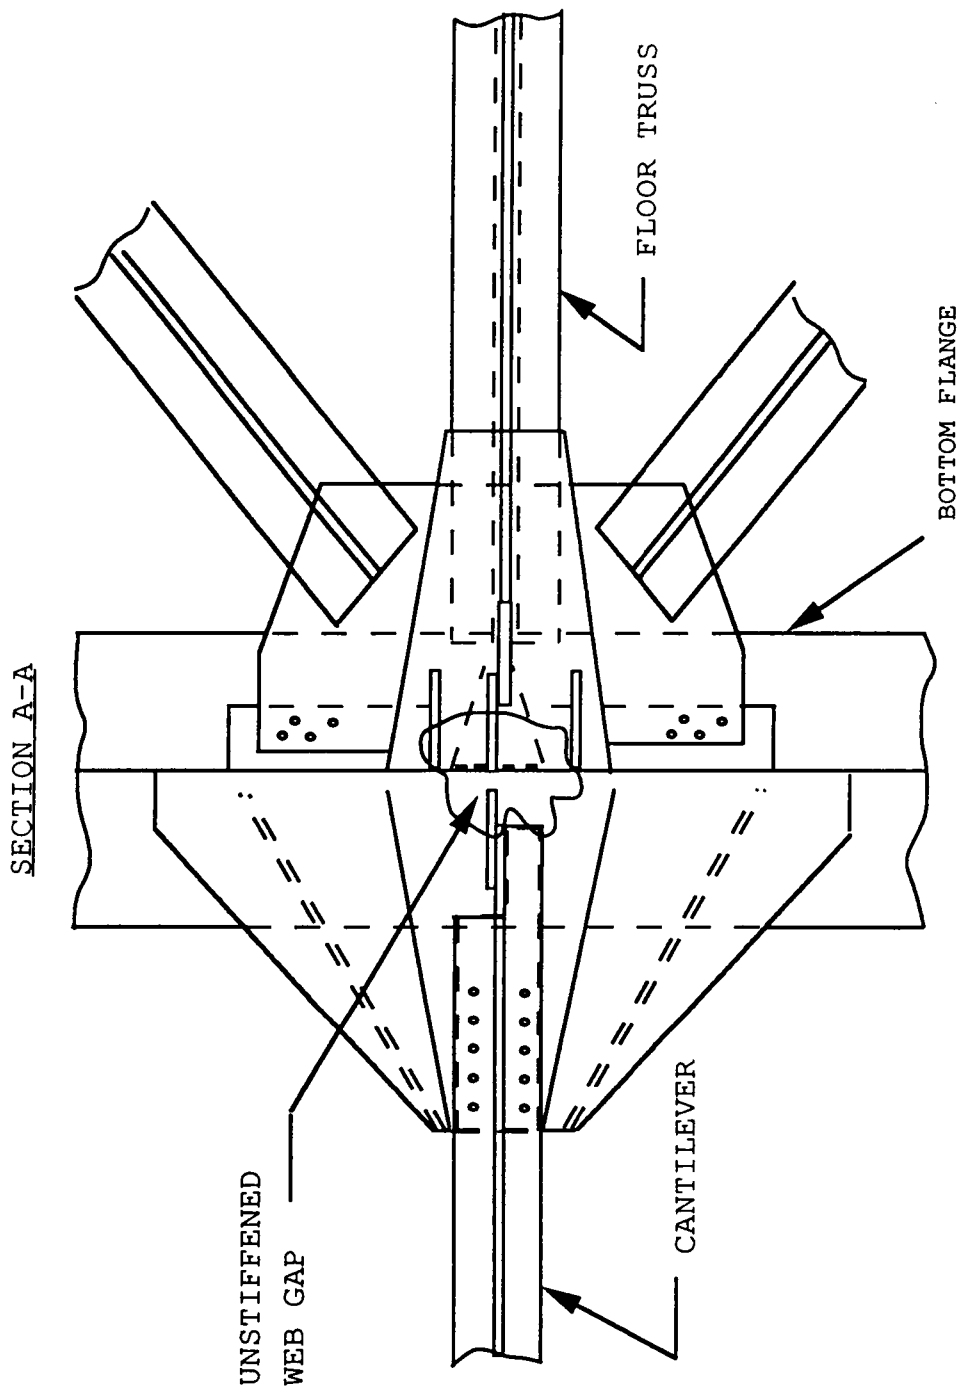
Figure 4.4 - Gages at Exterior Girder Web Gap

At each of the locations within span two, the web gap on the exterior girder web was instrumented(Figure 4.4). Three of the four locations received two gages in each of the two web gaps. At the failure location, only the web gap on the opposite side of the vertical stiffener from the fracture was instrumented because of the presence of bolts used to fasten the repair plates in place. A strain gage was located at each side of the web gap(Figure 4.4) to allow for the determination of stresses within the gap. The location of these gages also made it possible to determine if there were any out-of-plane distortions induced over the length of the gap.

If out-of-plane distortions were present, outputs from these gages would be of opposite signs or significantly different. The diagonal X-bracings connected to the lateral gusset plate at this location were also fitted with strain gages. These gages would reveal the contribution these bracing members had to out of plane bending in the web gap.

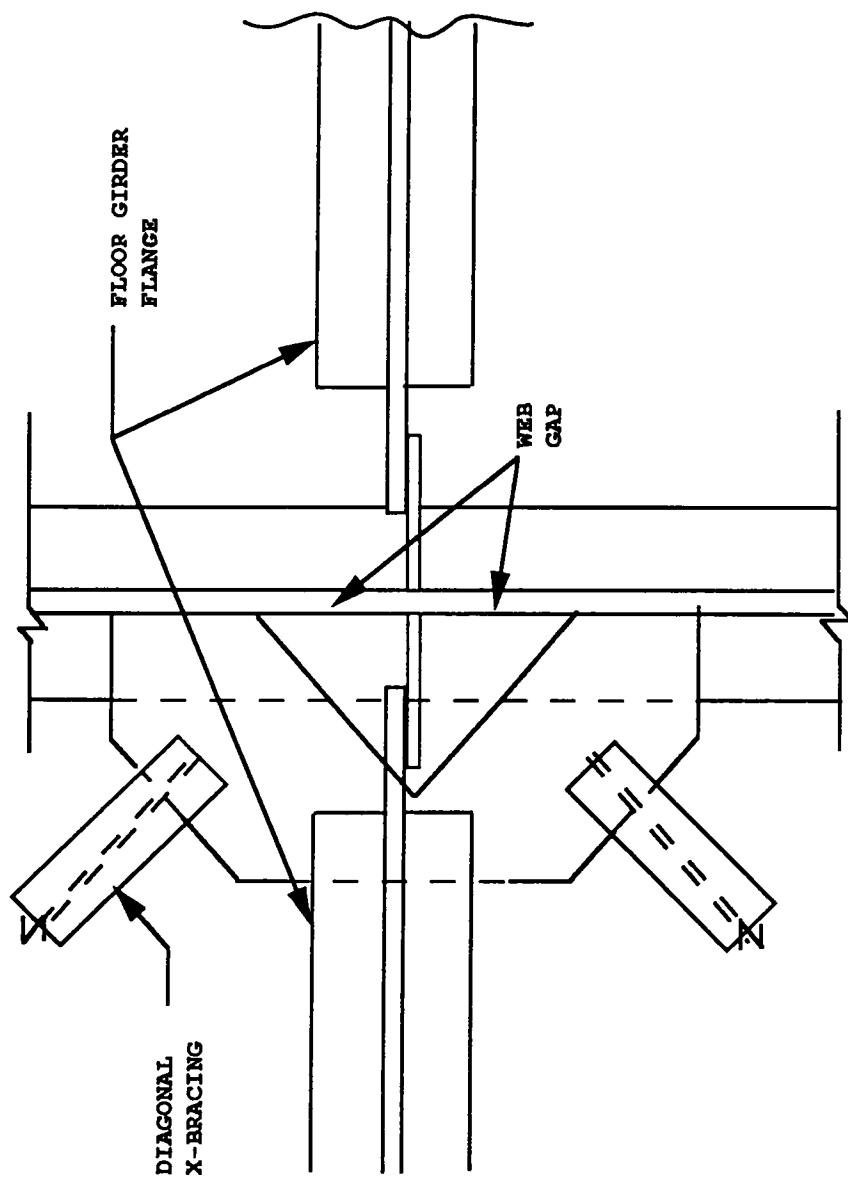
Figure 4.6 - Web Gap at Floor Girder  
to Main Girder Connection

A web gap also existed at the connection of the floor girders to the interior girder. This situation was similar to that which existed prior to the retrofit procedures used in span two. This web gap is not

stiffened on the opposite side of the web, as are the retrofitted web gaps of span two. Therefore, it would be more susceptible to out of plane distortion. This web gap received gages identical to those placed in the web gaps located in span two (Figure 4.6). The connection of the floor girders to the main girders was also examined. A possible high stress region exists where the top and bottom flanges are terminated. The termination of the flange web weld at this location creates a Category E detail. Therefore, gages were located on the web in this area at both the top and bottom of the floor girders.
