IDENTIFICATION OF TRAFFIC CONTROL PROBLEMS  
IN HIGHWAY CONSTRUCTION ZONES

A Thesis  
Presented for the  
Master of Science  
Degree  
The University of Tennessee, Knoxville

Danny Ray Middleton  
March 1979

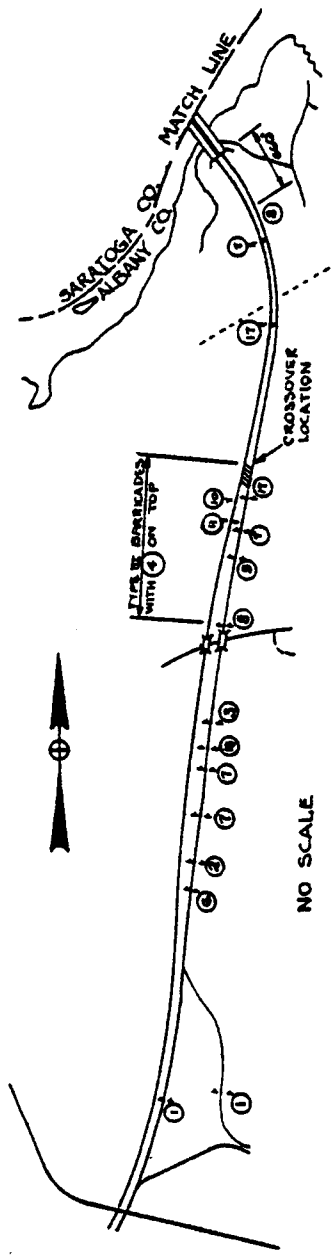
Figure 12-2. Traffic Control Diagram--MP 6.70 to MP 7.75.

4. Existing inapplicable lane markings were painted over and this may have created hazardous conditions during darkness and/or periods of wet pavement. A satisfactory means of removing old pavement markings while maintaining uniformity of appearance over the entire pavement surface has yet to be developed. A thin lift of asphalt in the area of the crossovers to cover old markings might have been feasible.

5. Lane tapers on both the northbound and southbound lane closures were 1,000 feet in length. If the speed limit of 40 mph were used with a lane width of 12 feet, the minimum taper length would have been:  $\frac{WS^2}{60} = 320$  feet. Perhaps the development of criteria for maximum taper lengths (in addition to minimum) would be justified for given conditions of speed and lateral traffic shift.

8. Barricades were used along the right side of the traveled way turned parallel to the direction of traffic. The barricades thus afforded very little target value for oncoming vehicles and may have even created a hazard by their orientation to traffic.

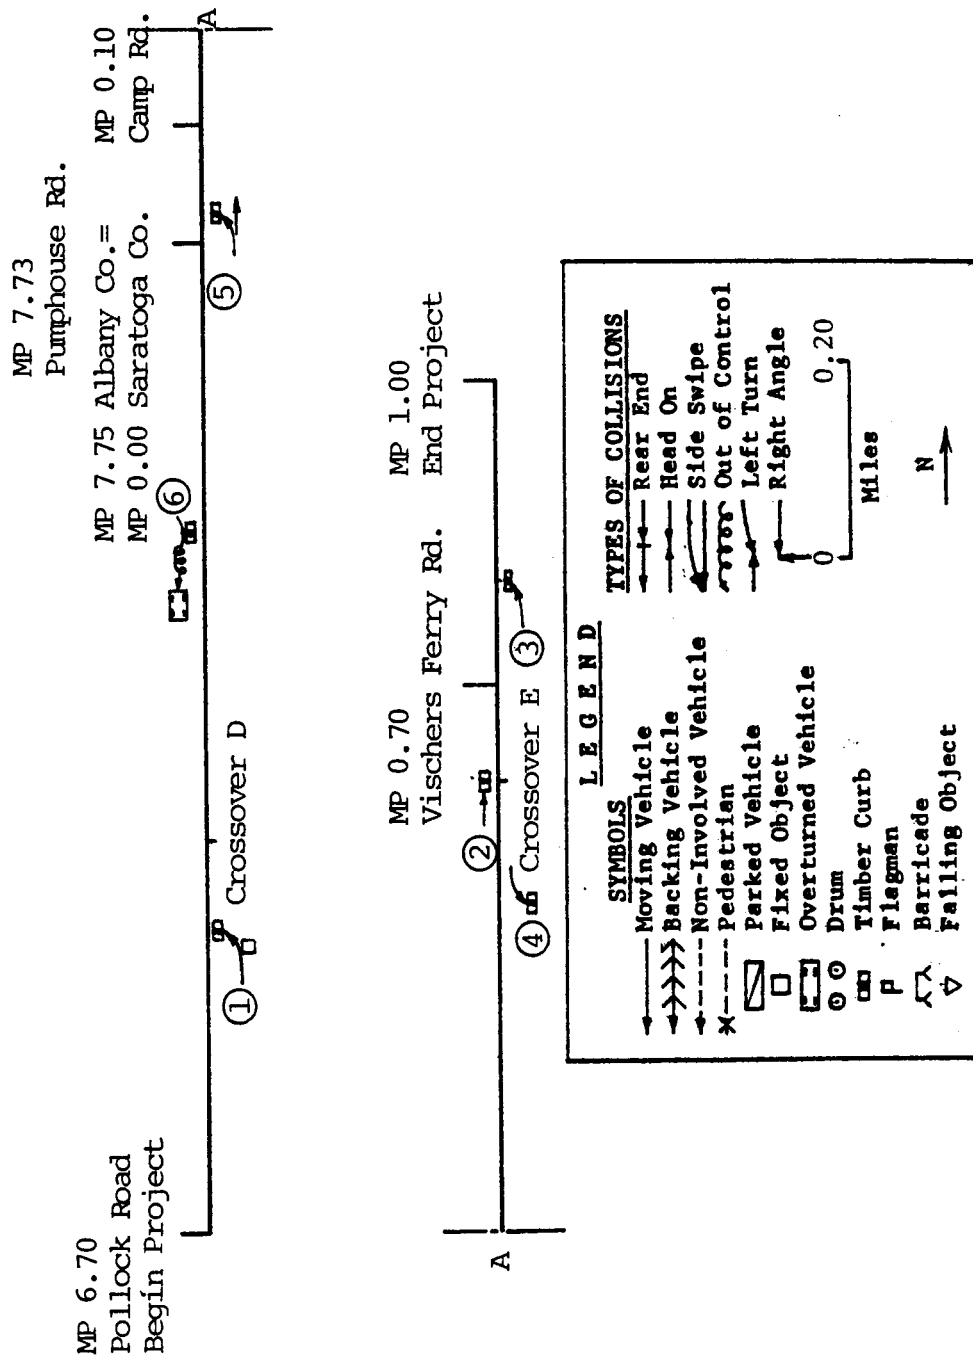
Figure 12-4. Collision Diagram--March 10, 1975 to December 1, 1975.

Figure 12-4 is a collision diagram of the construction related accidents referenced to the accident listing in Table 12-1. All of these accidents occurred in the roadway section which served opposing traffic separated by the timber curb. Two occurred in the vicinity of the crossovers.

| No. | Date | Time | Type | Contributing Factors |
|---|---|---|---|---|
| 5 | 10-11-75 | 3:00 pm | PDO-RE | Vehicle 2 overtook Vehicle 1, struck 1 then hit timber curb. |
| 6 | 10-23-75 | 11:00 am | PDO-OT | Vehicle speeding and struck median barrier in construction area, ran off road and overturned. |

properly redirecting errant vehicles and probably would have resulted in less property damage.

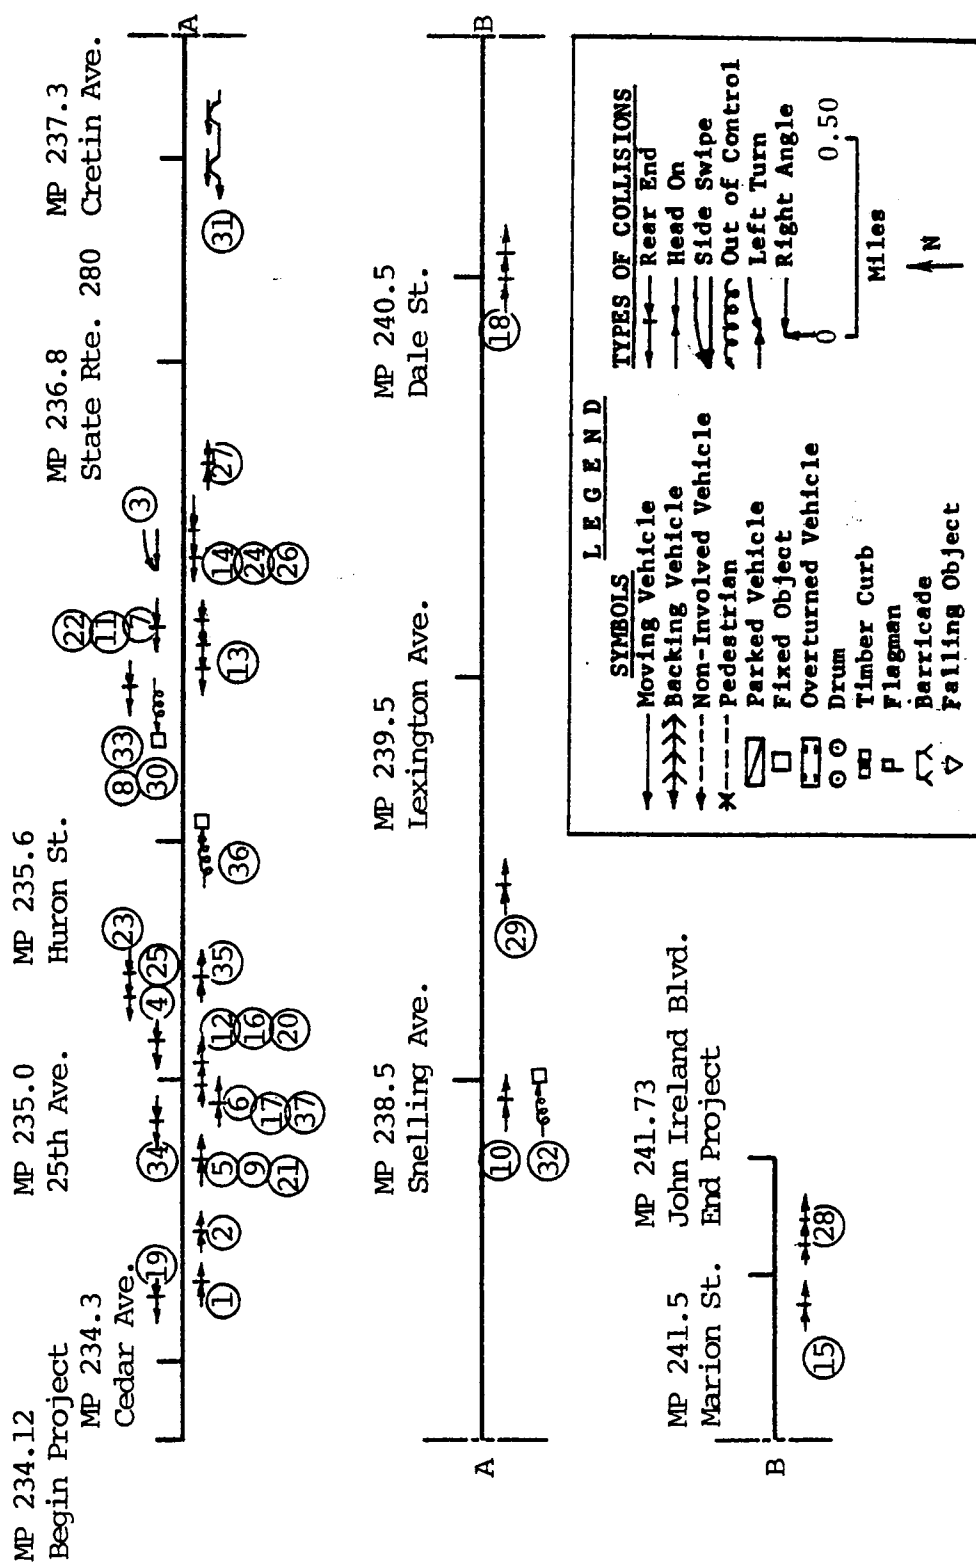
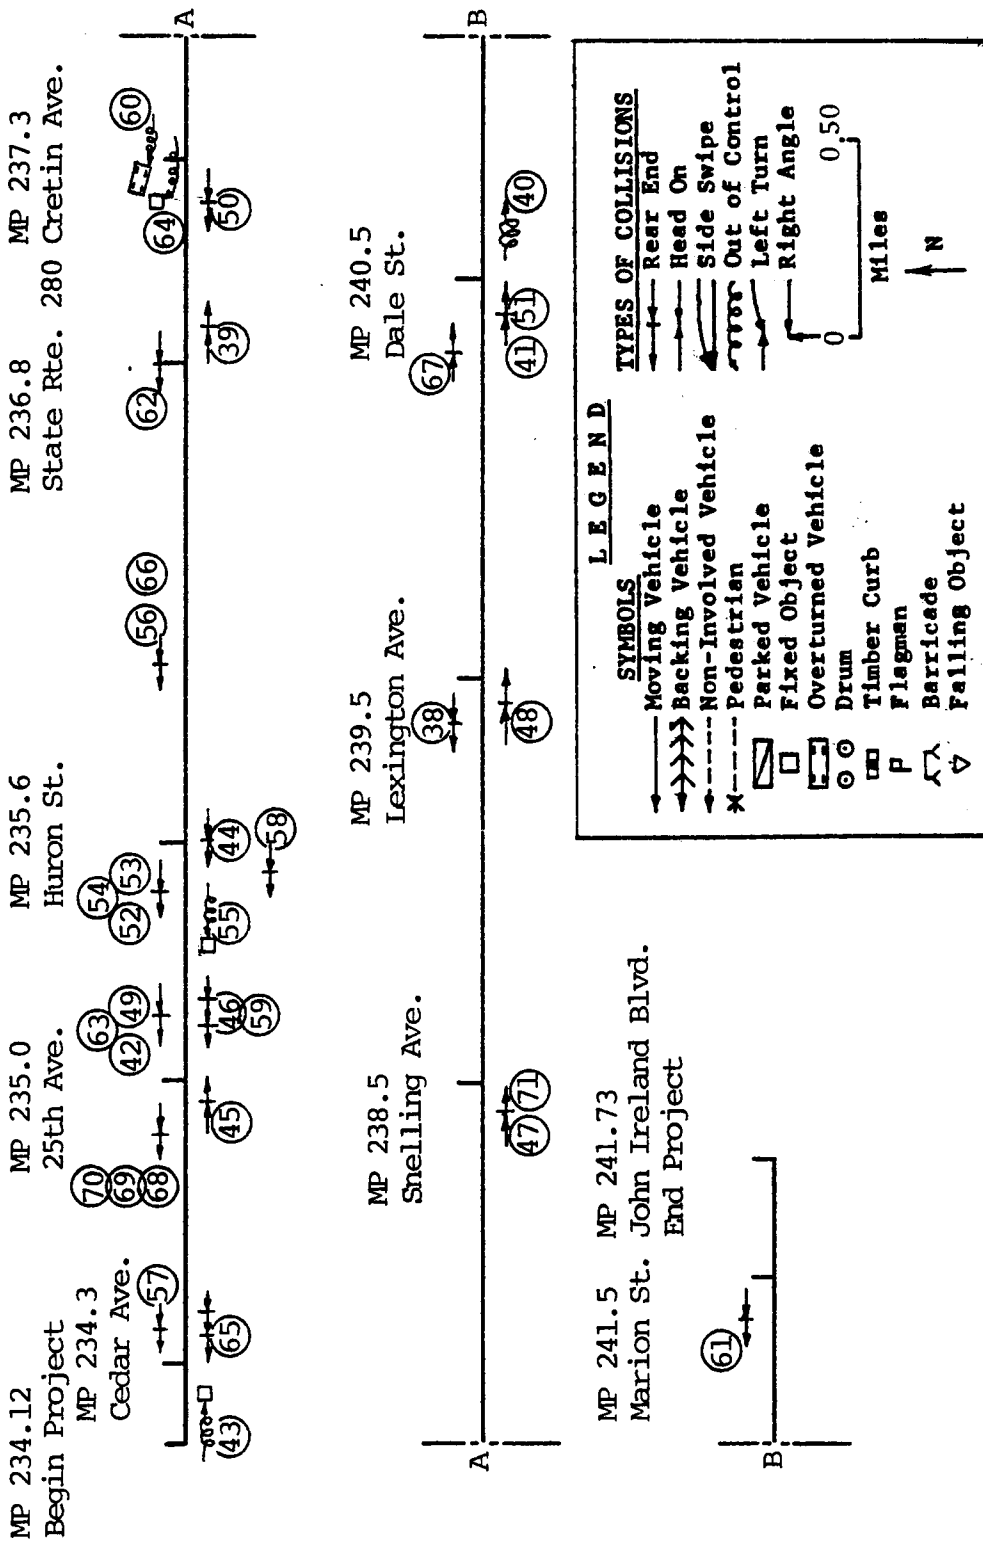
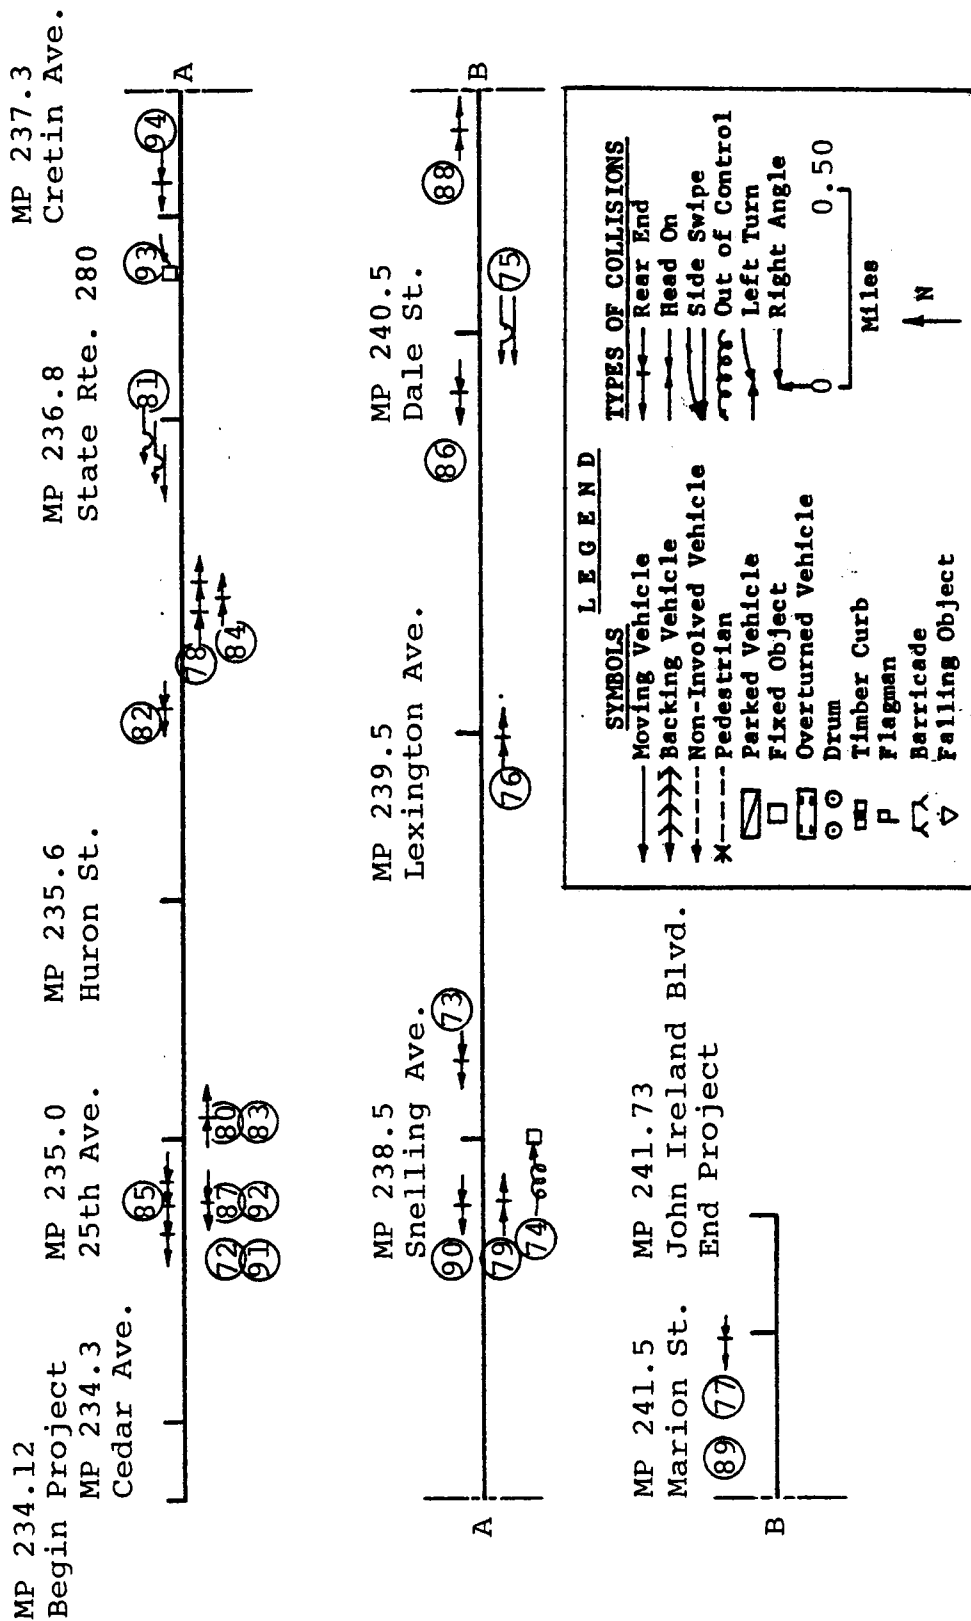
Figures 13-2, 13-3 and 13-4 are collision diagrams for the construction related accidents referenced to the accident listing in Table 13-1. The vast majority of the accidents were rear-end type which occurred at the points of congestion.

The following problems were found with traffic control on this project and were derived from analysis of accident reports, construction logs and traffic control drawings. Accident numbers mentioned within the problems correspond to similarly numbered accidents in the Collision Diagrams (Figures 13-2, 13-3 and 13-4) and the Construction Related Accident Listing (Table 13-1).

| No. | Date | Time | Type | Contributing Factors |
|---|---|---|---|---|
| 93 | 8-16-73 | 5:15 pm | PDO-FO | Vehicle slowed for construction traffic, veered left into concrete median barrier. |
| 94 | 8-16-73 | 5:15 pm | I-RE | Vehicles 1, 2 & 3 involved in rear-end collision approaching congestion. |

1. Numerous barricades were placed such that the stripes were slanted the wrong way. This problem was particularly widespread during the first few days of the project. Assistance by Federal Highway Administration personnel and State Highway Department personnel helped to rectify this situation within a short period of time.

3. Contractor vehicles and ready-mix concrete trucks were observed using the closed lanes to move through the project. There was little problem with the traveling public following these project vehicles except in areas which were cleaned up in preparation for opening. The contractor was asked to limit his use of these lanes and to place barricades across the full width until they were opened.

4. Temporary lane closures were reported which used improper traffic control. For example, the electrical subcontractor was observed restricting one half of the left lane on the exit ramp from I-94 west-bound to Snelling Avenue with no lane closure of any type. Fortunately this operation caused conflict in the traffic stream for only a short period of time.
