# MSE 489 Senior Design Class Project 2

## Final Project Report Failure Analysis of Leaking Stainless Steel Pump Casing

Author: Marybeth Parker  
Date: April 13, 2011

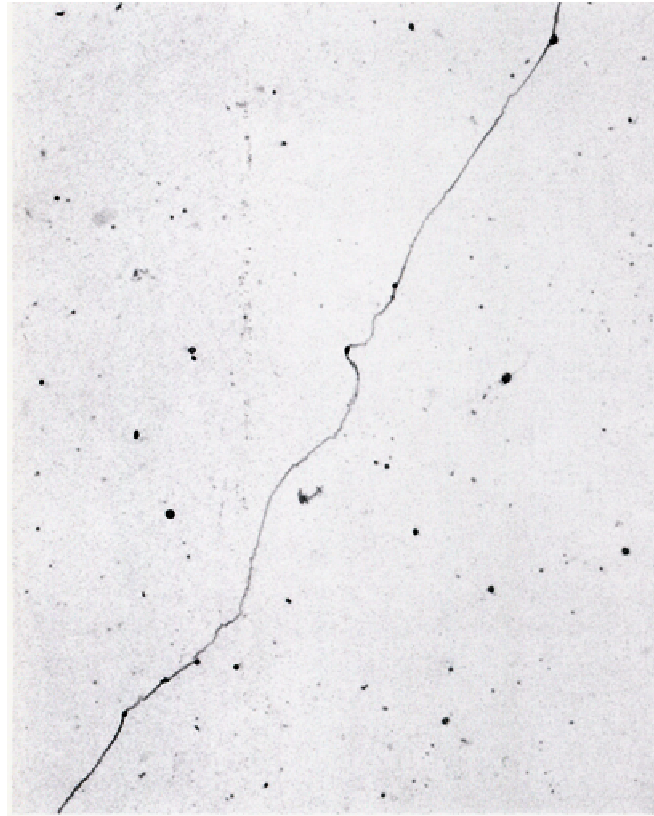
A micrograph for CN7M showing a typical as cast microstructure is shown in Figure 10. This shows grain boundaries and inclusions. The microstructure for a sample of CN7M with the correct solution treatment can be seen in Figure 11. This shows some inclusions, but no carbides. A sample with incorrect heat treatment can be seen in Figure 12. This shows significant carbide in the grain and in the grain boundary.

Figure 10: As-cast sample at 200 x magnification etched with Oxalic acid. Picture shows austenite with dispersed inclusions and carbides along grain boundaries.

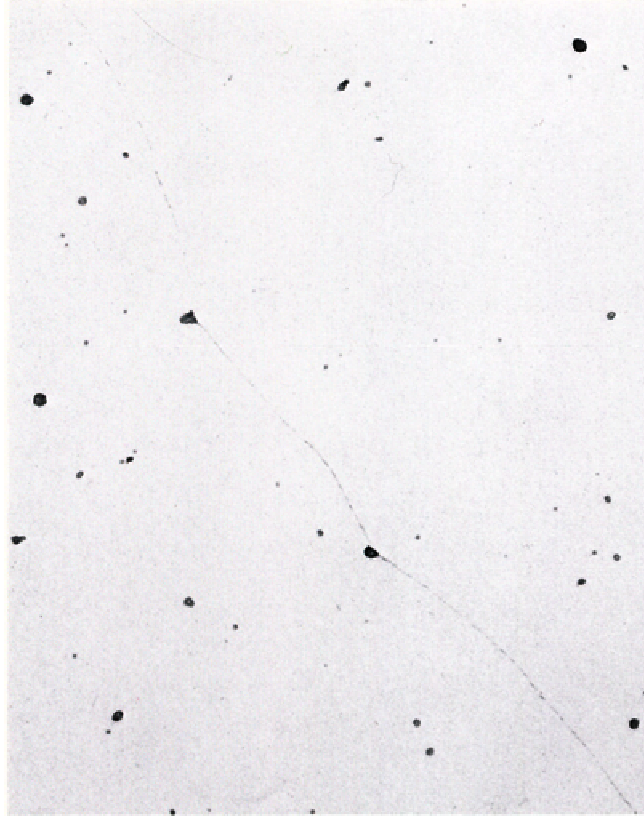
Figure 11: Solution treated 1 hour at 2150 °F (1175 °C), water quenched (correct heat treatment) shown at 200 x magnification showing austenite with dispersed inclusions. Oxalic acid etch.

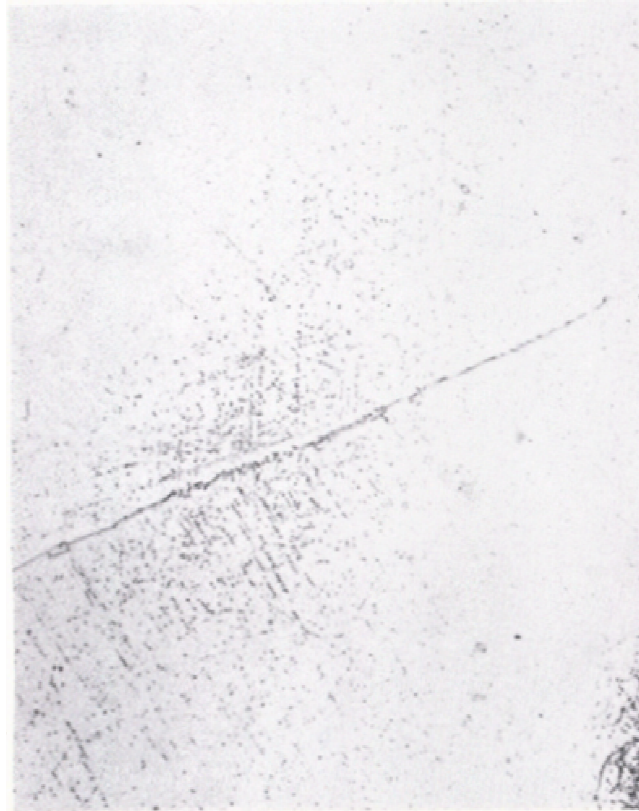
Figure 12: Improper heat treatment, 15 minutes at 1800 °F (980 °C), water quenched shown at 1000 x magnification shows grain boundary and dispersed carbides in austenite matrix. Oxalic acid etch.
