Studies of High Temperature Hydrogen Related Damage in  
Welded Carbon Steel Components used in  
Refineries

A Thesis Presented for the  
Master of Science  
Degree  
The University of Tennessee, Knoxville

Maneel Bharadwaj  
May 2015

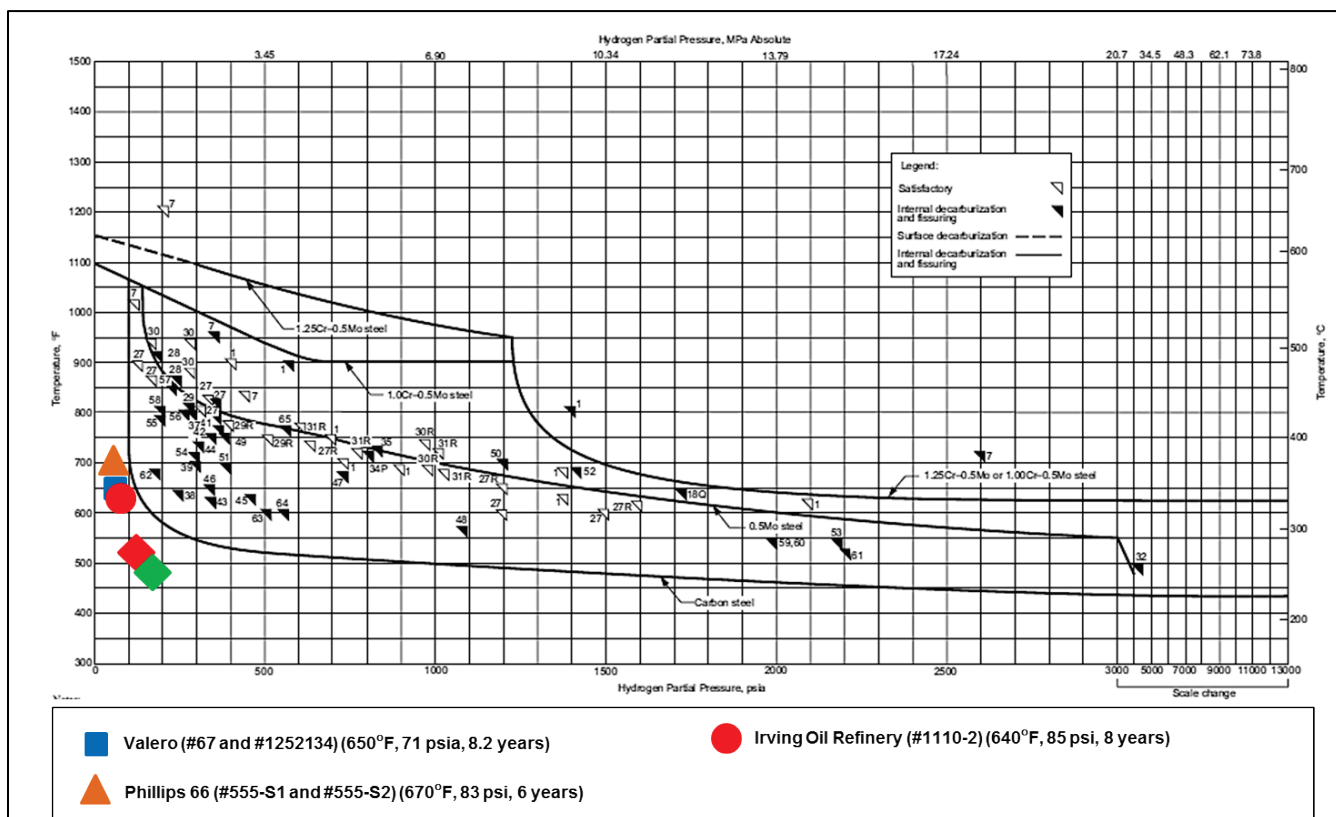
The operating conditions (temperature and hydrogen partial pressure) of all five components were superimposed on the API RP 941 (7<sup>th</sup> edition) as shown in Figure 24, and all the components were found to be below the carbon steel Nelson curve (within the safe operating guidelines). The position of the operating conditions for all the components were also superimposed in all the previous editions of Nelson diagram in API RP 941, and they were also positioned below the carbon steel limit line (within the safe operating guidelines). Thus, none of these components should have been reported for HTHA damage when operating at these conditions. Figure 25 shows the position of each components received at UTK with respect the carbon steel curve developed by G.A. Nelson in 1949 (green solid line), current carbon steel line in API RP 941 (2008) Nelson diagram (black solid line), and relocation of carbon steel line suggested by Chemical Safety Board (dashed blue lines) <sup>37, 38</sup>. Note: The positions of all the components are higher than the CSB suggested relocation of carbon steel line in the Nelson diagram in the HTHA susceptible region. The

Figure 24. API RP 941 Nelson Diagram shows all the Heats used in the Current Study are below the Knee of the Carbon Steel Limit Line. Complete Operating Conditions for all the Heats used in the Current Study are shown in Table 1.

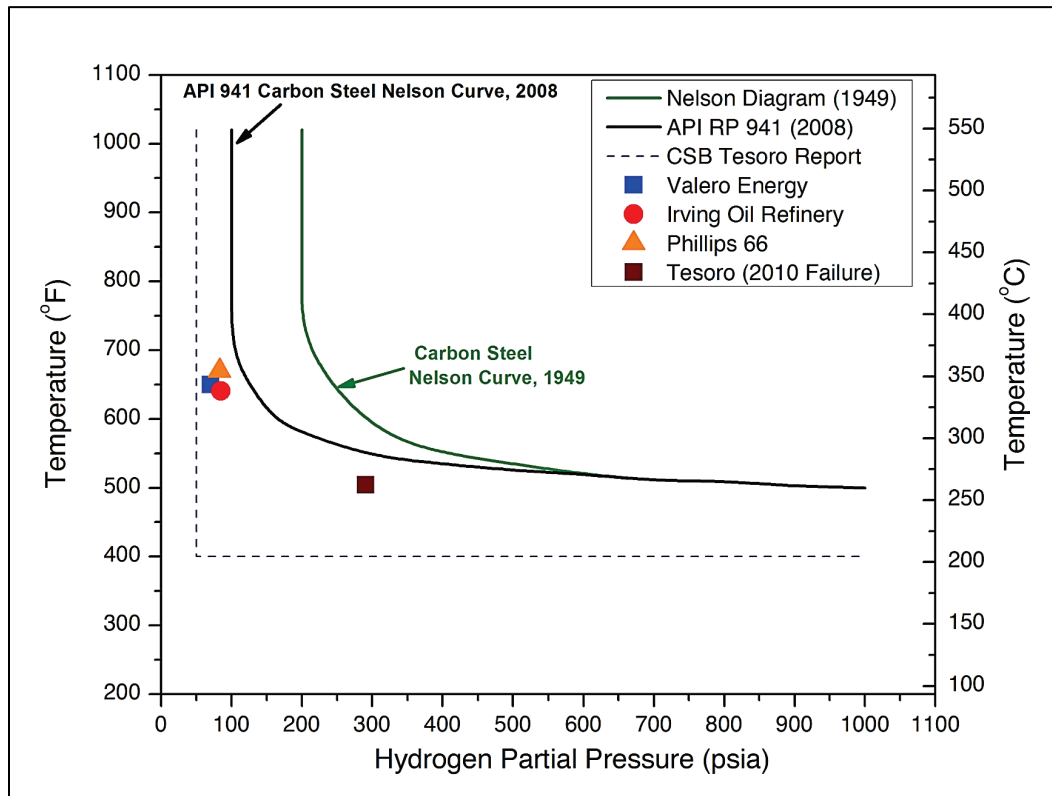
Figure 25. Operating Conditions of all Components Received at UTK with Respect to the Carbon Steel Nelson Curves (1949 and API RP 941 - 2008). The Plot also shows the Position of these Components with Respect to the Suggested Repositioning of the Nelson Curve by the CSB after Tesoro Refinery Incident in 2010<sup>23, 37, 38</sup>. Complete Operating Conditions for all the Components used in the Current Study are shown in Table 1.

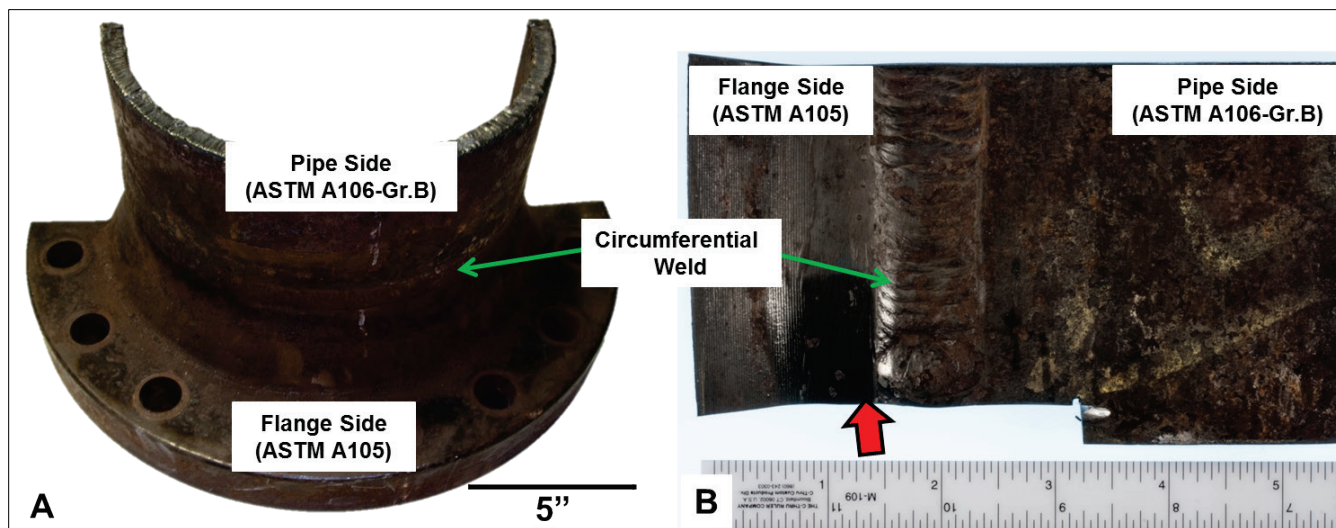
the approximate crack location per Wayland Engineering's finding in the flange base metal as shown in Figure 28B.<sup>80</sup>

Figure 28. As-Received Photographs of the Irving Oil Refinery Flange-to-Pipe Welded Component received from Wayland Engineering for HTHA Evaluation, (A) #1110-2, and (B) Section #1110-2-1 extracted from Flange-to-Pipe Welded Component #1110-2 by Wayland Engineering. Green Arrows show the Location of the Flange-to-Pipe Circumferential Weld. Red Arrow Indicates the Approximate Crack Location in the Flange Base Metal. The Exact Location of Section #1110-2-1 with respect to the Flange-to-Pipe Welded Component #1110-2 is Unknown.

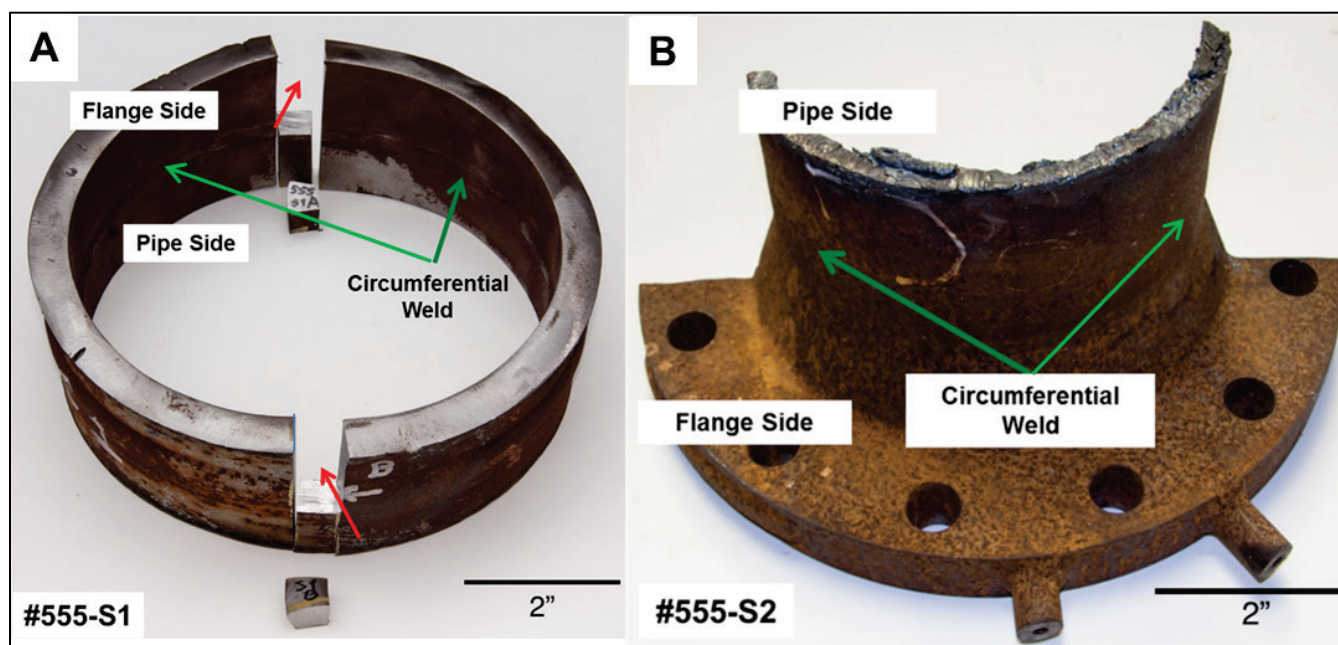
As-Received photographs of the P66 flange-to-pipe welded components #555-S1 are shown in Figure 29A. Samples #555-S1-A and #555-S1-B, shown by red arrows in Figure 29A (Flange #555-S1), were evaluated by P66 for damage to

Figure 29. As-Received Photographs of the Flange-to-Pipe Welded Components Received From Phillips 66, (A) #555-S1 and (B) #555-S2. Samples #555-S1A and #555-S1B (shown by red arrows in Figure 19A) were evaluated by Phillips 66 for Damage to the Weld/Flange Location prior to shipping the Components to UTK.

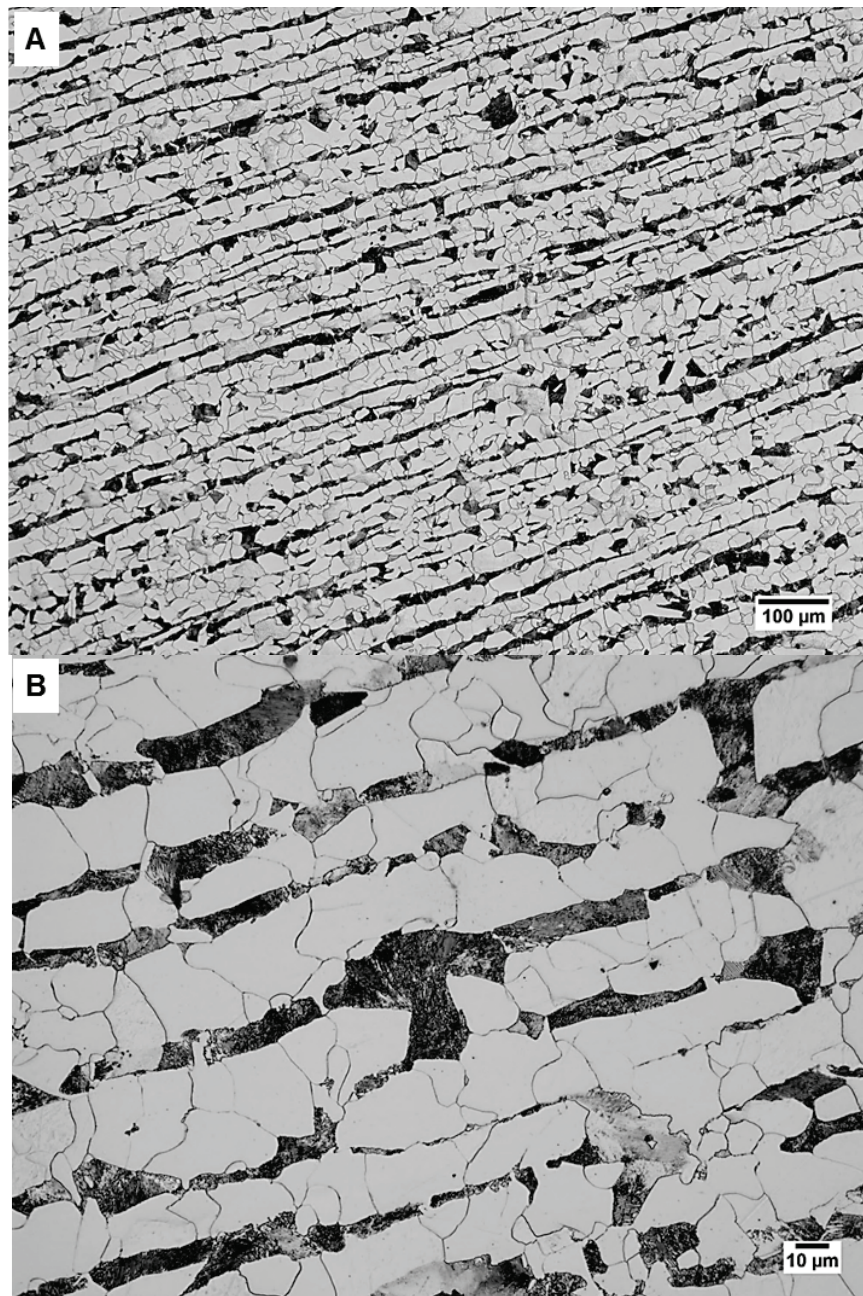
Figure 39. Photomicrographs of the Flange Base Metal showing Forging Texture in Valero Flange #67, (A) 100X and (B) 500X, 2% Nital Etch. Microstructure consists of Ferrite and Pearlite, ASTM Grain Size #6.

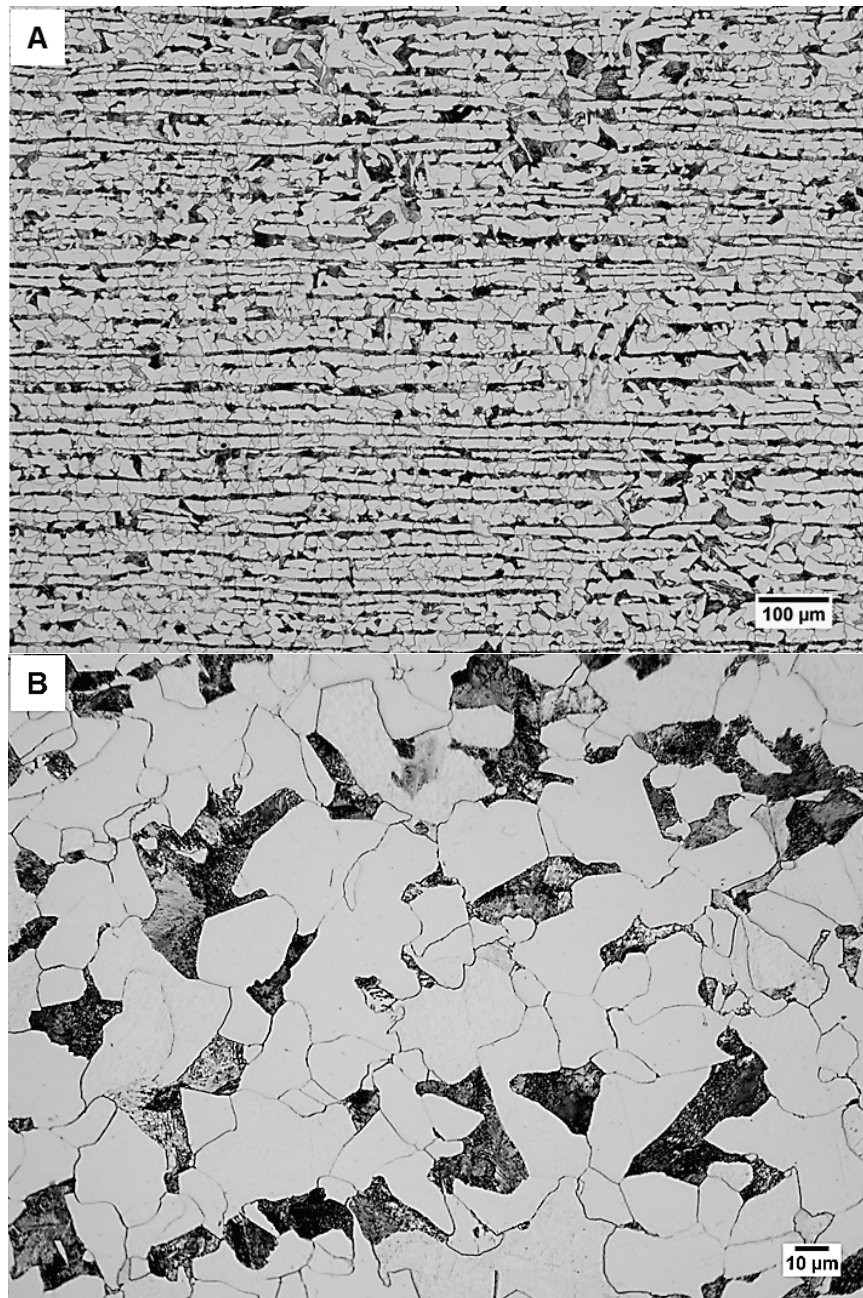
Figure 40. Photomicrographs of the Pipe Base Metal showing the Plate Rolling/Forming Texture in the Longitudinal Direction in Valero Flange #67, (A) 100X and (B) 500X, 2% Nital Etch. Microstructure consists of Ferrite and Pearlite, ASTM Grain Size # 6.

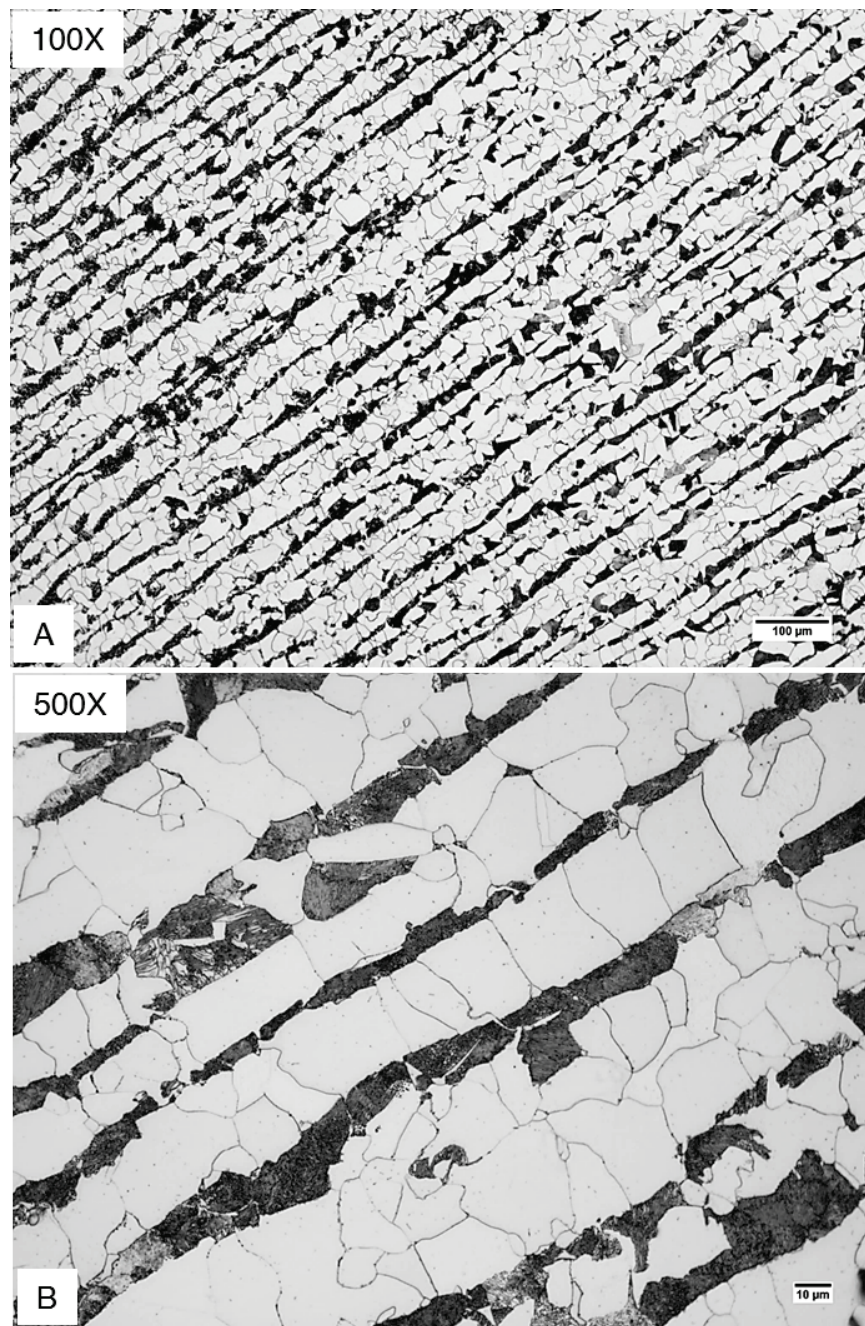
Figure 42. Photomicrographs of the flange base metal just outside of the visible HAZ showing the forging texture in Valero Flange #1252134, 2% Nital Etch, ASTM Grain Size #6.

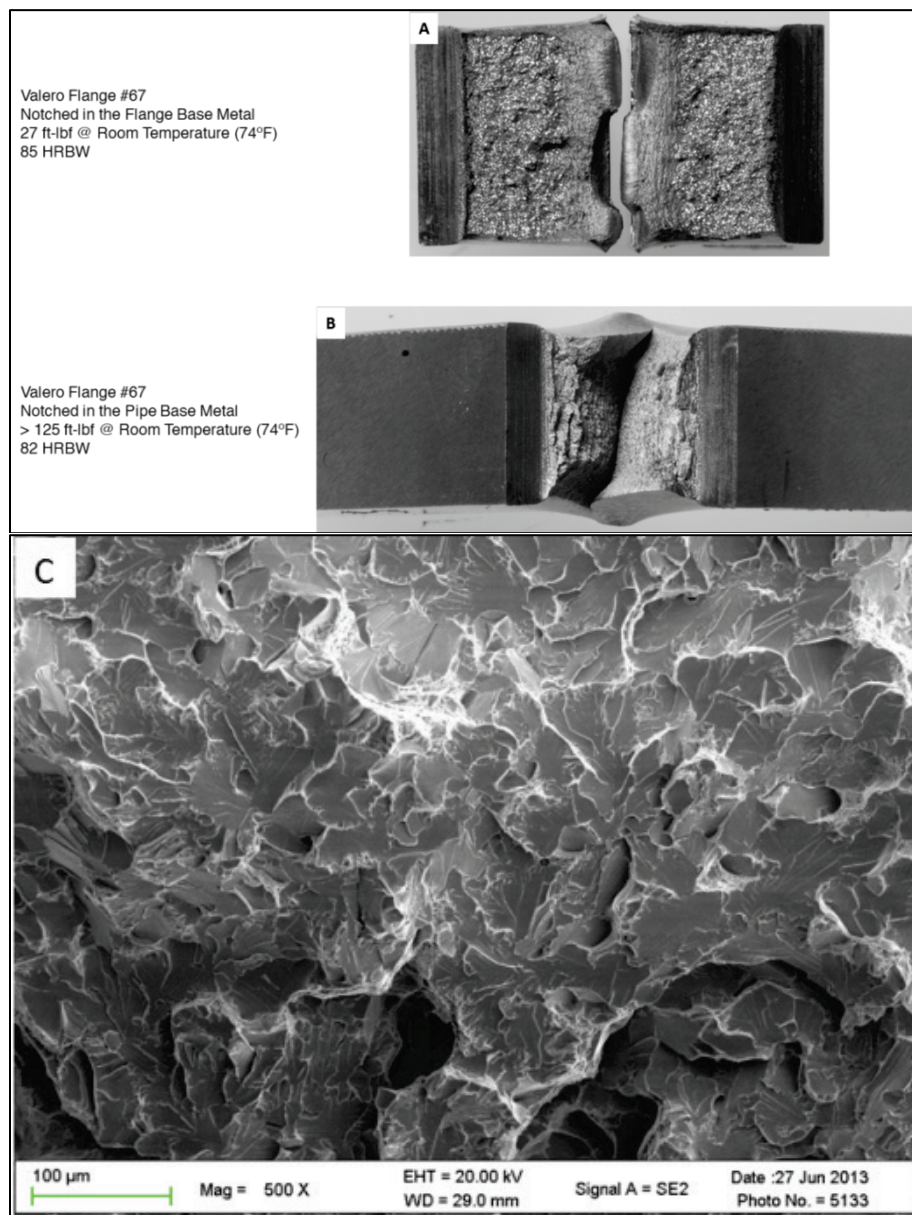
exhibited a “rock-candy” appearance. However, the Flange #67 pipe base metal exhibited superior ductility/toughness with absorbed energy greater than 125 ft-lbf. Figure 43 show macrographs of broken Charpy bars extracted from (A) flange and (B) pipe base metal from Flange #67. Figure 43C shows a SEM fractograph Charpy impact specimen from the flange base metal at 500X. The fracture surface shows 100% transgranular cleavage fracture (see Figure 43C). The absorbed energies of the flange and pipe base metals for flange-to-pipe welded component #1252134 were 31 ft-lbf and >125 ft-lbf, respectively. Figure 44 shows fractographs of the Charpy bars extracted from the (A) flange and B) pipe base metals.

(a) Fracture surface of the Charpy Specimens Exhibited Rock Candy Appearance with Intergranular Separation Morphology.

(b) Charpy Specimens did not break and absorbed more than 125 ft-lbf of Energy.

Figure 43. Fractographs of Charpy Impact Specimens Tested at Room Temperature (74°F) for Valero Flange #67, (A) Notched in the Flange Base Metal (27 ft-lbf), (B) Notched in the Pipe Base Metal (> 125 ft-lbf) and C) SEM Fractograph of Flange Base Metal from Figure 43A, 500X.

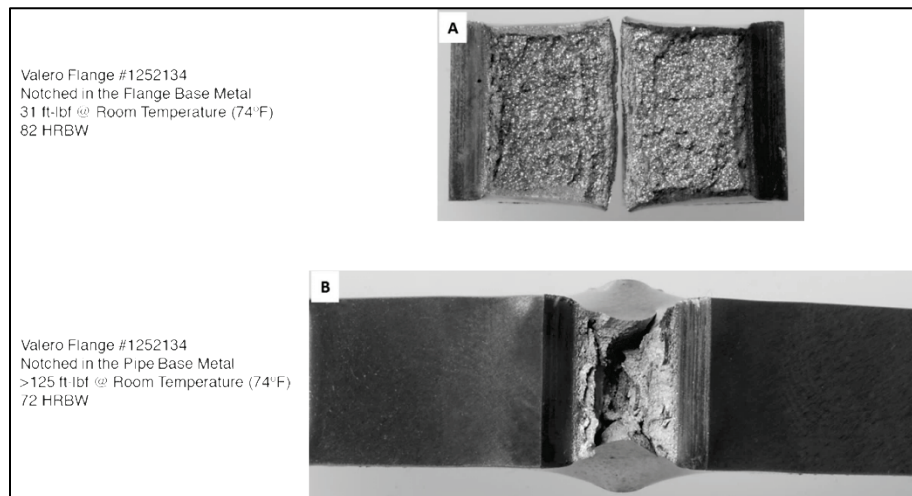
Figure 44. Fractographs of Charpy Impact Specimens Tested at Room Temperature (74°F) for Valero Flange #1252134, (A) Notched in the Flange Base Metal (31 ft-lbf) and (B) Notched in the Pipe Base Metal (>125 ft-lbf).

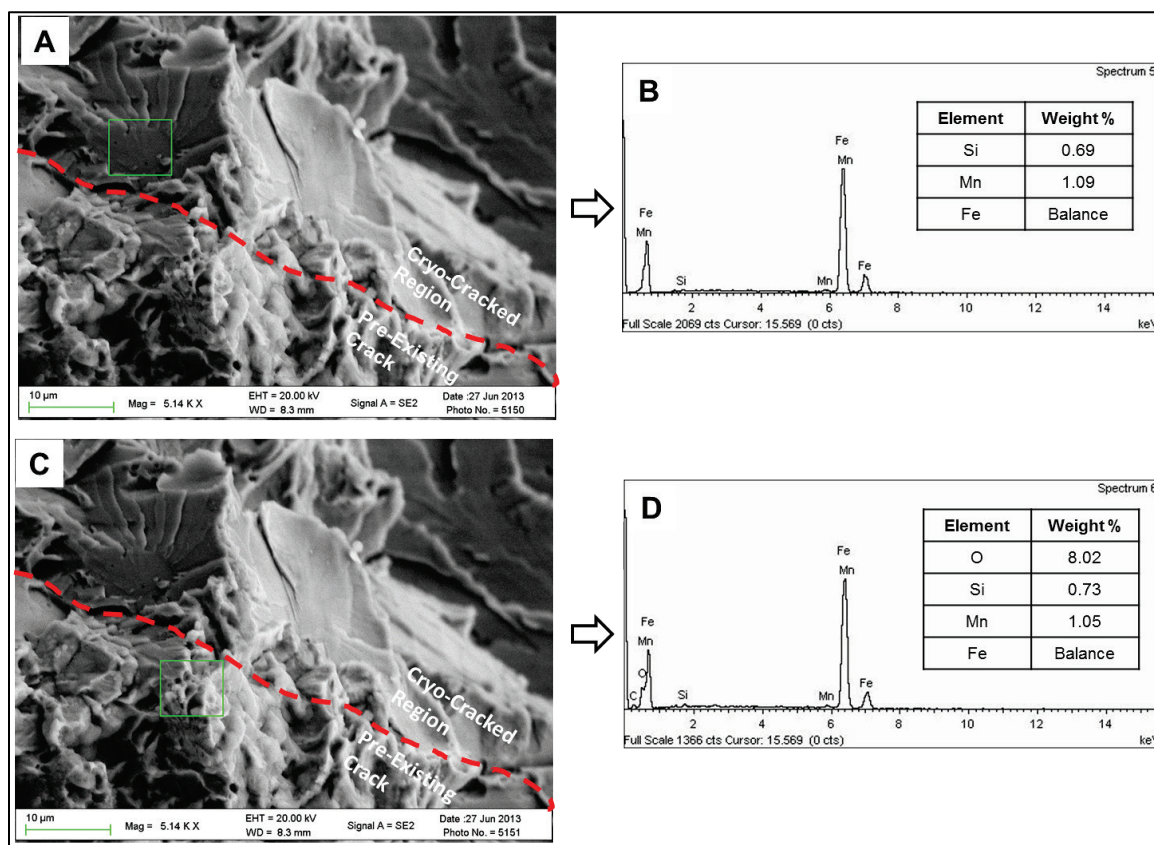
Energy Dispersive Spectroscopy (EDS) analysis in the pre-existing cracked area (highlighted by green boxes) in Figure 46A and Figure 46C are shown in Figure 46B and Figure 46D, respectively. The EDS analysis shows the presence of oxygen (8 wt. %) in the pre-existing crack surface compared to the surface generated from the “Cryo-Cracking” which did not detect any oxygen. The pre-existing cracked surface exhibited intergranular separation, which was masked by partial oxidation from the service-exposure as shown by fractographs in Figure 47, (A) 20,000X and (B) 40,000X. Thus, the cracking mechanism in Valero

Figure 46. SEM Fractographs of a “Cryo-Cracked” Sample Extracted from Valero Flange #67.  
Two Green Boxes in SEM Fractographs A and C correspond to EDS Spectrums  
Locations in B and D.

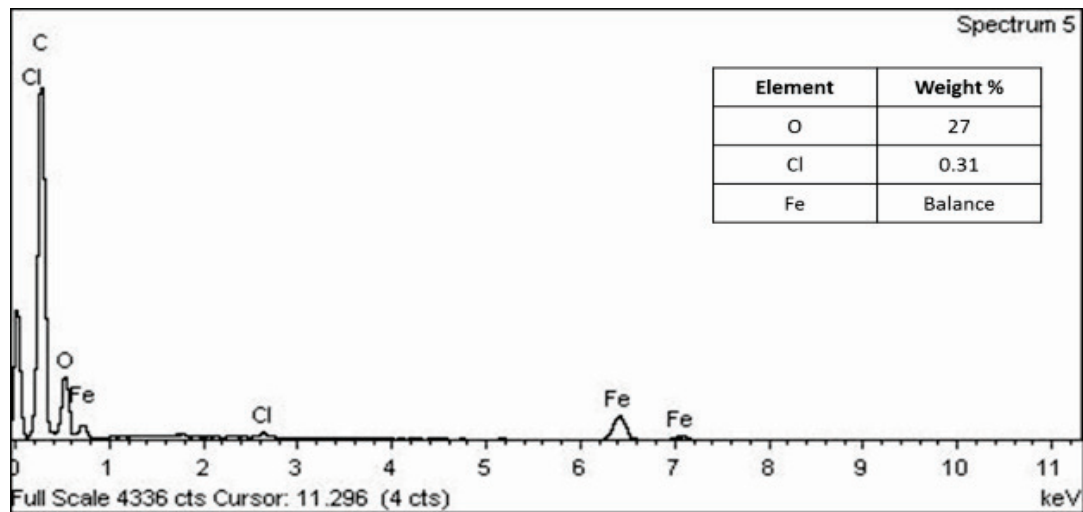
Figure 48 shows an EDS spectrum obtained from the pre-existing cracked region adjacent to the exposed surface (inside diameter surface) of Flange #67, showing the presence of chlorine (0.31 wt. %) along with iron, carbon, and oxygen. The EDS spectrum of the pre-existing cracked surface immediately below the crack tip is shown in Figure 49. Sulfur and chlorine were not detected in the region immediately below the crack tip and in the “Cryo-Cracked” region (overload).

Figure 48. EDS Analysis of the Pre-Existing Cracked Surface at a Location adjacent to the Inside Diameter Surface in Valero Flange #67.

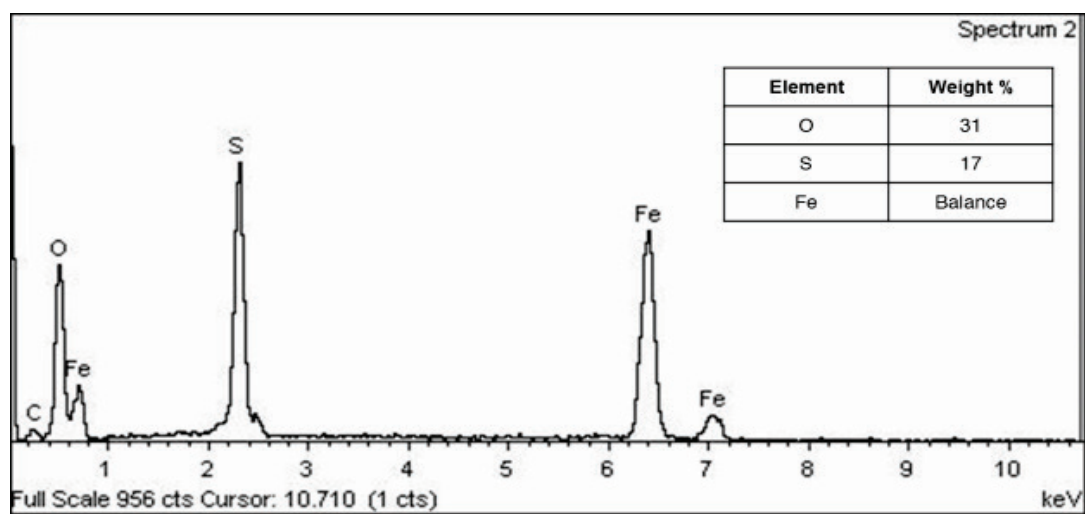
removed from flange-to-pipe welded component #1252134 (not cracked) showed a composition similar to the scale fragments from flange-to-pipe welded component #67 (see Figure 50).

Figure 50. EDS Analysis of the Scale Removed from the Exposed Surface (Inside Diameter Surface) of Valero Flange #67.

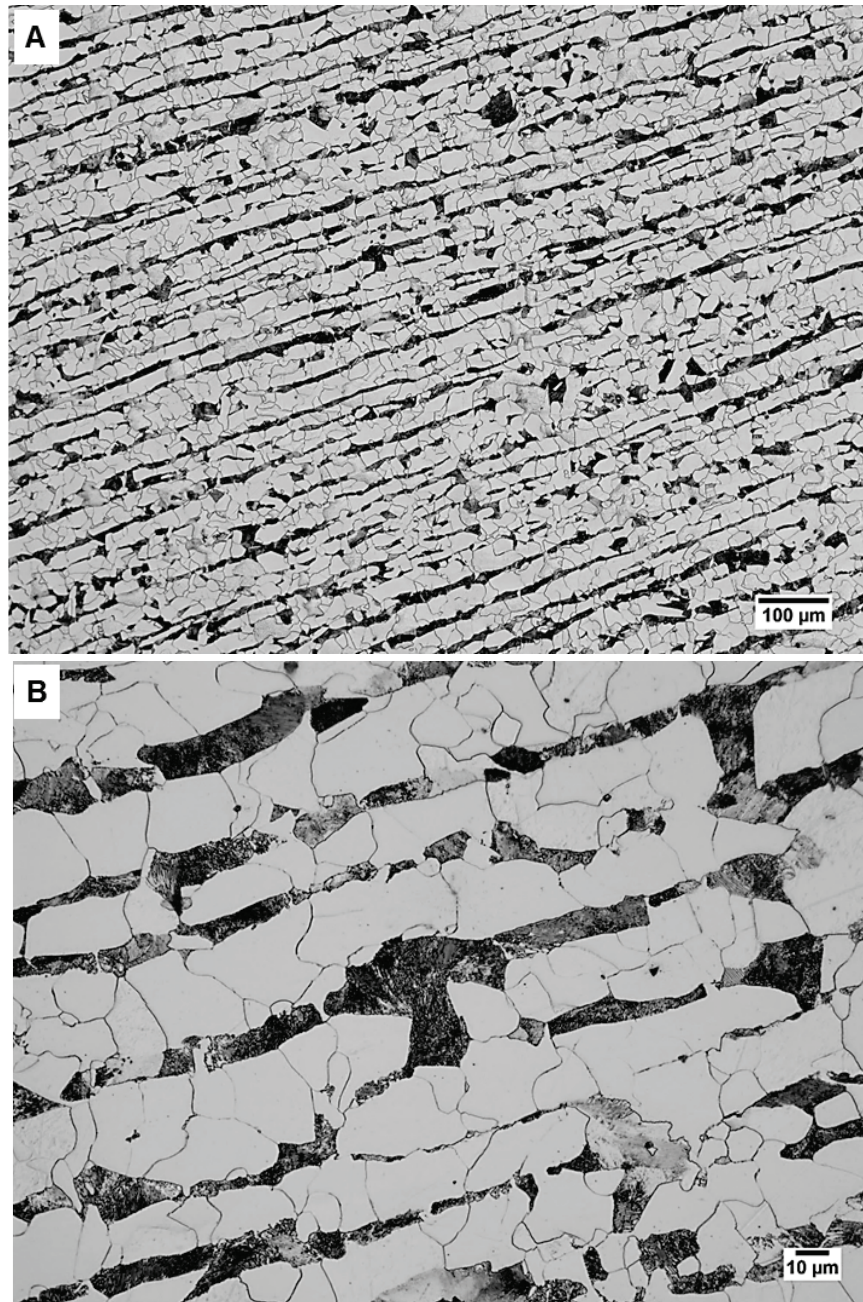
Figure 54 and Figure 55 shows the microstructure of the flange and pipe base metals, respectively at (A) 100X and (B) 500X showing a typical forging and rolling texture in IOR Flange #1110-2. The microstructures of the flange and pipe base metal are composed of ferrite and pearlite, which is considered typical for ASTM A105 for the flange material and ASTM A106-Gr.B for the pipe material. The ASTM grain size for the flange and the pipe base metal is approximately 5-6, which is normal for these materials.

Figure 54. Photomicrographs of the Flange Base Metal showing a Typical Forging Texture in IOR Flange #1110-2, (A) 100X and (B) 500X, 2% Nital Etch. Microstructure consists of Ferrite and Pearlite, ASTM Grain Size #6.

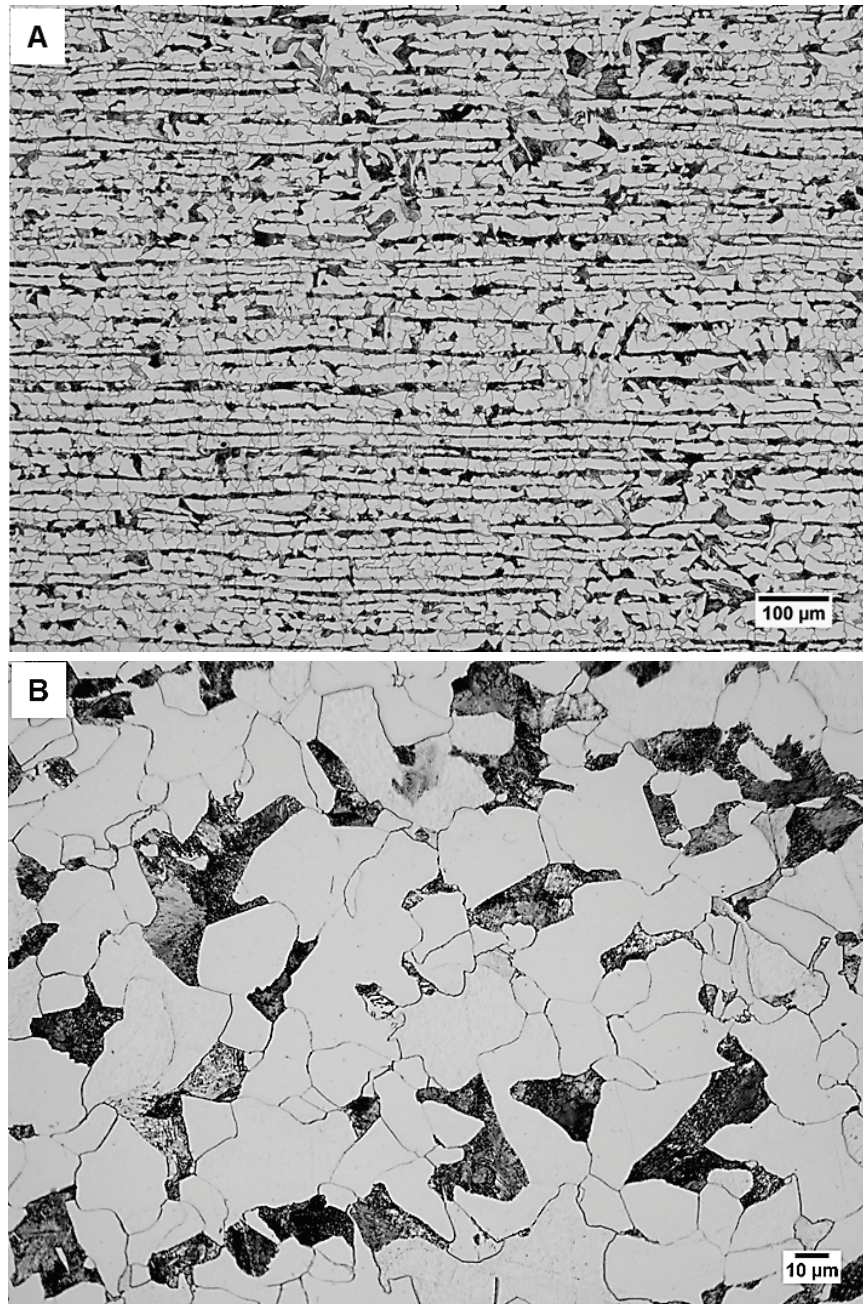
Figure 55. Photomicrographs of the Pipe Base Metal showing the Plate Rolling Texture in the Longitudinal Direction in IOR Flange #1110-2, (A) 100X and (B) 500X, 2% Nital Etch. Microstructure consists of Ferrite and Pearlite, ASTM Grain Size #6.

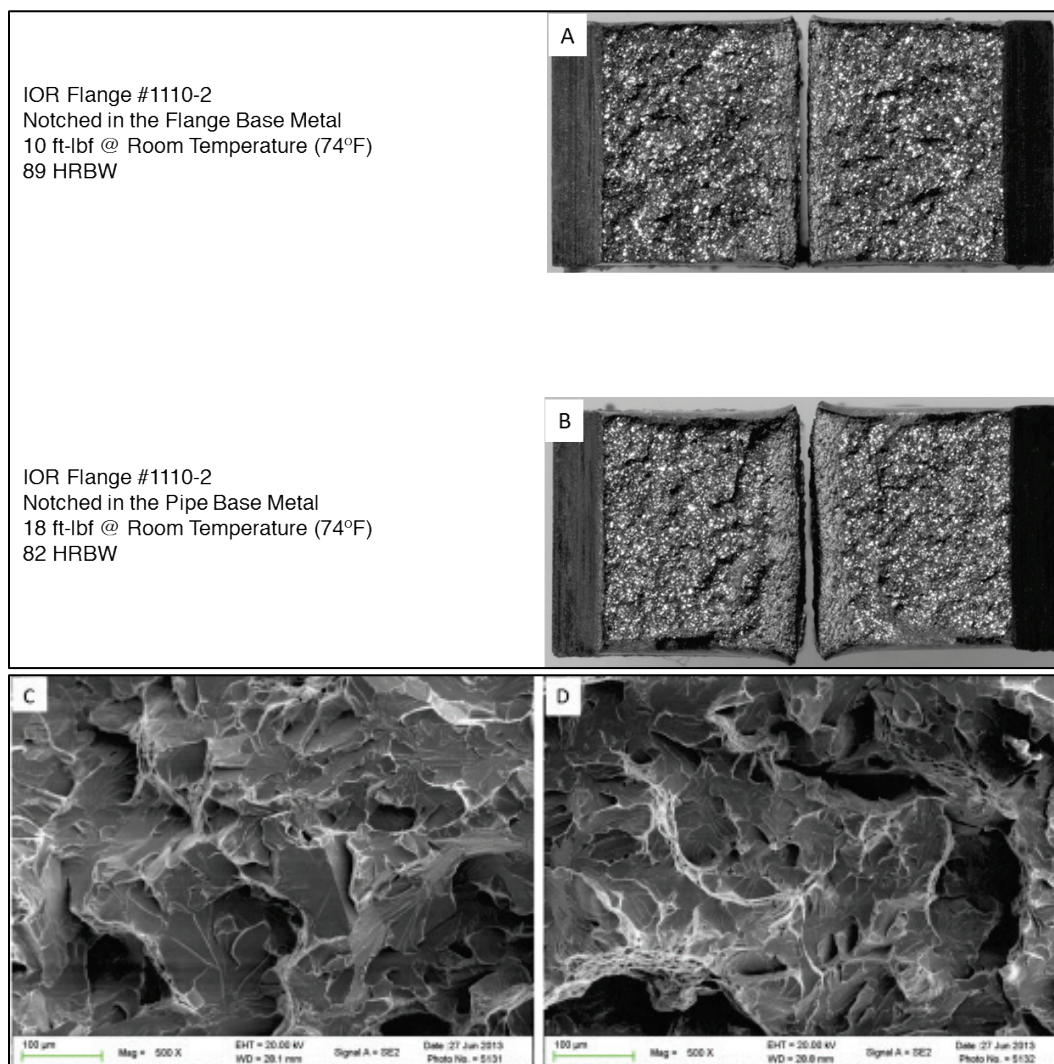
Exploratory Charpy impact toughness tests were performed at room temperature (74°F) on IOR Flange #1110-2. Charpy samples were prepared such that the notch of the specimen is approximately 5 mm away from the fusion line for both flange and pipe base metal samples. The Charpy impact toughness for IOR Flange #1110-2 for both pipe and flange base metal was 18 ft-lbf and 10 ft-lbf, respectively. Figure 56 shows the photomacrographs of the fracture surfaces of the Charpy bars extracted from (A) flange base metal and (B) pipe base metal. Figure 56 shows SEM fractographs at 500X exhibiting transgranular cleavage fracture morphology on Charpy bars extracted from (C) flange base metal, and (D) pipe base metals.

Figure 56. Fractographs of the Charpy Impact Specimens tested at Room Temperature (74°F) for IOR Flange #1110-2, (A) Flange Base Metal (10 ft-lbf), (B) Pipe Base Metal (18 ft-lbf), (C) SEM Fractograph of the Charpy Fracture Surface from Flange Base Metal, 500X and (D) SEM Fractograph of the Charpy Fracture Surface from Pipe Base Metal, 500X.

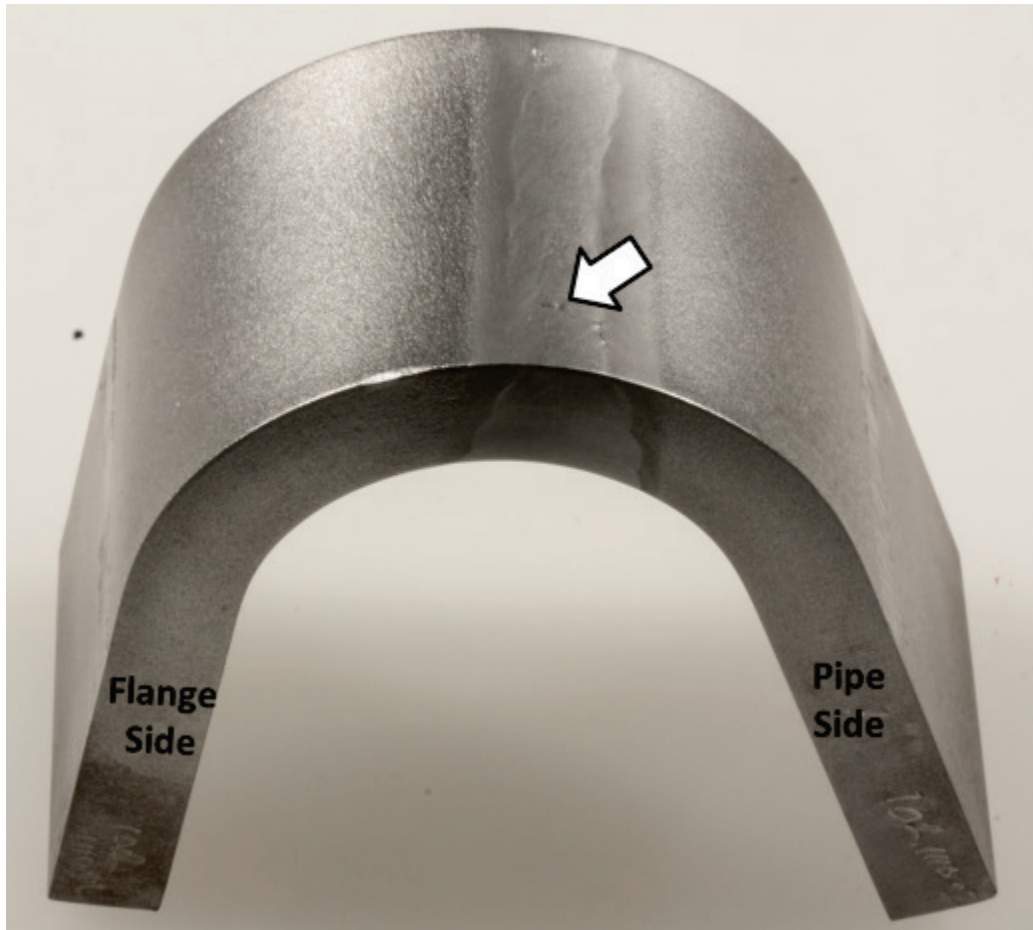
An ASME Section IX root bend test on IOR flange-to-pipe welded component #1110-2 sample did not show any cracking or evidence of strain aging, and the material was fully ductile in all regions with 20% outer-fiber strain. The photograph of the specimen after the bend test is shown in Figure 57.

Figure 57. Photograph of ASME IX Bend Specimen extracted from Irving Oil Refinery Flange-to-Pipe Welded Component #1110-2. The Bend Specimen was centered in the Flange Base Metal just outside of the Visible HAZ (~5 mm from the fusion line), and it Exhibited Fully Ductile Behavior with 20% Fiber Strain in all Regions. White Arrow indicates a typical Weld Deposit Slag Inclusion.

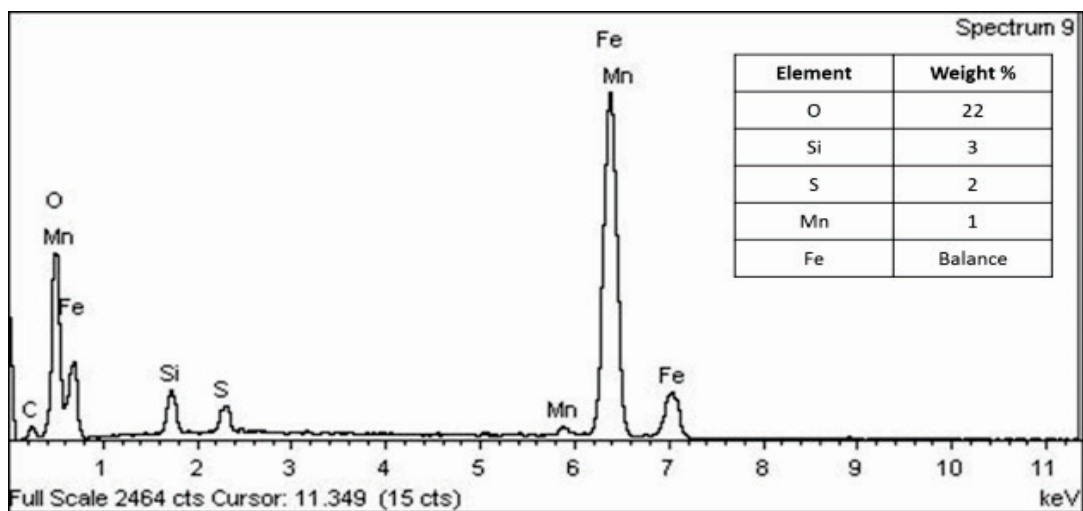
Figure 60. EDS Analysis of the Pre-existing Crack Surface at the Location adjacent to the Inside Diameter Surface in IOR Flange-to-Pipe Welded Component #1110-2. The Analysis showed the presence of 2 wt. % Sulfur and 3 wt. % Silicon.

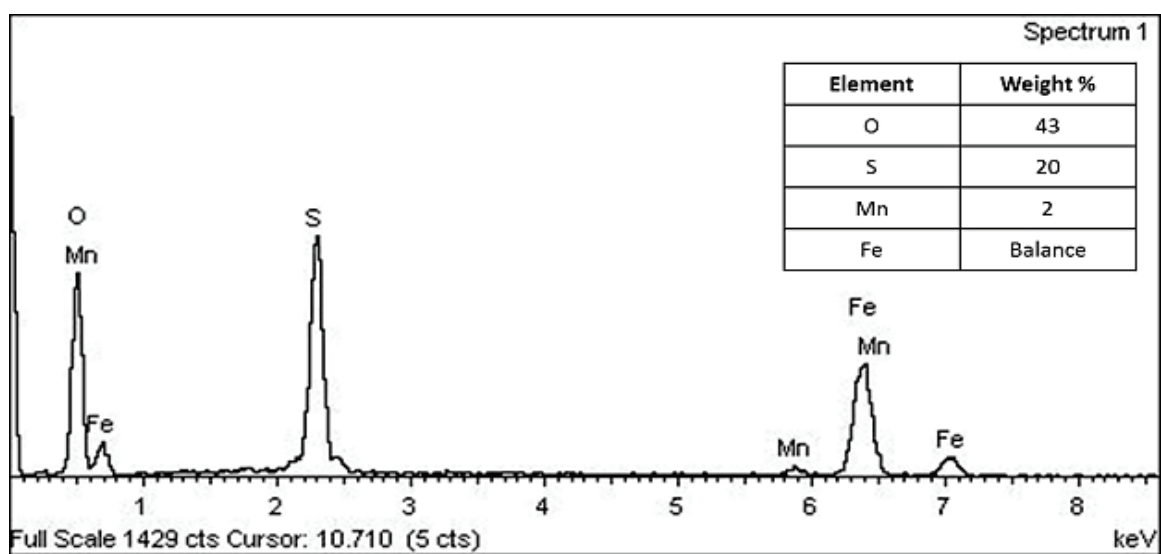
Figure 62. EDS Assessment of the Scale Fragments Removed from the IOR Component #1110-2.

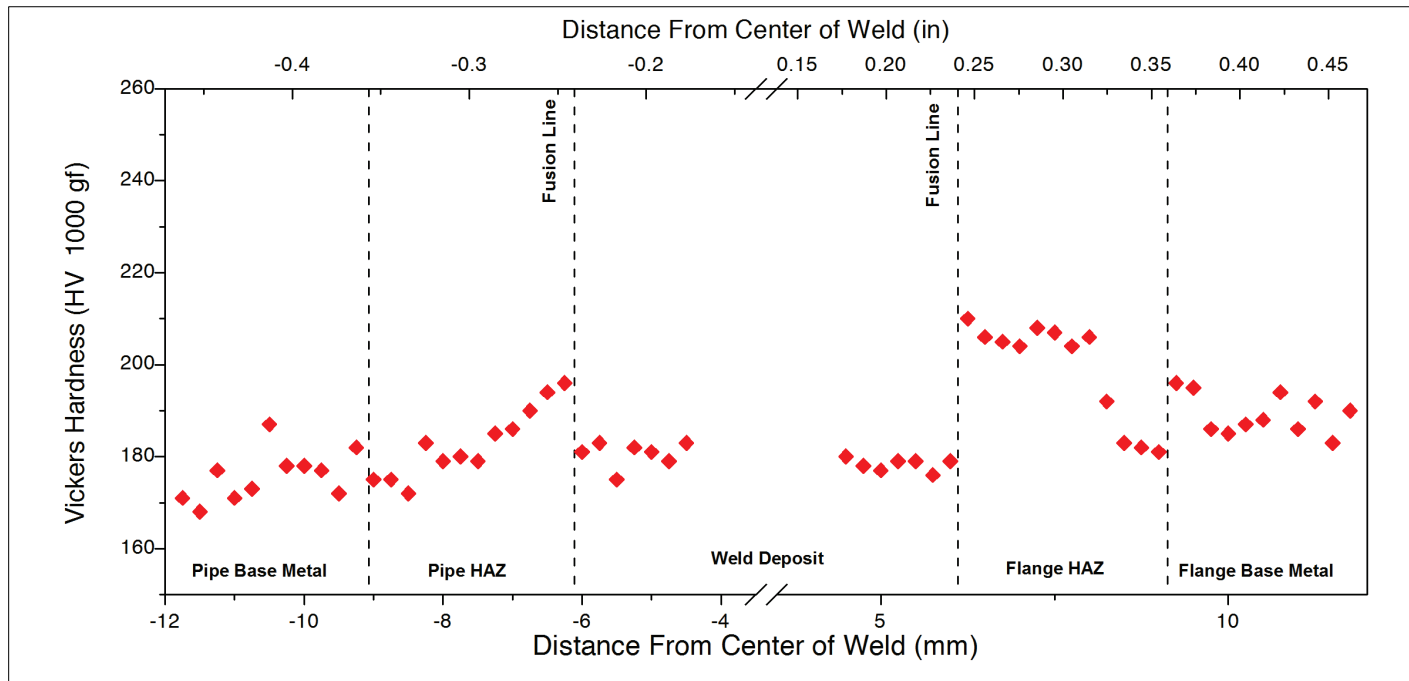
A Vickers micro-hardness traverse (1000 gf. load) was conducted across the IOR flange-to-pipe welded component #1110-2. The traverse did not show any hardening or softening behavior immediately adjacent to the crack location in the flange base metal just outside the visible HAZ (see Figure 63).

Figure 63. Vickers Micro-hardness Traverse on the IOR Flange-to-Pipe Welded Component #1110-2 across the Flange and Pipe HAZs using 1000 gf load. The Traverses are Similar and Reflect the Starting Hardnesses of Flange and Pipe Material. The Traverse shows no Evidence of Softening or Hardening just outside of the Flange HAZ where cracking was observed using Optical Microscopy.

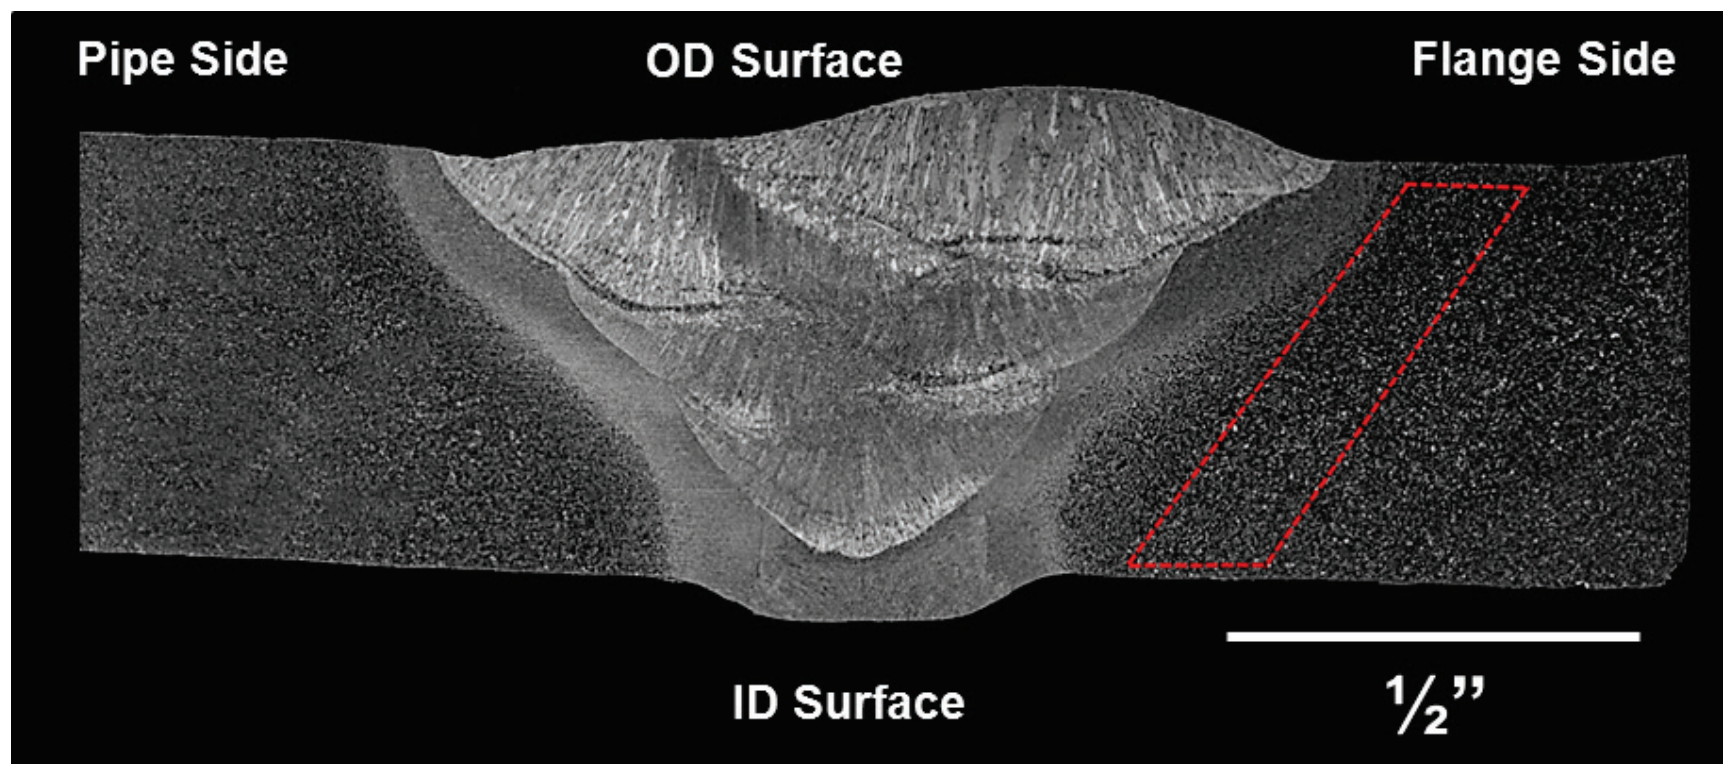
The P66 flange-to-pipe welded components #555-S1 and #555-2 were both operating under the same conditions (time, temperature and hydrogen partial pressure). However, the component #555-S1 showed the presence of microfissures and #555-S2 was free of any fissuring or internal decarburization. The macroscopic examination of both flange-to-pipe weld components show differences in the etching characteristics (see macrographs in Figure 64 and Figure 65), and reflects a potential difference in the use of the welding processes/parameters. The undamaged flange-to-pipe welded component (#555-S2) exhibits smaller size weld beads and has higher number of weld passes (number of passes #11) compared to the damaged component (#555-S1) which exhibit larger size weld beads and fewer number of weld passes (number of passes #9). The use of different heat-input is also evident in the width of two heat-affected zones between #555-S1 (damaged component = 3 mm) and #555-S2 (undamaged component = 2 mm). Information on welding parameters is unavailable for both P66 flange-to-pipe welded components #555-S1 and #555-S2.

Figure 64. Photomacrograph of P66 Component #555-S1. Microfissures were readily observed (at 100X magnification using optical microscopy in the as-polished condition) outside of the Visible HAZ in the Flange Base Metal from the ID Surface to  $\frac{1}{2}$  the Wall-Thickness. Microfissures were observed to a Lesser Extent (scattered) from the  $\frac{1}{2}$  Wall-Thickness to the OD Surface. Maximum Extent of Damage was observed adjacent to the ID Surface. Approximate Location of fissuring is shown by the Red Boxed Region in the above Macrograph. No Damage was observed in the Weld Deposit, Pipe or Flange HAZs or in the Pipe Base Metal, 2% Nital Etch.
