Studies of High Temperature Hydrogen Related Damage in  
Welded Carbon Steel Components used in  
Refineries

A Thesis Presented for the  
Master of Science  
Degree  
The University of Tennessee, Knoxville

Maneel Bharadwaj  
May 2015

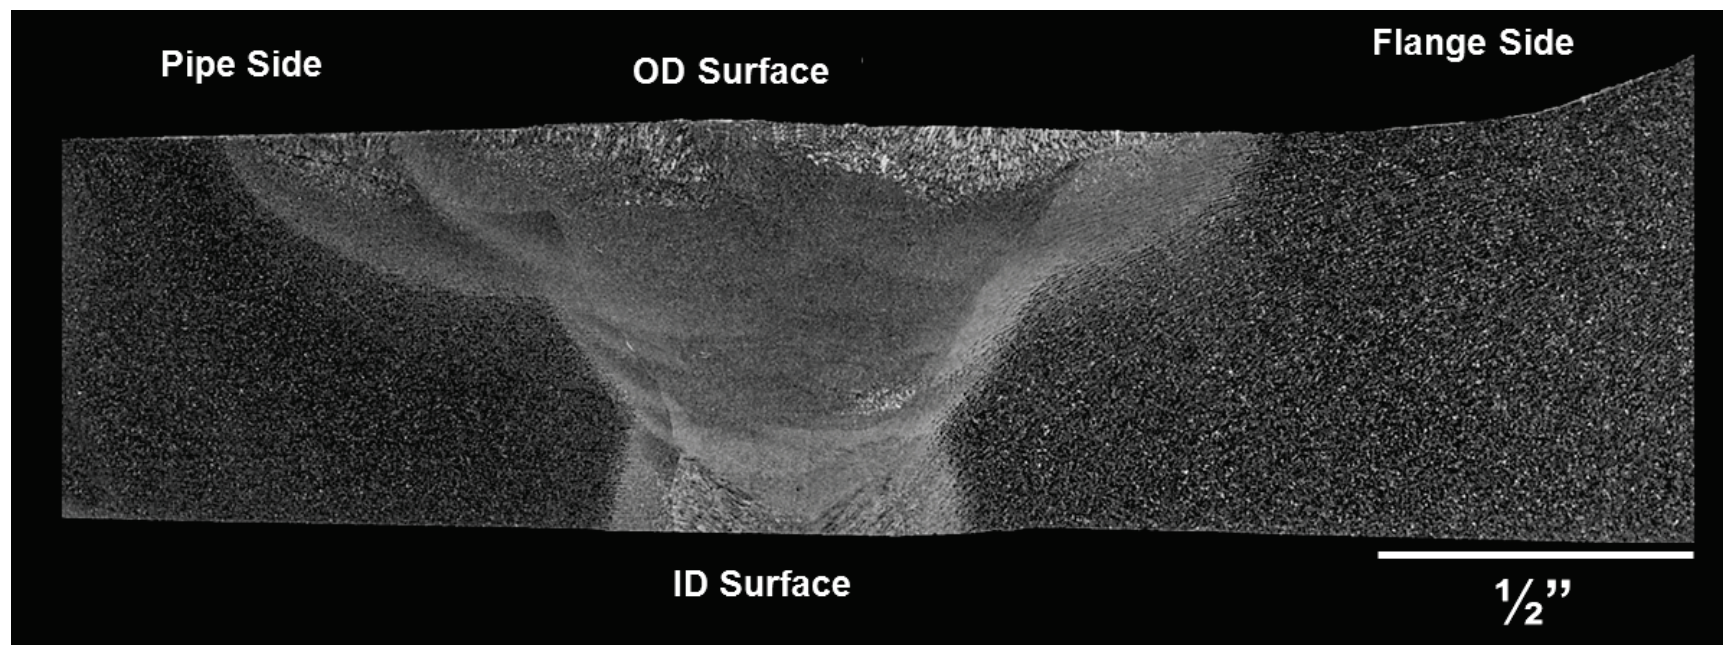
Figure 65 shows the photomacrograph of a sample (#555-S2-1) extracted from flange-to-pipe welded component #555-S2. No evidence of decarburization or fissuring was observed in the weld deposit, pipe HAZ, flange HAZ, or in the pipe or flange base metals. The outside surface of the flange-to-pipe welded component #555-S2 had been ground smooth to contour the weld, and the inside surface had been ground flush by P66 prior to the receipt of the component by the University of Tennessee. From the appearance of the inside and outside

Figure 65. Photomacrograph of P66 Component #555-S2. No evidence of Decarburization or Fissuring was observed in the Weld Deposit, Pipe or Flange HAZs or in the Pipe or Flange Base Metals, 2% Nital Etch. (Note: OD Surface had been Ground Smooth to Contour the Weld, and the ID Surface had been Ground Flush by P66 prior to the receipt of Component by UTK.

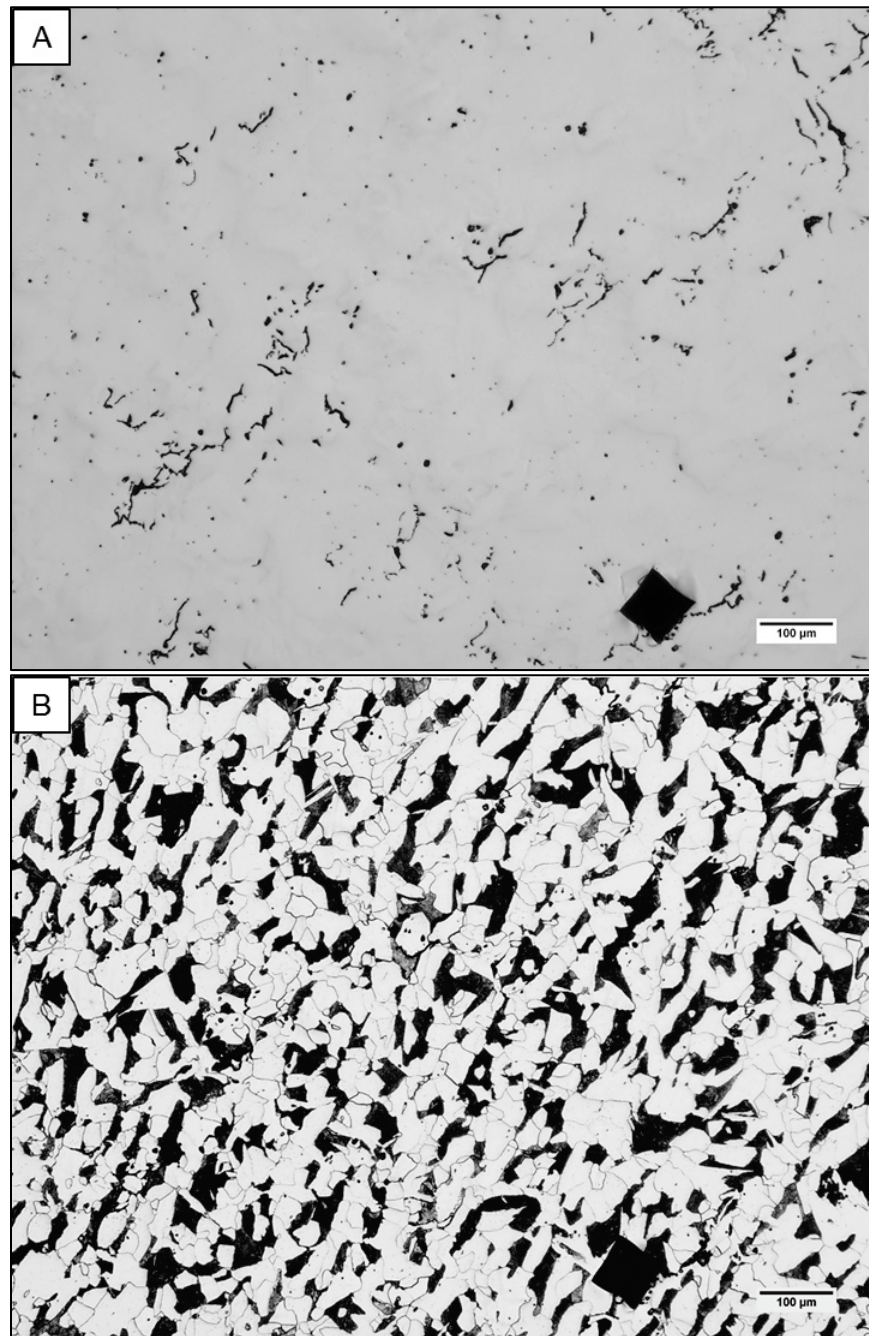
Microfissures were observed in the flange base metal just outside of the visible HAZ. Optical micrographs at 100X adjacent to the ID surface in the flange base metal in as polished condition and after etching show the presence of microfissures along grain boundaries in Figure 66. Fissures were readily visible at 100X in as-polished condition (see Figure 66A), but were difficult to depict when etched with 2% Nital (see Figure 66B) (note: micrographs were obtained at the same location before and after etching, Vickers indent was used as a marker). Figure 67 shows the higher magnification optical micrograph of the flange base metal just outside of the visible HAZ revealing microfissures at 600X along ferrite-ferrite (red arrows) and ferrite-pearlite boundaries (green arrows).

Figure 66. Photomicrographs of the Flange Base Metal (at 100X) just outside of the visible HAZ adjacent to the ID surface, (A) As-Polished and (B) 2% Nital Etch. ASTM G.S. #7, 70% Ferrite, and 30% Pearlite.

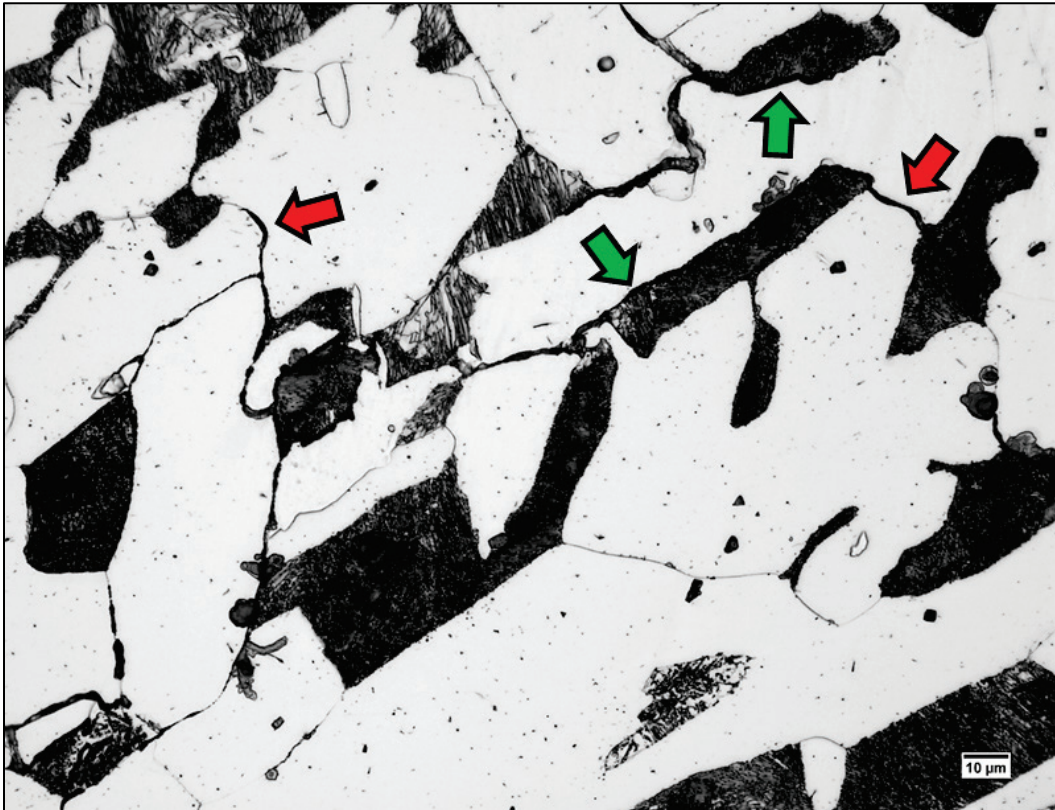
Figure 67. Photomicrograph of the Flange Base Metal just outside of the Visible HAZ adjacent to the ID Surface in P66 #555-S1 showing the Evidence of Microfissures along the Ferrite-Ferrite (red arrows) and Ferrite-Pearlite Boundaries (green arrows), 600X, 2% Nital Etch.

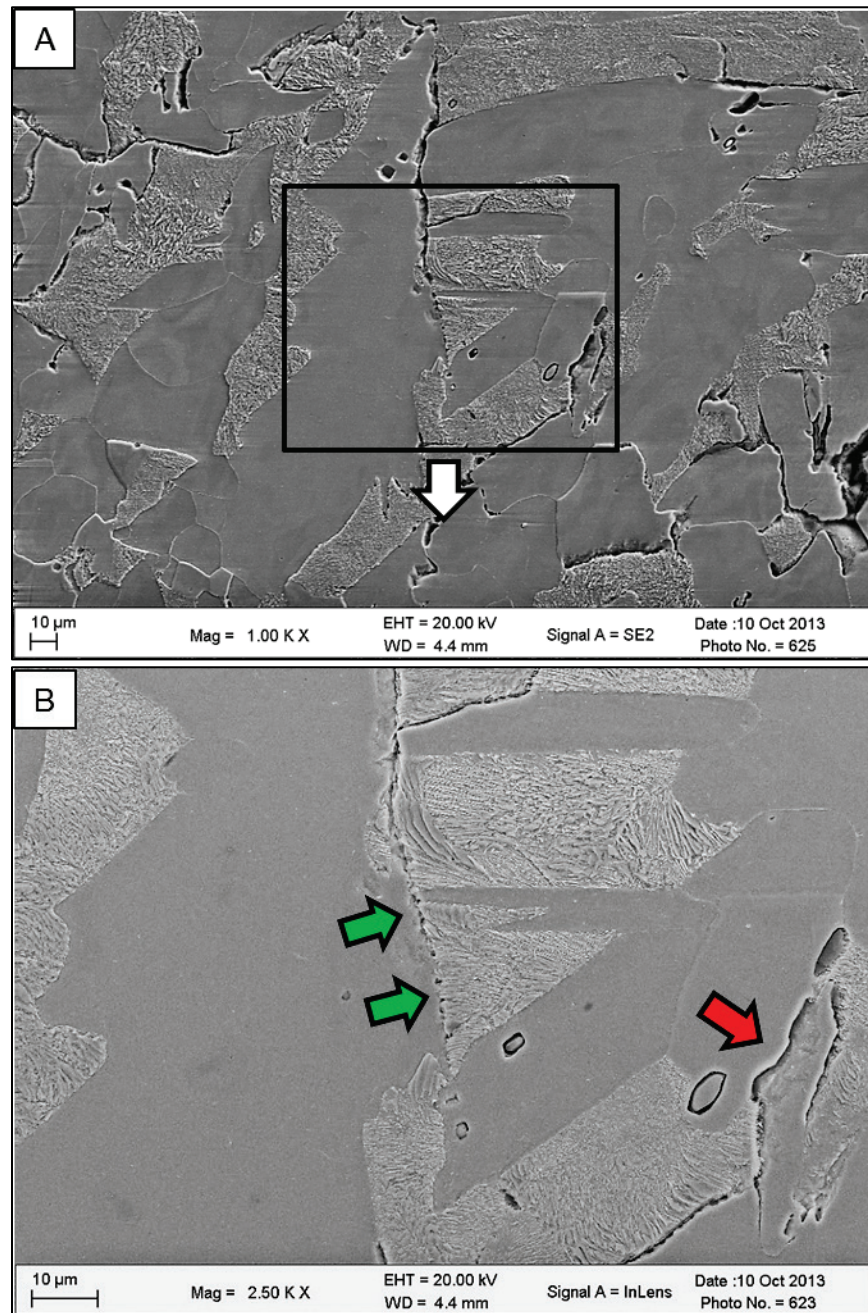
The SEM was utilized to further characterize the nature of the microfissures observed in the flange base metal just outside of the visible HAZ adjacent to the ID surface using high magnification microscopy in Flange #555-S1. Cavitation and fissuring was observed along ferrite-ferrite and ferrite-pearlite boundaries. Figure 68 shows the SEM micrographs at (A) 1000X, and (B) 2500X. Figure 69 shows the SEM micrographs at (A) 5000X, and (B) 10000X, which show the evidence of microfissures along ferrite-pearlite (shown by green

arrow) and ferrite-ferrite boundaries (shown by red arrow). Also, note the formation of voids/cavities ahead of the tip of micro-fissure (as shown by green arrows Figure 68 and Figure 69). Figure 69 show voids/cavities linked-up to form microfissures at a (A) ferrite-pearlite boundary (shown by green arrow) and B) a ferrite-ferrite triple point separation (shown by red arrow). The voids/cavities sizes ranged from  $\frac{1}{4} \mu\text{m}$  to  $\frac{1}{2} \mu\text{m}$ .

Figure 68. SEM Micrographs Showing Fissuring/Cavities along a Ferrite-Ferrite (red arrow) and Ferrite-Pearlite Boundaries (green arrows) in the Flange Base Metal just outside of the Visible HAZ adjacent to the ID surface in #555-S1, 2% Nital Etch.

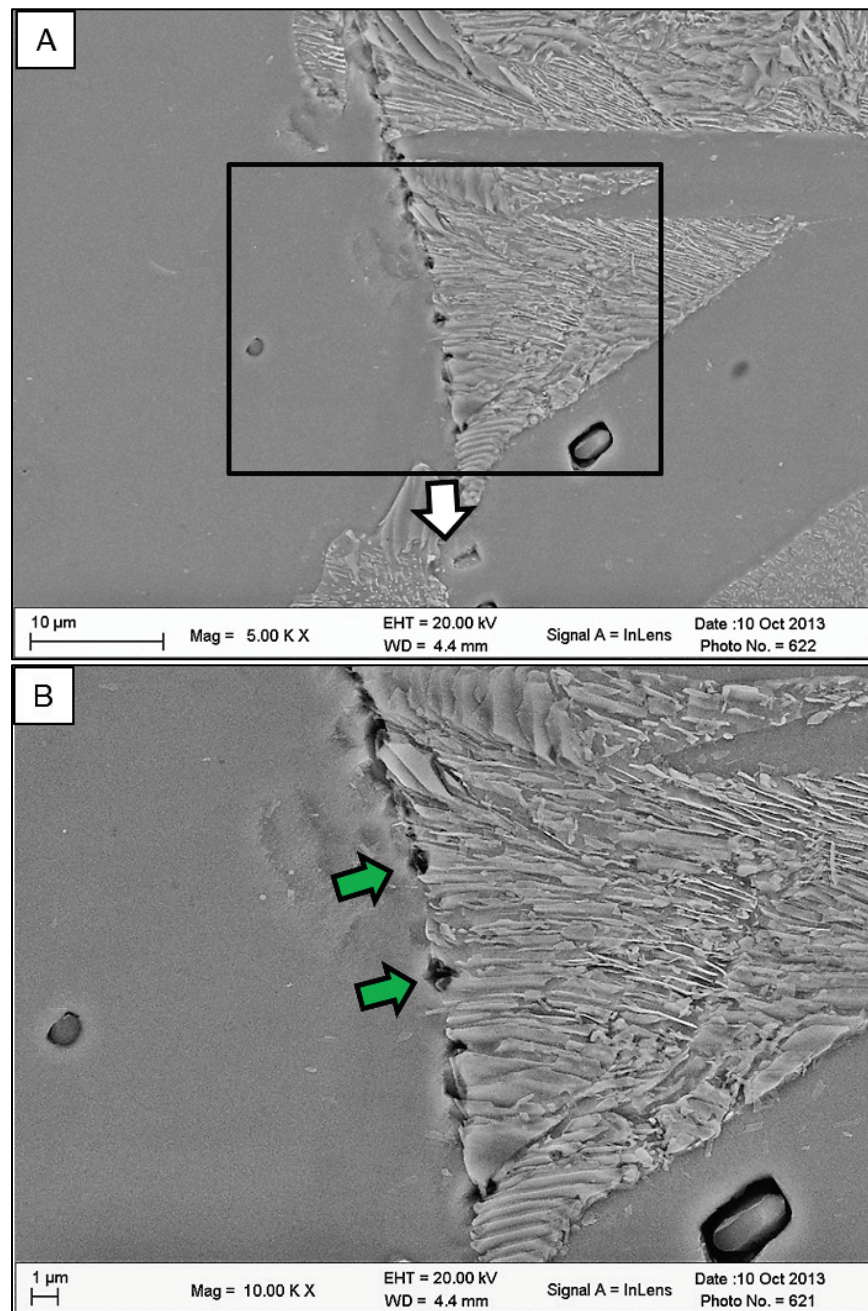
Figure 69. SEM Micrographs Showing Voids/Cavities along a Ferrite-Pearlite Boundary (green arrows) in the Flange Base Metal just outside of the Visible HAZ adjacent to the ID Surface (Location 1 in Figure 64) in #555-S1-1, 2% Nital Etch.

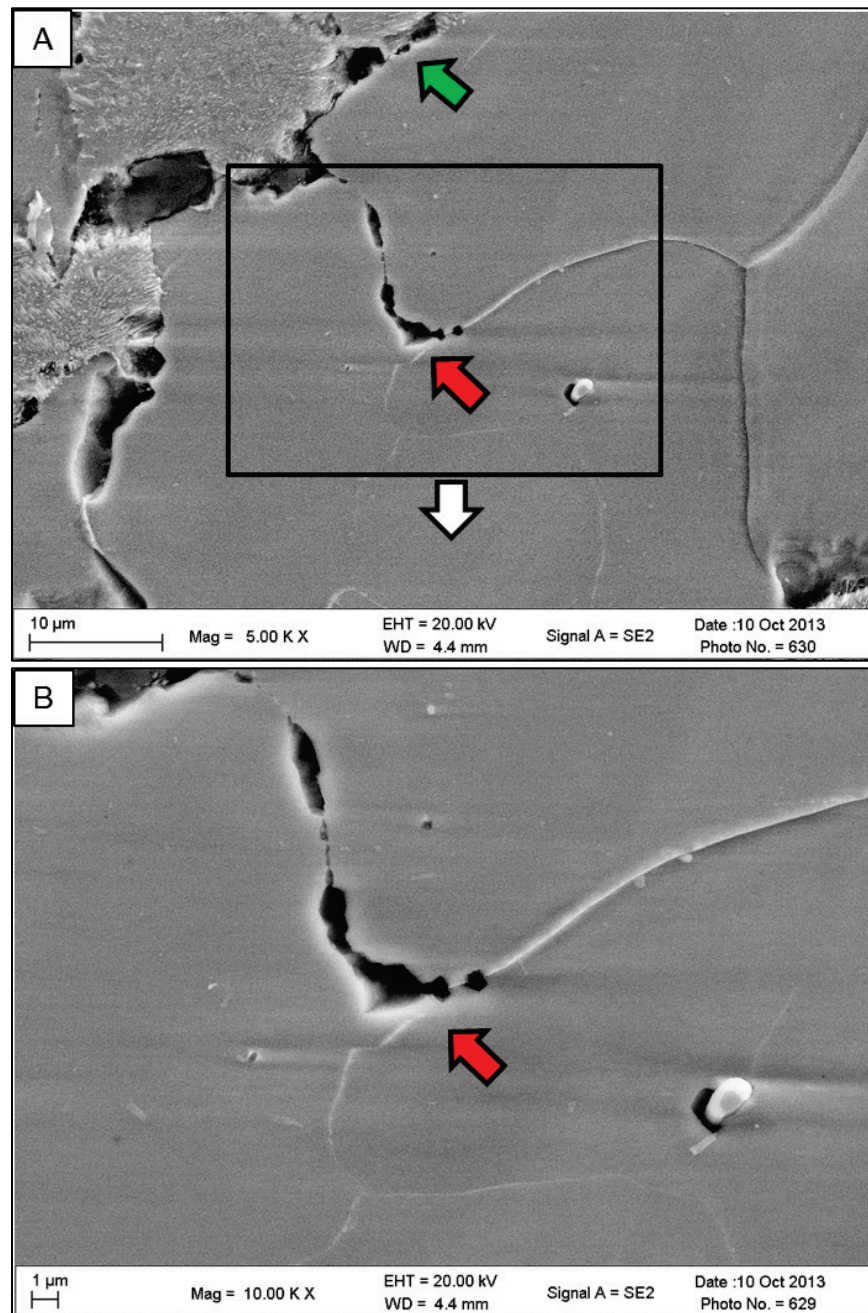
Figure 70. SEM Micrographs Showing Voids/Cavitation Linked-up to form Microfissures at a Ferrite-Pearlite Boundary (green arrow) and a Ferrite-Ferrite Triple Point Separation (red arrow) in the Flange Base Metal just outside of the Visible HAZ adjacent to the ID Surface in #555-S1-1, 2% Nital Etch.

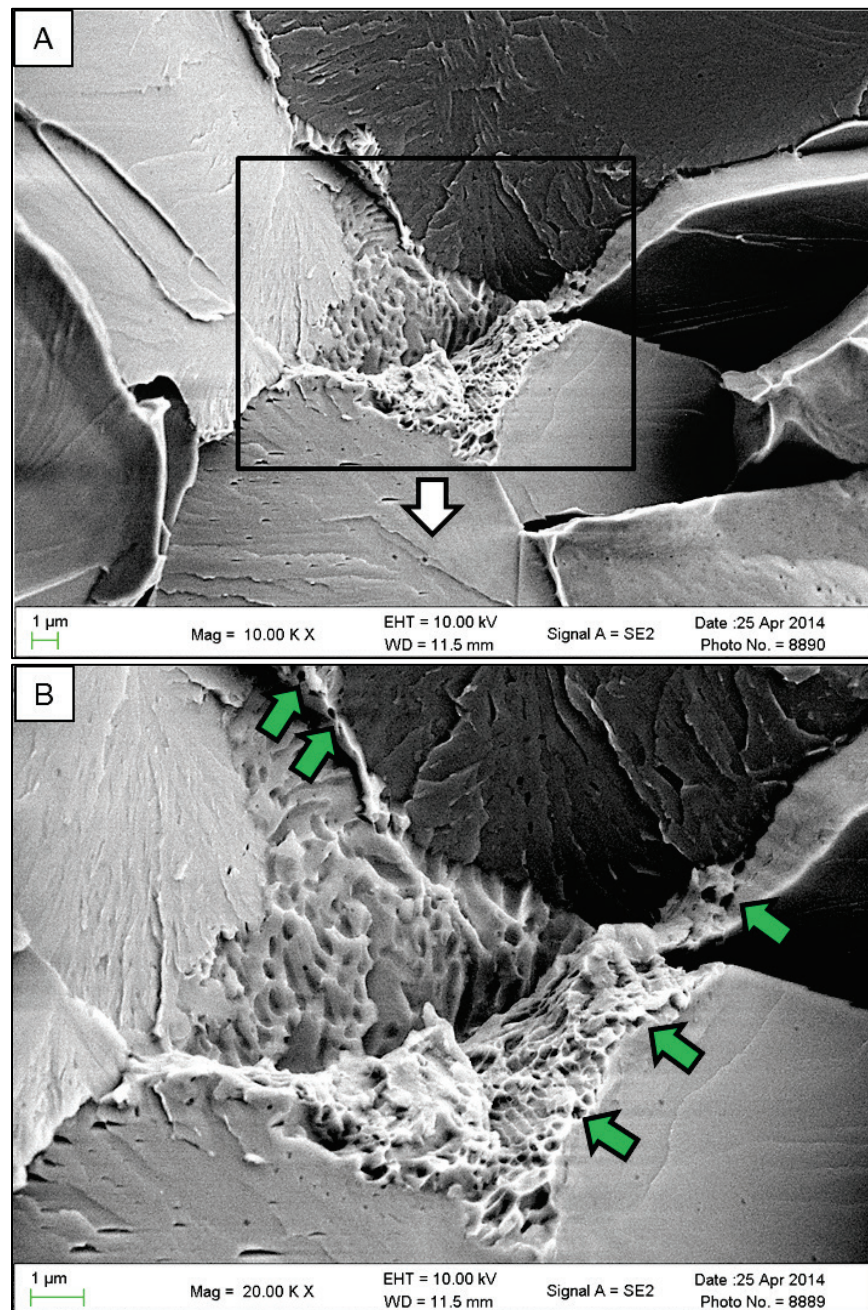
The SEM fractographs of the “Cryo-Cracked” specimen extracted from the damaged region of the flange base metal (just outside of the visible HAZ) adjacent to the ID surface of flange-to-pipe welded component #555-S1 show the formation of voids/cavities and intergranular separation. SEM fractographs in Figure 71 at (A) 10,000X and (B) 20,000X show the formation of voids/cavities along the ferrite-pearlite boundary (see green arrows). SEM fractographs in Figure 72 at (A) 20,000X and (B) 40,000X show voids/cavities along ferrite-pearlite boundaries (see green arrows). Figure 74 at (A) 20,000X and (B) 40,000X show the evidence of intergranular separation and the formation of voids/cavities along ferrite-ferrite grain boundary (see red arrows). The voids/cavities size ranged from  $\frac{1}{4}$   $\mu\text{m}$  to  $\frac{1}{2}$   $\mu\text{m}$ . Note that the size and shape of the voids/cavities is similar to those observed in polished and etched samples by SEM examination in Figure 69.

Figure 71. SEM Fractographs of the Flange Base Metal just outside of the Visible HAZ adjacent to the ID Surface in P66 #555-S1 showing formation of Voids/Cavities along the Ferrite-Pearlite Boundary (shown by green arrows). Voids/Cavities sizes ranged from  $\frac{1}{4}$  µm to  $\frac{1}{2}$  µm.

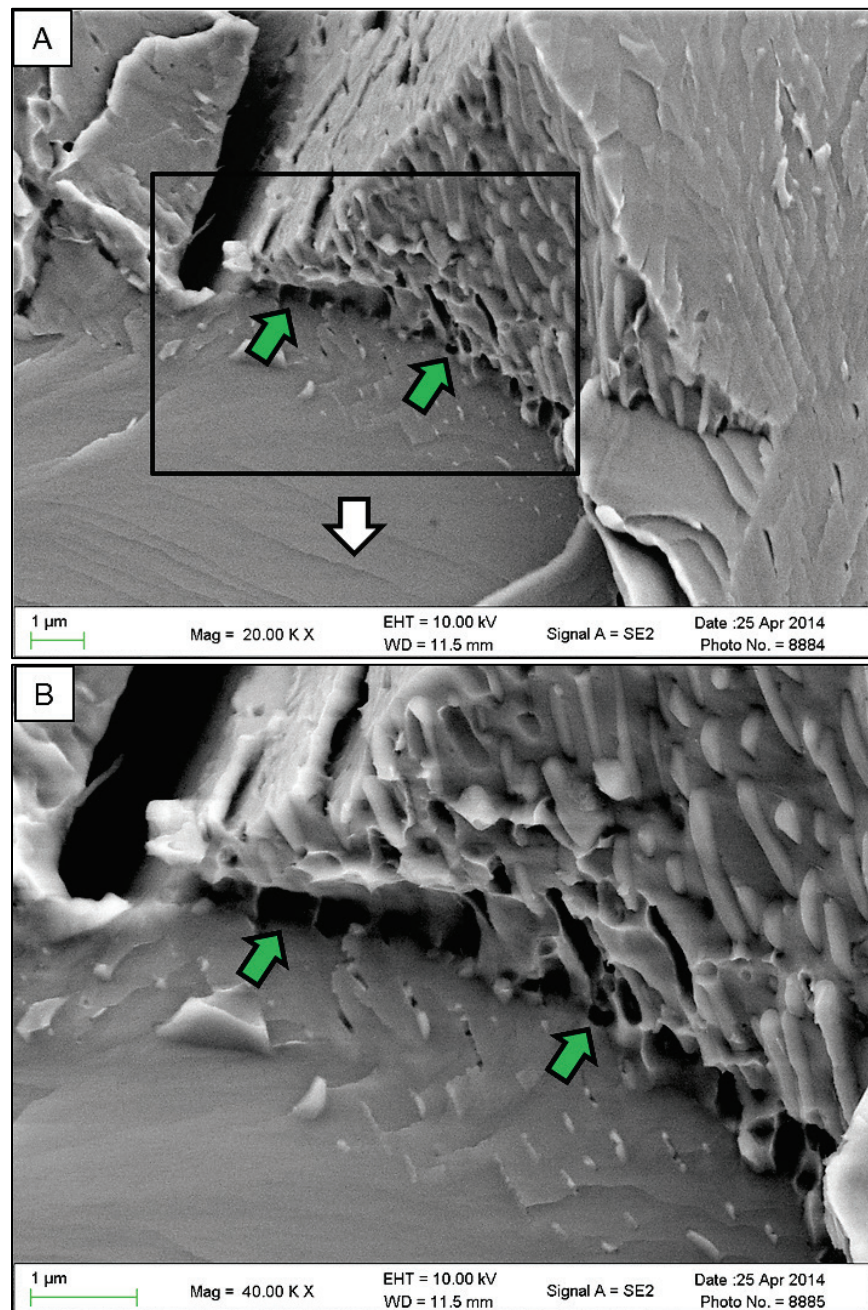
Figure 72. SEM Fractographs in the Flange Base Metal just outside of the Visible HAZ adjacent to the ID Surface in P66 #555-S1 showing Voids/Cavities along the Ferrite-Pearlite Boundary (shown by green arrows).

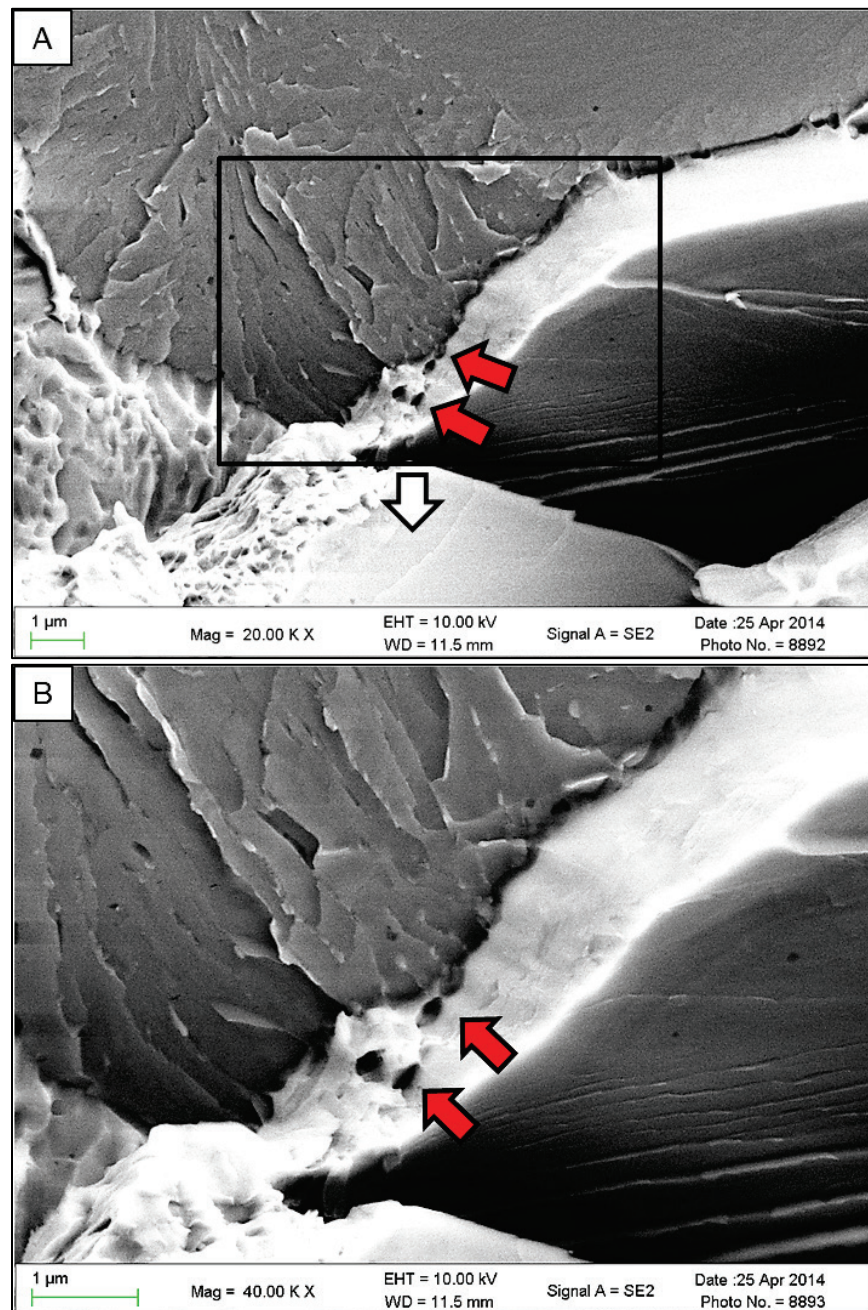
Figure 73. SEM Fractographs of the Flange Base Metal just outside of the Visible HAZ adjacent to the ID Surface in P66 #555-S1 showing Intergranular Separation and formation of Cavities along the Ferrite-Ferrite Grain Boundary (shown by red arrows). Cavities sizes ranged from  $\frac{1}{4}$  µm to  $\frac{1}{2}$  µm.

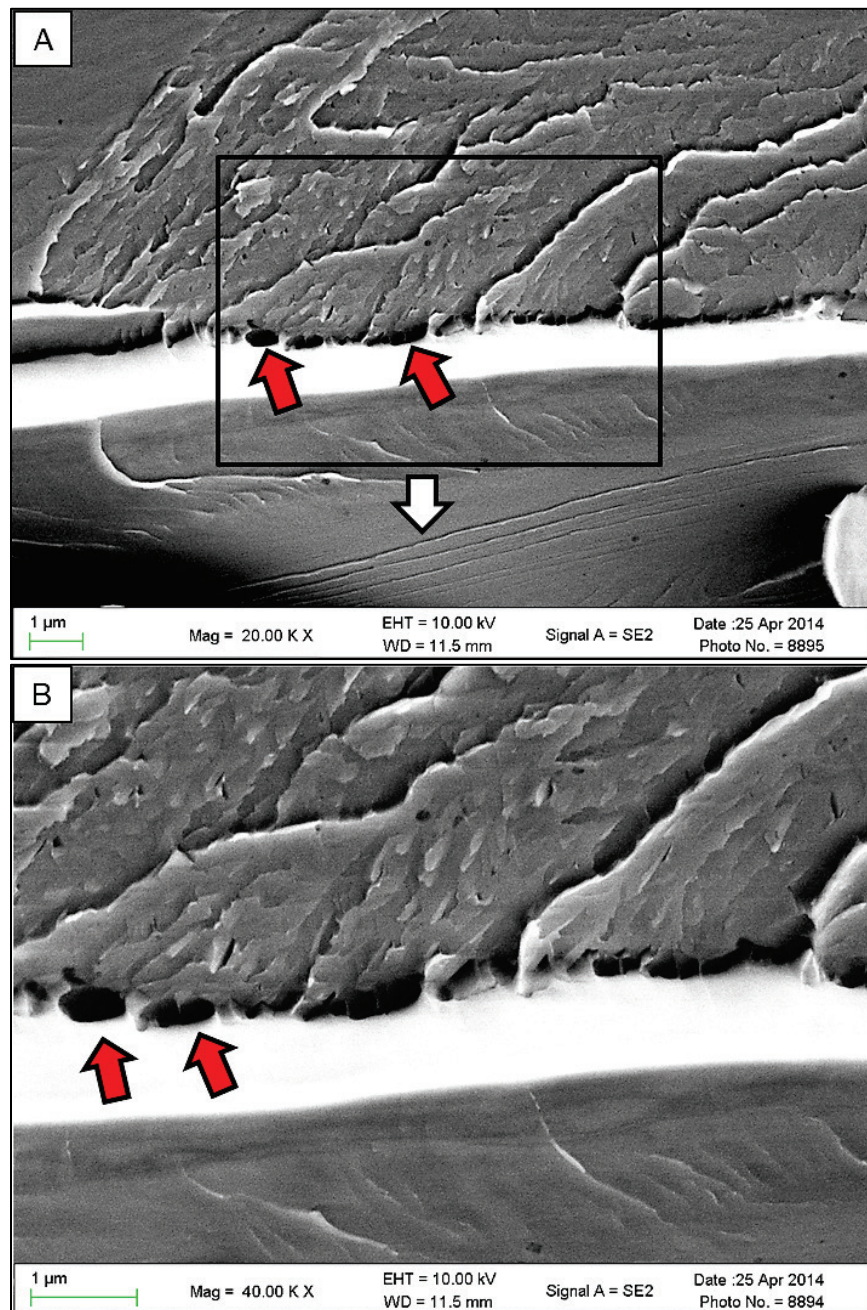
Figure 74. SEM Fractographs of the Flange Base Metal just outside of the Visible HAZ adjacent to the ID Surface in P66 #555-S1 showing Intergranular Separation and formation of Cavities along the Ferrite-Ferrite Grain Boundary (shown by red arrows). Cavities sizes ranged from  $\frac{1}{4}$  μm to  $\frac{1}{2}$  μm.

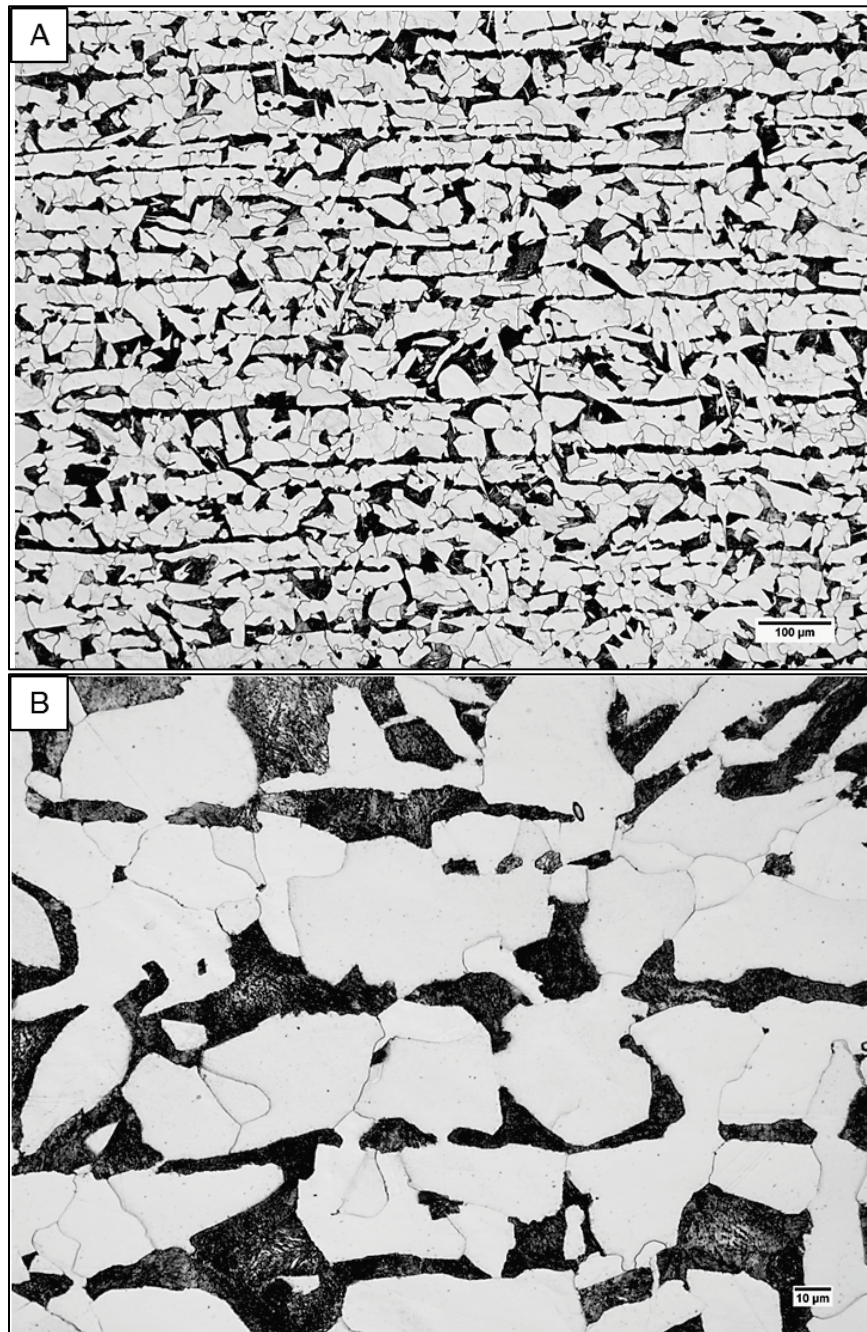
Figure 75 show photomicrographs of the pipe base metal at (A) 100X and (B) 500X respectively; the microstructure consists of 75% ferrite and 25% pearlite with an ASTM grain size #6. The microstructure exhibits directional features resulting from segregation and rolling, which is typical of piping products. No evidence of decarburization or fissuring, which is a common feature of traditional high temperature hydrogen attack (HTHA), was observed in the pipe base metal, pipe and flange HAZs or in the weld deposit in flange-to-pipe welded component #555-S1.

Figure 75. Photomicrographs of the Pipe Base Metal in #555-S1 with No evidence of Decarburization or Cracking. Ferritic and Pearlitic Microstructure with typical Directional Features resulting from Segregation and Rolling, ASTM G.S. #6, 75 % Pearlite and 25 % Ferrite. 2% Nital Etch.

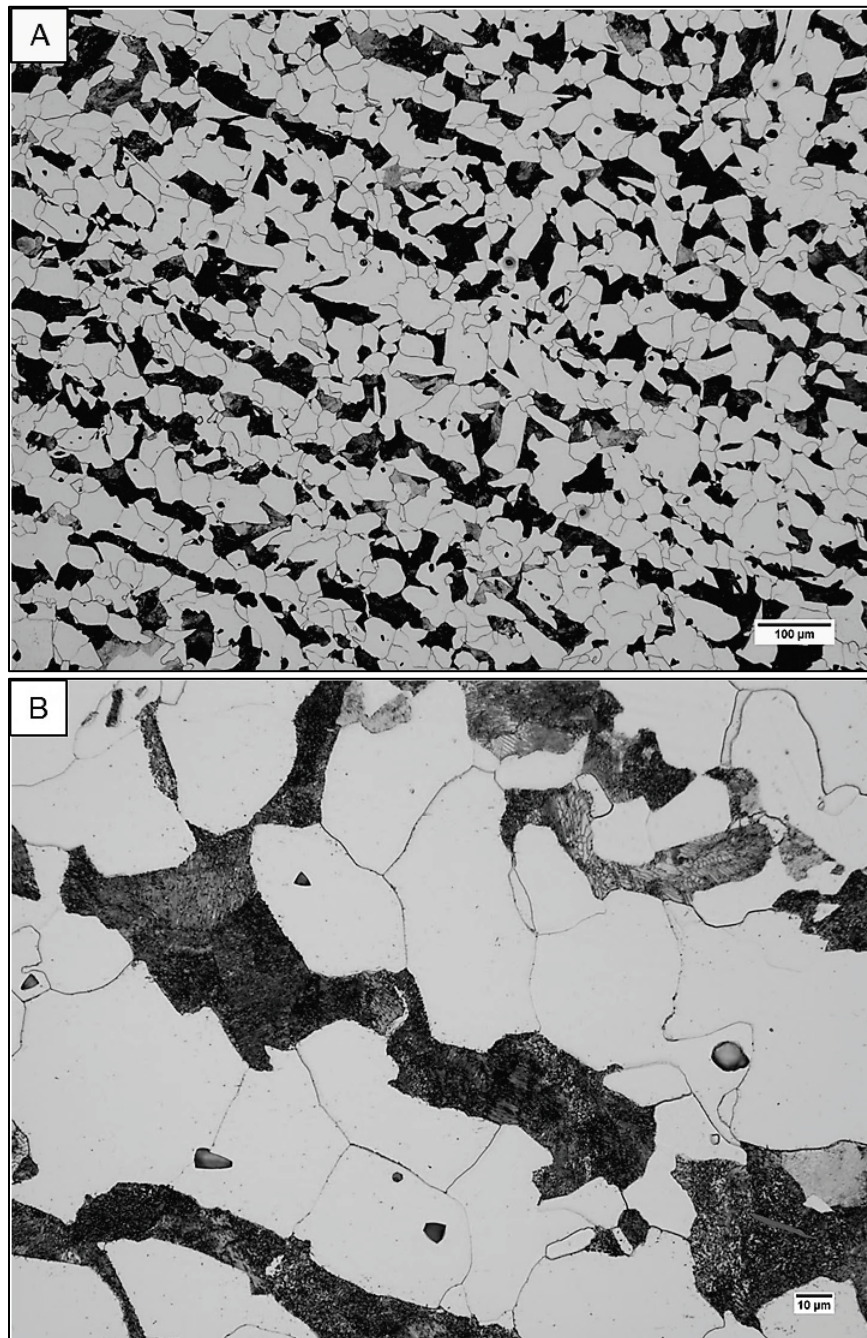
The microstructure of Flange #555-S2 was composed of ferrite and pearlite for both pipe and flange base metals. Figure 76 show photomicrographs of the flange base metal at (A) 100X and (B) 500X, respectively showing a typical forging pattern. Microstructure consists of 75% ferrite and 25% pearlite with an ASTM grain size #6. Figure 77 shows photomicrographs of the pipe base metal at (A) 100X and (B) 500X, respectively, showing typical pipe rolling/forming texture. Microstructure consists of 80% ferrite and 20% pearlite with an ASTM grain size #6. Two samples were extracted 180 degrees apart circumferentially

from Flange #555-S2 for a microstructural examination. No evidence of decarburization or fissuring/cracking which are common features of traditional high temperature hydrogen attack (HTHA) was observed in the pipe base metal, flange base metal, pipe and flange HAZs or in the weld deposit in Flange #555-S2.

Figure 76. Photomicrographs of the Flange Base Metal just outside of the Visible HAZ adjacent to the ID Surface in P66 #555-S2. Ferritic and Pearlitic Microstructure with typical Forging Texture. ASTM G.S. #6, 75% Ferrite, 25% Pearlite, 2% Nital Etch.

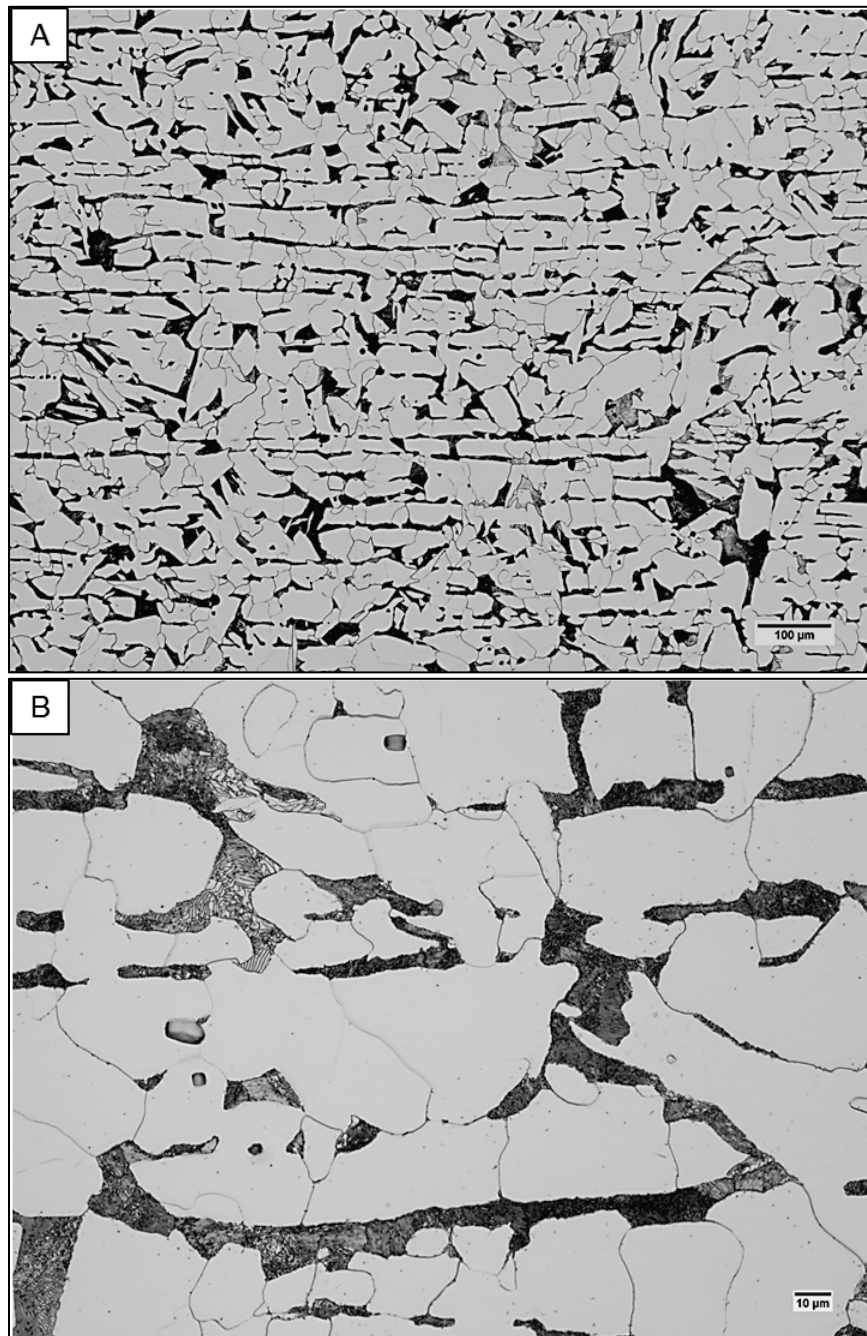
Figure 77. Photomicrographs of the Pipe Base Metal adjacent to the ID Surface in P66 #555-S2,. Ferritic and Pearlitic Microstructure with typical Directional Features Resulting from Segregation and Rolling. ASTM G.S. #6, 80% Ferrite, 20% Pearlite, 2% Nital Etch.

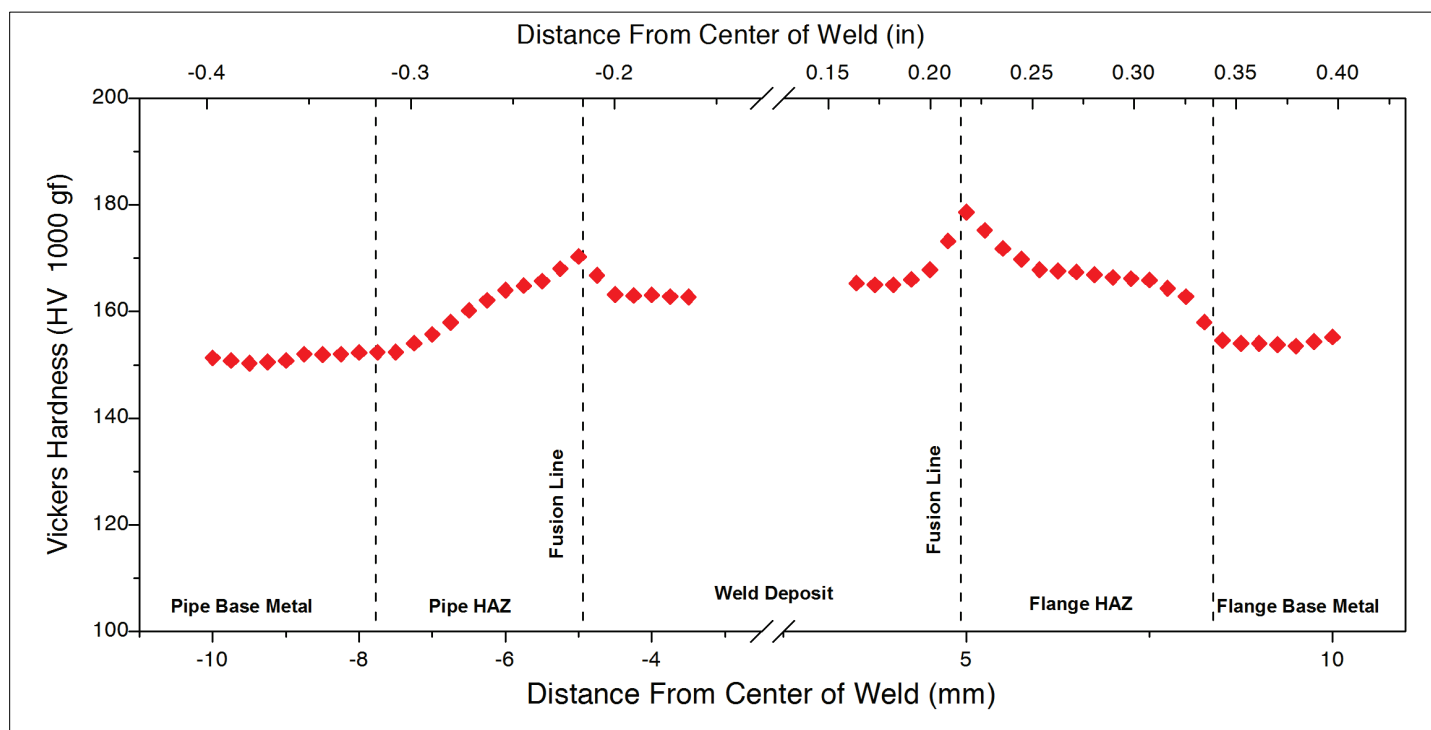
Table 8 shows the measured hardness values and estimated tensile strengths for both P66 flange-to-pipe components #555-S1 and #555-S2. The hardnesses of the pipe, flange, and the weld deposit are considered normal at 82-87 HRBW for #555-S1 (damaged). The hardness of the pipe, flange and weld deposit for #555-S2 (undamaged) are slightly lower at 70-81 HRBW. Measured hardness (HRBW) was used to estimate tensile strength (ksi) from the appropriate tables in ASTM A370 (see Table 8 for detailed hardness/strength results). The strength requirements of ASTM A106-Gr.B (60 ksi) for pipe base metal and ASTM A105 (70 ksi) for flange base metal were met by conversion<sup>85-87</sup>. The differences in the hardness/strength are reflective of the difference in carbon content in flange and pipe components. Vickers micro-hardness on the damaged flange #555-S1 across the pipe and flange HAZs is shown in Figure 78. The hardness traverse on the damaged flange across the pipe and flange HAZs is shown in Figure 79. The traverses for both components #555-S1 and #555-S2 are similar, and reflect the starting hardnesses of the flange and pipe material. The hardness of the flange base metal immediately outside of the visible HAZ (adjacent to the microfissures) is 82 HRB (154 HV). Thus, there is no significant

difference in the hardness of the flange base metal between the area adjacent to the microfissures and the unaffected base metal (within +/- 5 HV).

Figure 78. Vickers Micro-hardness Traverse on the P66 Flange-to-Pipe Welded Component #555-S1 across the Flange and Pipe HAZs using 1000 gf load. The Traverses are Similar and Reflect the Starting Hardnesses of Flange and Pipe Material. Hardnesses in the area adjacent to the Microfissures (flange base metal just outside of the visible HAZ) and the Unaffected Flange Base Metal show no Significant Difference in Hardness Results (within  $\pm 5$  HV).

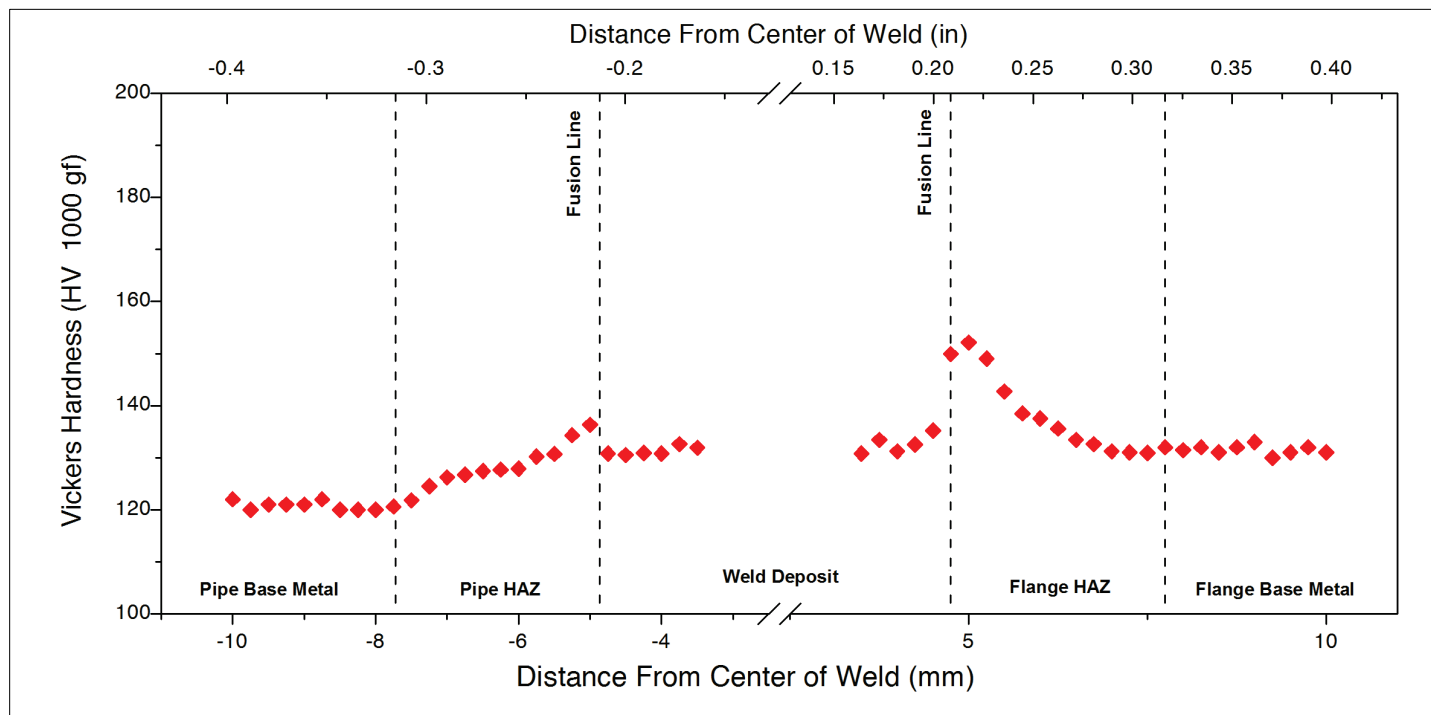
Figure 79. Vickers Micro-hardness Traverse on the P66 Flange-to-pipe Weld Component #555-S2 across the Flange and Pipe HAZs using 1000 gf load. The Traverses are Similar and Reflect the Starting Hardnesses of Flange and Pipe Material.

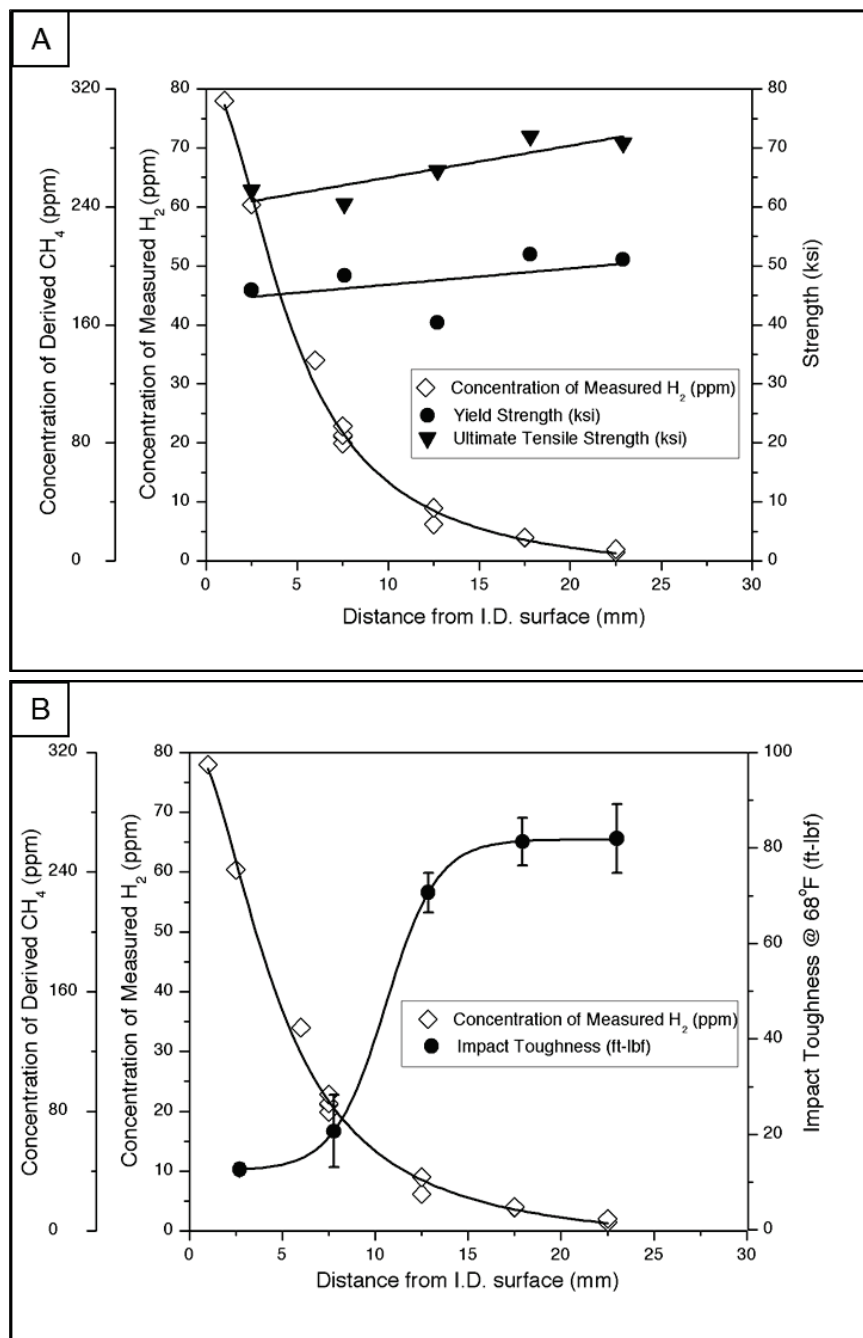
The hardness and strength (by conversion) results of P66 flange-to-pipe welded component #555-S1 show that at the early stages of HTHA these properties are not significantly impaired. The earlier studies on C-1/2 Mo steel at UTK also showed similar results at this level of methane (28 ppm). Figure 80A shows the co-relation between the strength (ksi) as a function of methane content (ppm) and Figure 80B shows the co-relation between the impact toughness (ft-lbf) as a function of methane content (ppm) <sup>39</sup>. The strength and toughness results are not significantly impaired on C-1/2 Mo when the methane content is less than 30-35 ppm <sup>39</sup>.

Figure 80. Concentration of Methane,  $\text{CH}_4$  (ppm) content vs. Change in Mechanical Properties (Strength and Toughness) on C-1/2 Mo Steel as a Function of Wall-thickness <sup>39</sup>.
