U.S Inflight Icing Accidents and Incidents, 2006 to 2010.

Appiah-Kubi, Philip, "U.S Inflight Icing Accidents and Incidents, 2006 to 2010.." Master's Thesis, University of Tennessee, 2011.
http://trace.tennessee.edu/utk_gradthes/1055

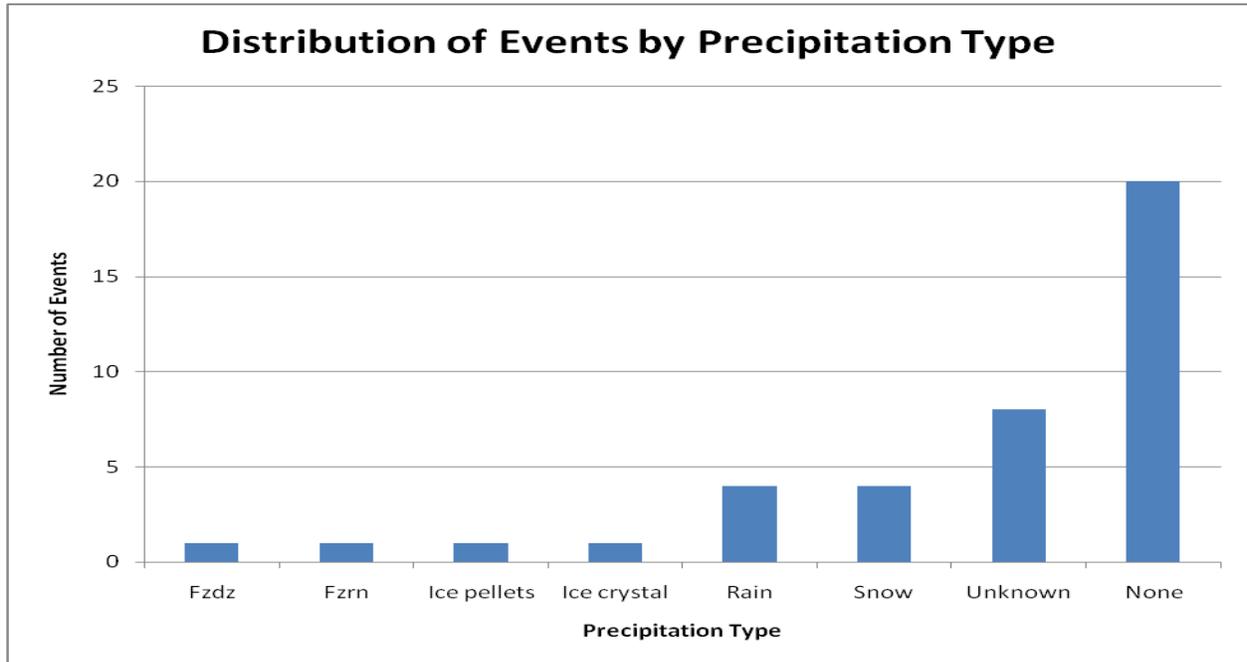
Figure 1: Distribution of Events by Surface Precipitation Type

As much as 50% of the accidents occurred when there was no surface precipitation at the accident site. Snow and rain contributed 10% each. Freezing rain, freezing drizzle, ice pellets and ice crystal contributed 2.5% each, while the remaining 20% occurred under unknown surface precipitation. From 1978 to 2005, Mr. Green³ observed that freezing precipitation and snow accounted for 33% and 32% respectively of inflight icing accidents. These values would be more useful if there were ways to determine the type of precipitation that the accident aircraft went through from the period prior to ice accretion, and the occurrence of the first performance or aerodynamic stability and control event prior to the accident. Unfortunately, the current state of the art is not capable of providing this data. ICEPRO⁷ software although yet to be integrated into transport aircraft, is purported to have the capability to inform aircrew of particular inflight icing conditions, icing severity, and how these icing conditions may alter the aircraft's baseline performance, and stability and control. The surface precipitation data does little to explain exactly what the aircraft went through inflight before the accident. It is possible for an aircraft to accumulate inflight icing in an area with little or no precipitation, but end up stalling and crashing at a place with entirely different surface precipitation. Figure 1 (all figures shown in appendix II) shows the statistical display of the surface precipitation data.

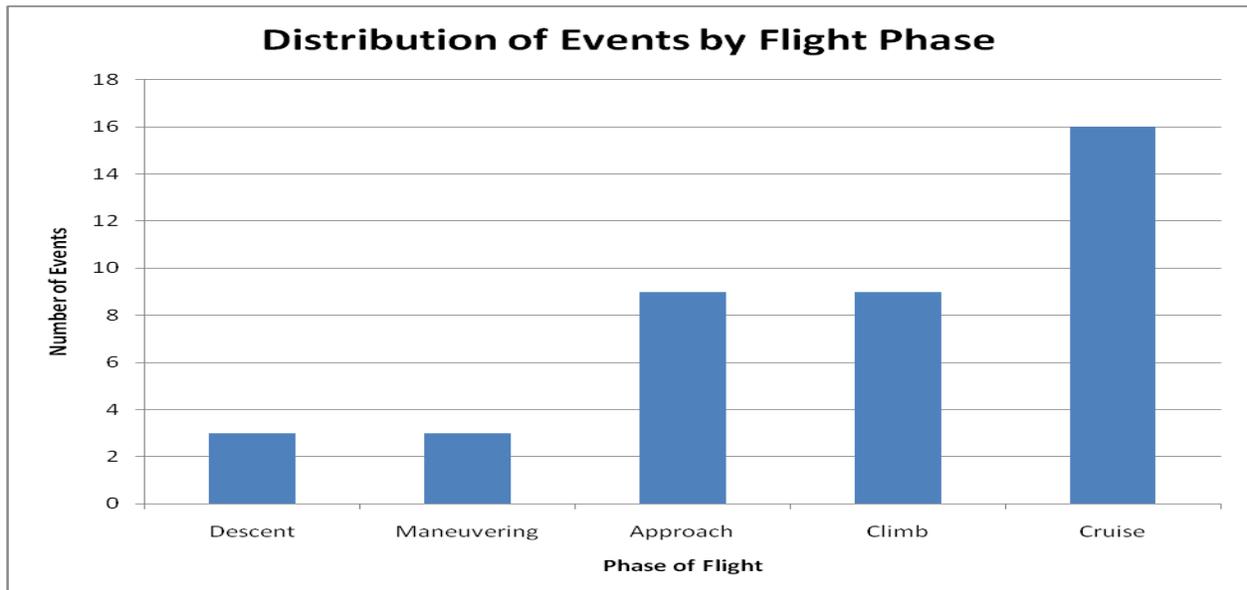
Figure 2: Distribution of Events by Phase of Flight.

An aircraft in the cruise phase is more likely to accrete ice than any other phase. Ice accretion in 40% of the accidents from 2006 to 2010 was detected during the cruise phase of the flight. This is consistent with Steven Green's³ observations on inflight icing accidents from 1978 to 2005. The majority of the accident aircraft accreted ice during the cruise phase of the flight. This should be expected since cruise forms the greater duration of most air transportation. Figure 2 shows the distribution of the number of events by the phase of flight.

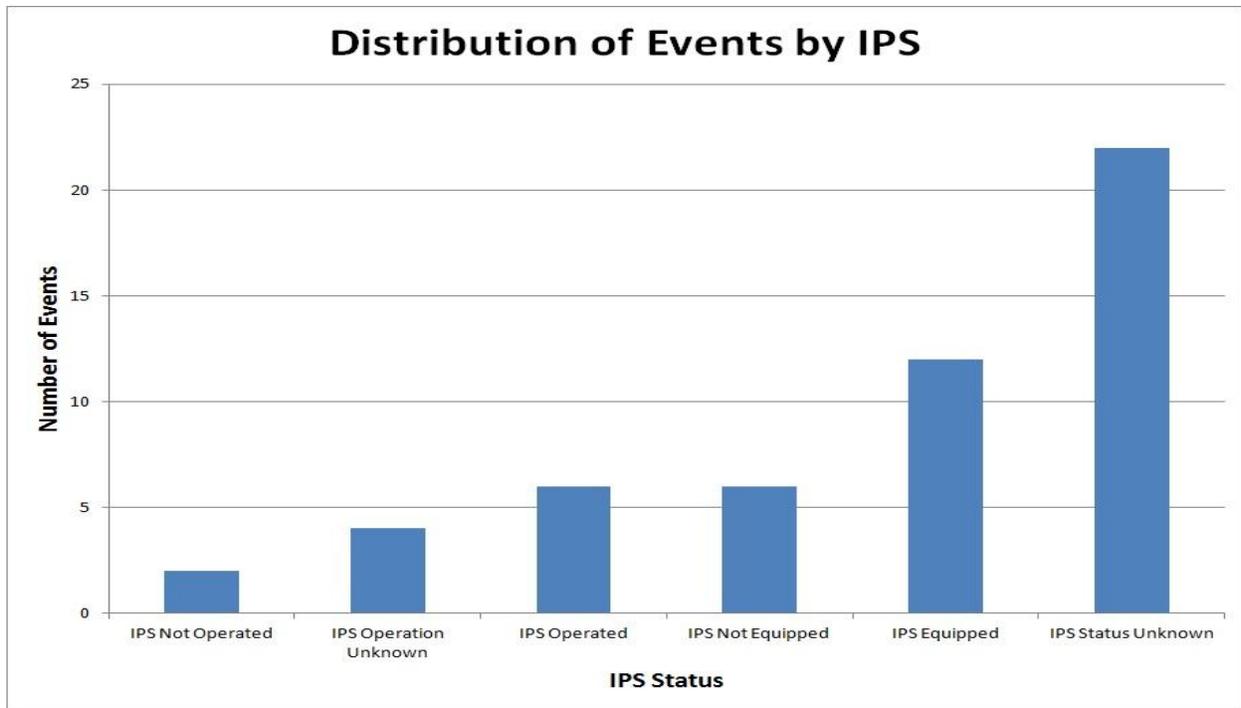
Figure 3: IPS Status and Operation

operated. Some reports also do not state whether the accident aircraft was equipped with IPS. From Figure 3 the status of the IPS equipment was unknown for 22 of the accidents.

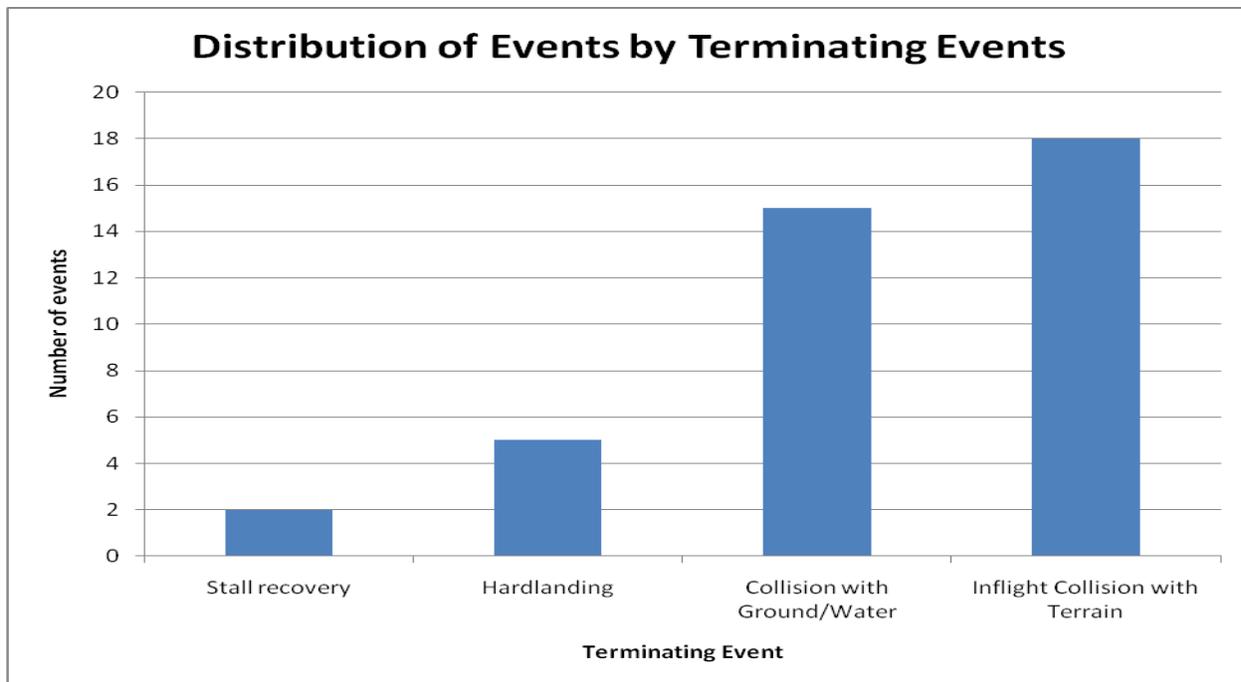
Figure 4: Distribution of Terminating Events

Out of the 40 accidents, only 2 recovered from stall. Five resulted in hard landing, 18 resulted in inflight collision with terrain and 15 resulted in a ground collision with ground or water. This is consistent with what Mr. Green observed from 1978 to 2005. Mr. Green observed that 53% of the accidents resulted in inflight collision with terrain, while 3.08% and 23.82% terminated in stall recovery and hard landing, respectively. Figure 4 shows the distribution of the terminating events from 2006 to 2010.

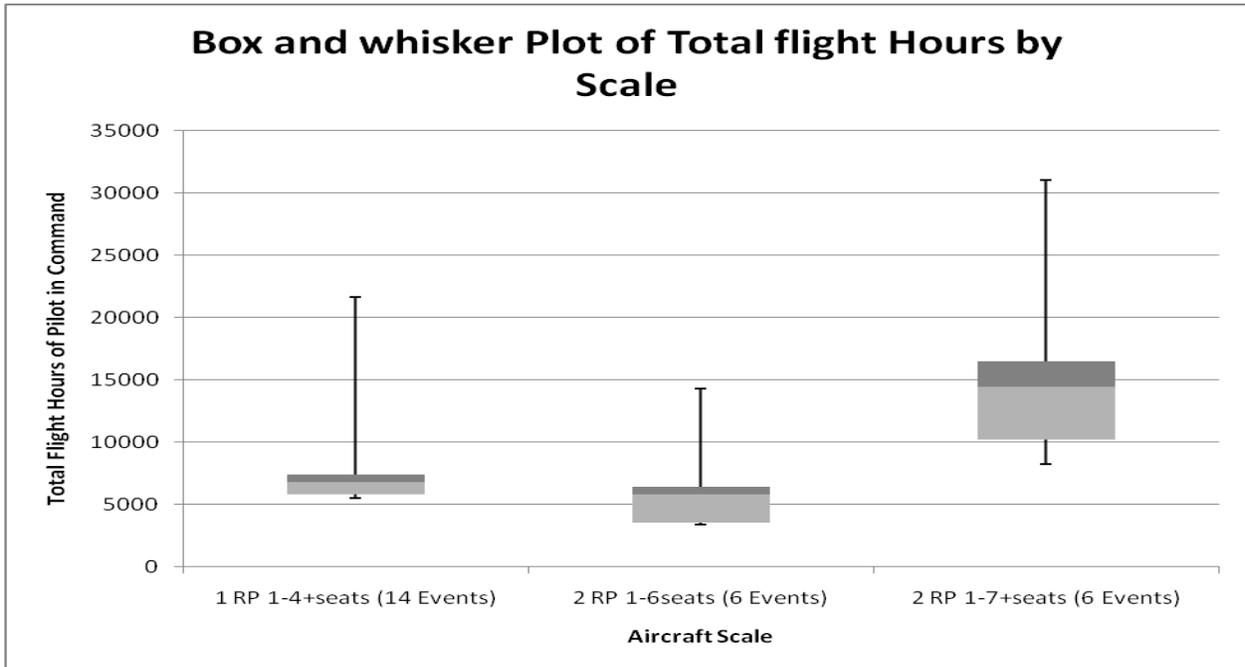
Figure 5: Distribution of Total Flight Hours by Scale

The research also considered the pilots total flight hours and the hours in the accident aircraft model/type. This was done only for the pilot in command as there were no details about the copilot's flight experience. In 14 of the accidents, the pilot in command's flight experience in the type/model of aircraft was unknown. For research purposes, the total flight hours of the captain and the first officer in type/model of the accident aircraft would be very useful. The box and whiskers plot in Figure 5 shows the total flight hours for the scales of aircraft that contributed to the greater number of the accidents. All the scales of aircraft in Figure 5 show extreme values to the right. The lower part of the boxes, the middle line and the upper part respectively represent the lower quartile (median of the lower half of the data), the median and the upper quartile (median of the upper half of the data).

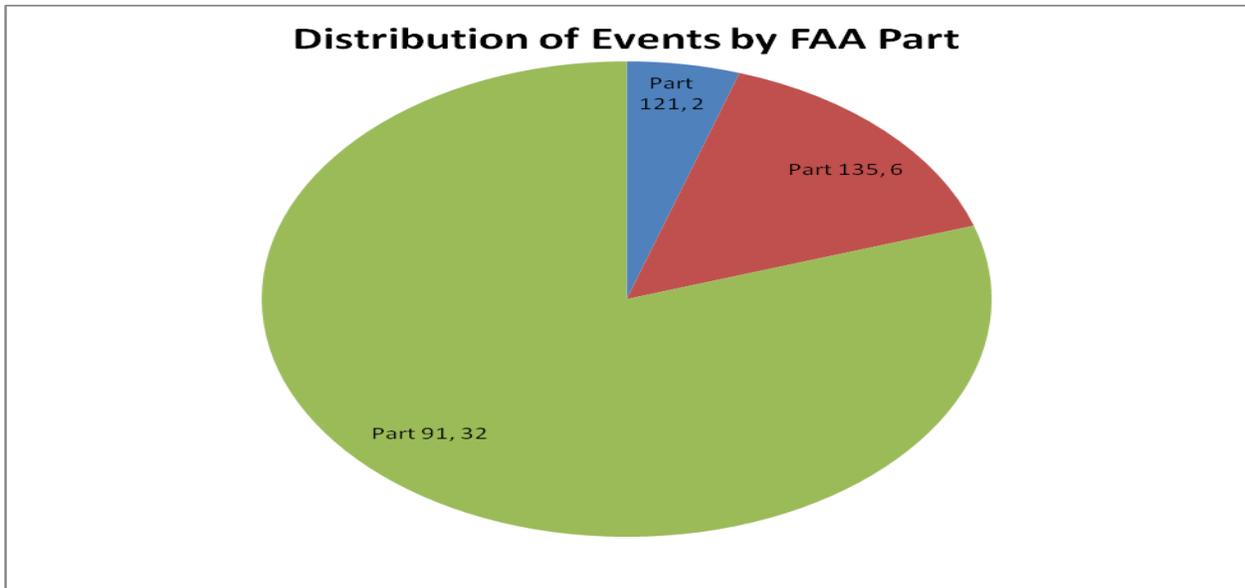
Figure 6: Distribution of Events by FAA Part

The FAA Part under which the aircraft were operating was also considered. Figure 6 shows that 80% of the accidents operated under FAA Part 91. 15% operated under Part 135, while 5% operated under Part 121. The Part 91 aircraft by regulation⁹ are mostly prevented from operating in moderate icing. These aircraft, personal and business/corporate flying jets ranging from single engine with four seats through corporate jets, are most common in icing events, Steven Green³ explained. He further explained that unlike Part 135 which demands considerable amount of training of crew members, Part 91 does not but solely relies on the licensing requirement applicable to all flights. Part 121 aircraft are mostly scheduled air carriers. These aircraft are equipped with IPS hence their contribution to a smaller percentage of the accidents.

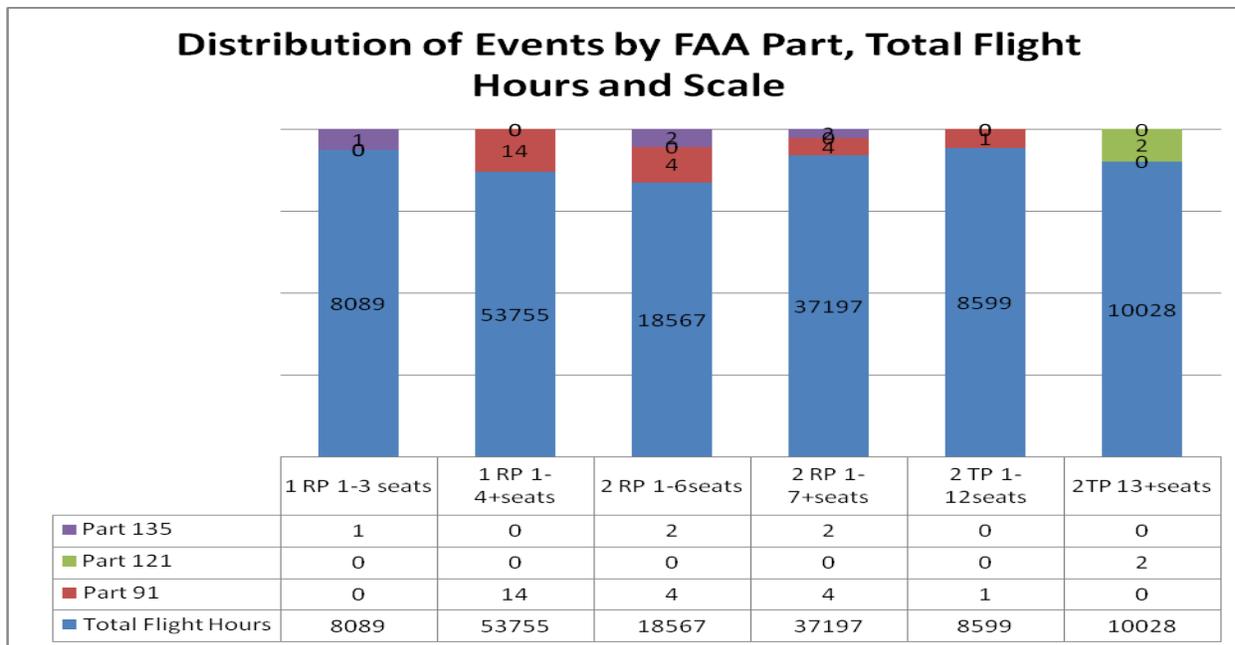
Figure 7: Distribution of Events by FAA Part and Total Flight Hours

The Part 91 aircraft which contributed to 32 out of the 40 accidents also accounted for a greater percentage of the total flight hours as show in Figure 7. The single reciprocal engine 1 to

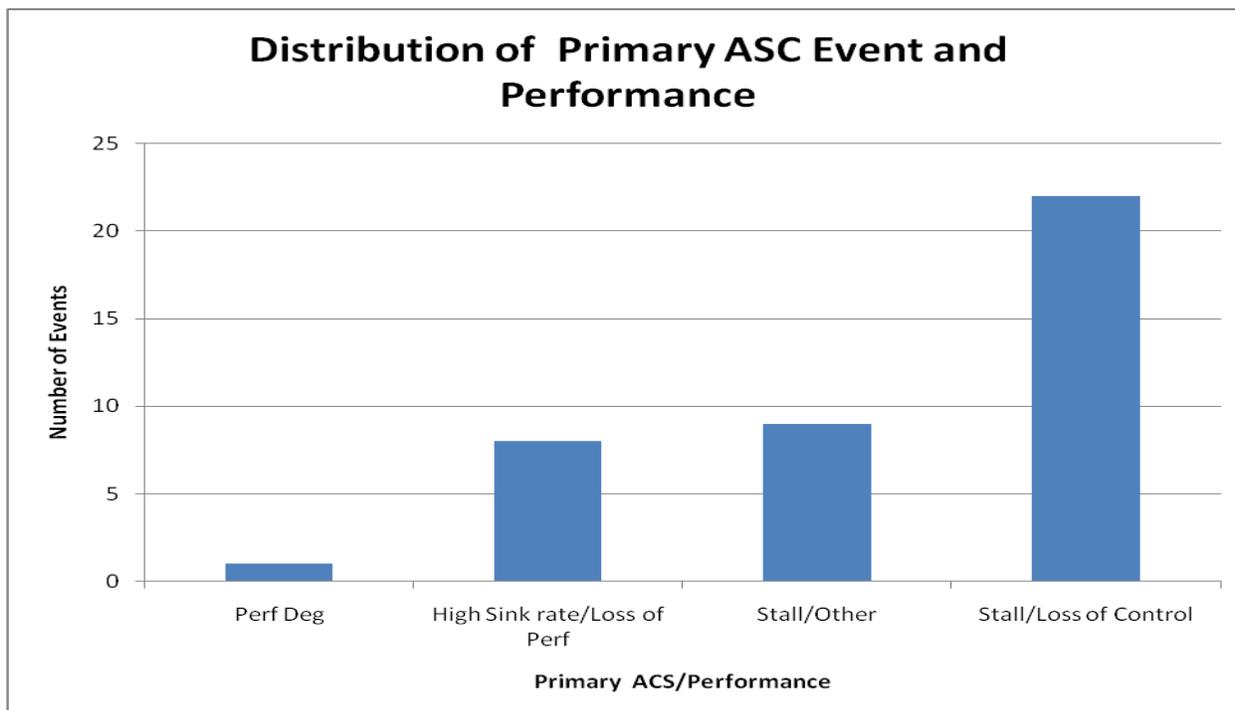
Figure 8: Distribution of ASC Events by Scale

The most common ASC events in the accidents were stall and loss of control. In most reports, these events were explicitly stated. Stall was inferred from reports that cited loss of control as the primary aerodynamic event without any other occurrence. From 1987 to 2005, most accidents³ involved stall, which was followed by loss of control. This trend was expected as inflight icing increases the stall speed; the Federal Aviation Regulations Aeronautical Information Manual⁸ explains that inflight icing has a cumulative effect on the performance of aircraft. It explains that inflight icing comes with reduced thrust, increased weight, loss of lift, and increased drag. This results in increased stall speed and performance degradation. It further explains that ½ inch of ice can reduce the lifting power of an aircraft by 50% and increase frictional drag by the same amount. Figure 8 shows the distribution of primary performance and ASC event. Twenty one (approximately 53%) of the accidents from 2006 to 2010 experienced stall and loss of control.
