I am submitting herewith a thesis written by Anita Polk-Conley entitled "Use of Remotely Sensed Data for Analysis of Hard Rock North Seepage Area, Fabius Mines, Alabama." I have examined the final copy of this thesis for form and content and recommend that it be accepted in partial fulfillment of the requirements for the degree of Master of Science, with a major in Engineering Science.

USE OF REMOTELY SENSED DATA FOR ANALYSIS OF HARD ROCK NORTH  
SEEPAGE AREA, FABIVS MINES, ALABAMA

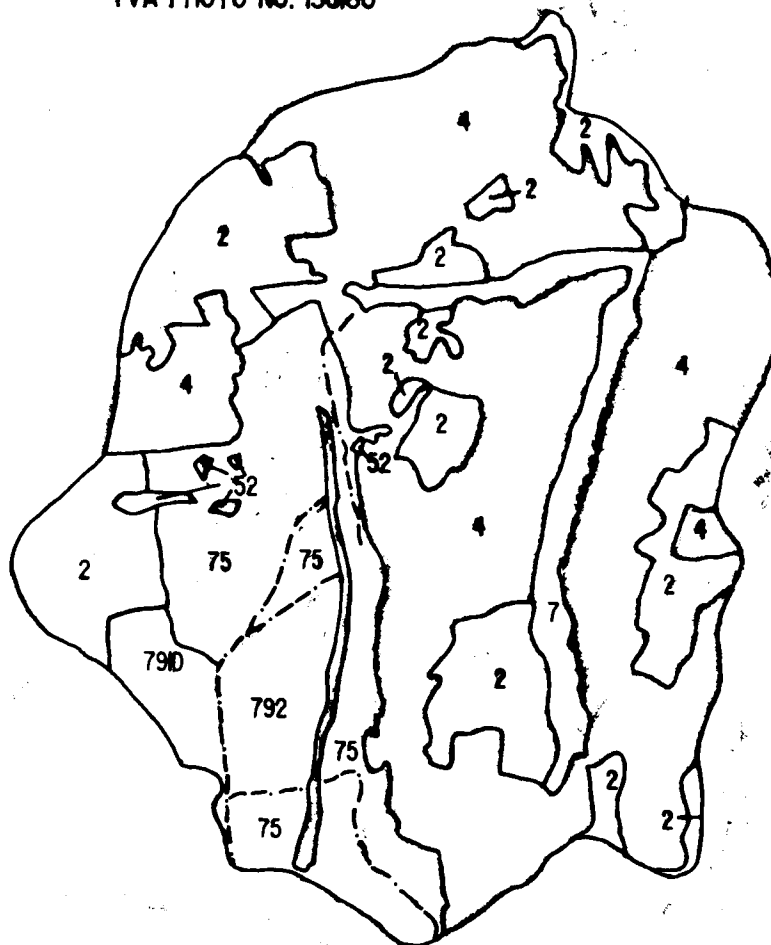
HRN WATERSHED AREA  
ACTIVE MINING LU/LC CLASSIFIED  
10 - 14 - 1977  
1 : 20,000  
TVA PHOTO NO. 138180

Figure 15. Active mining land use/land cover, 1977.
