**THE INFLUENCE OF ORGANIZATION CULTURE  
ON AVIATION SAFETY – A CASE STUDY OF A  
UNITED STATES NAVY FA-18 LANDING MISHAP**

A Thesis  
Presented for the  
Master of Science  
Degree  
The University of Tennessee, Knoxville

Peter J. Kind  
August 2004

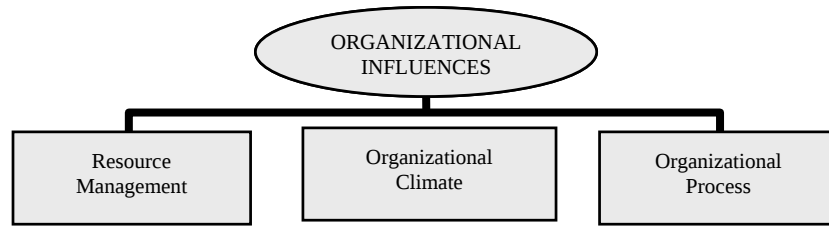
Figure 7. Organization Influences Classification (Naval Safety Center).

The final barrier or “slice” in the HFACS model is Organizational Influences. Decisions of upper-level management directly affect supervisory practices and conditions as well as the actions of individual operators. These influences usually represent the most latent conditions and as such may be in place well before the mishap. These failures occur in areas relating to resource management, climate, or processes as shown in figure 7.
