**TRANSPORTATION AND TRANSFORMATIONS:  
AN ARCHAEOLOGICAL AND HISTORICAL STUDY OF  
THE McBREARTY SITE (40KN270) AND CARRIAGE  
HOUSES IN THE NORTH KNOXVILLE AREA**

A Thesis Presented for the  
Master of Arts Degree

University of Tennessee, Knoxville

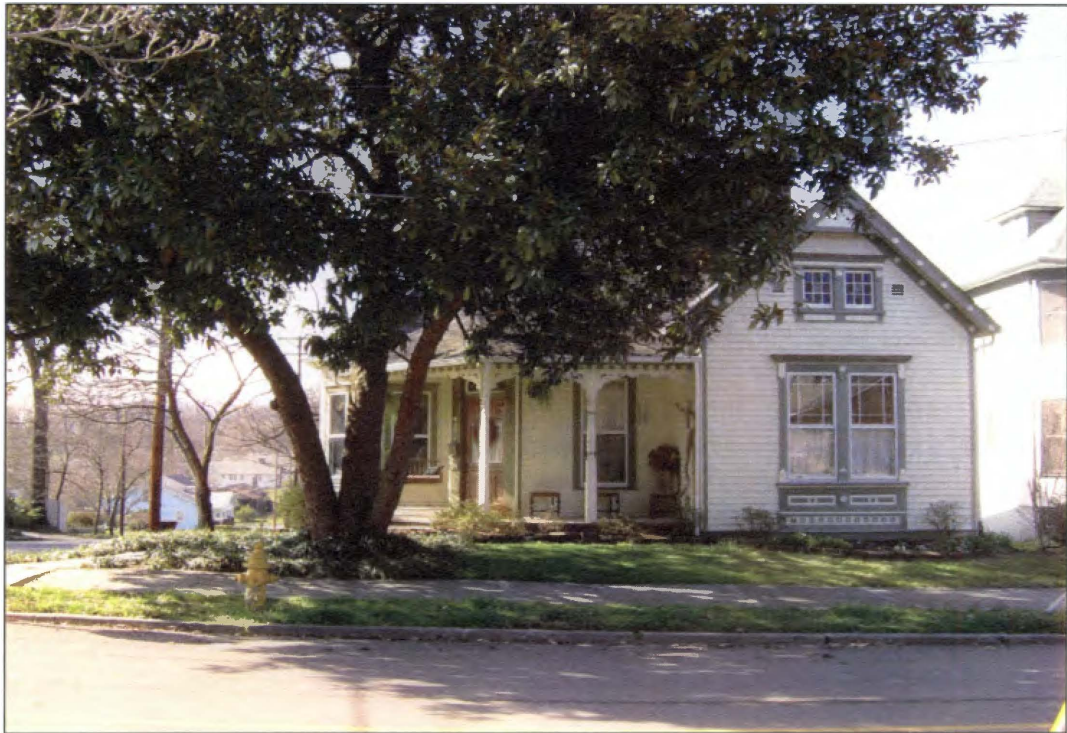
**Figure 2.** McBrearty house, southern facade.

*McBrearty House.* The McBrearty house is rumored to be one of the first houses built in the Old North Knoxville neighborhood (Figures 2 and 3). The architecture of the house is distinctively Victorian—a style known as Queen Anne Cottage, a folk form of architecture which grew out of the popular Queen Anne academic style popular in the late 19<sup>th</sup> century. The Queen Anne Cottage is characterized as being constructed of weatherboard, one and a half stories in height with a hip and gable roof, and corbelled chimneys with restrained Queen Anne massing, details, and sawn wood ornamentation. The cottage typically has a large porch with the roof supported by wooden columns which are often turned, chamfered or rounded. Post brackets, sawn wood, or louvered attic vents and spindle work balustrades are also often found, as are double sash windows

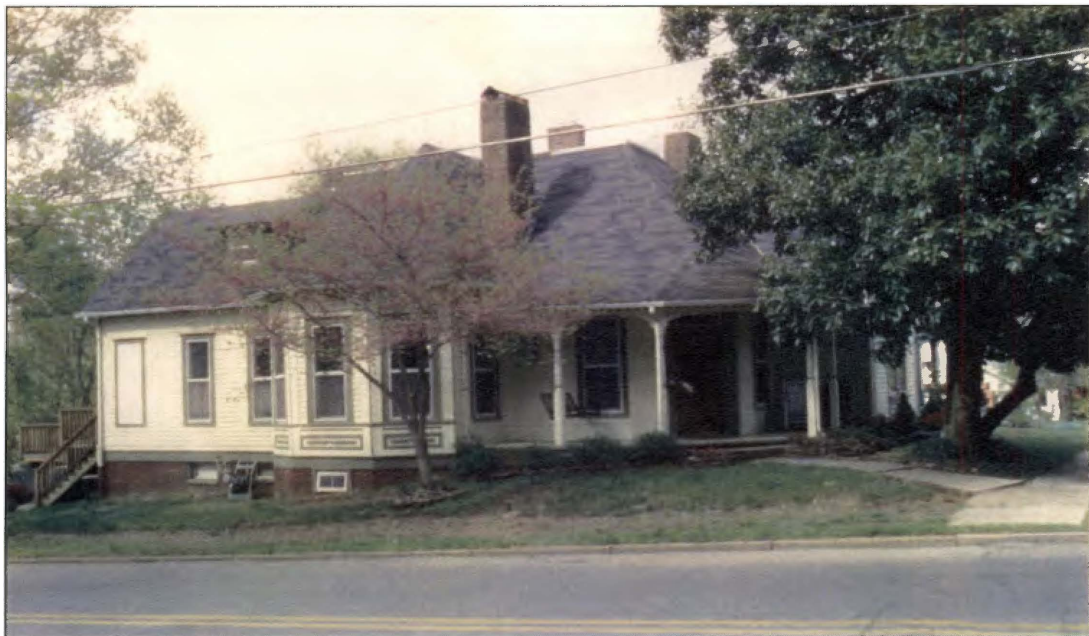
**Figure 3.** McBrearty house, southwest elevation.

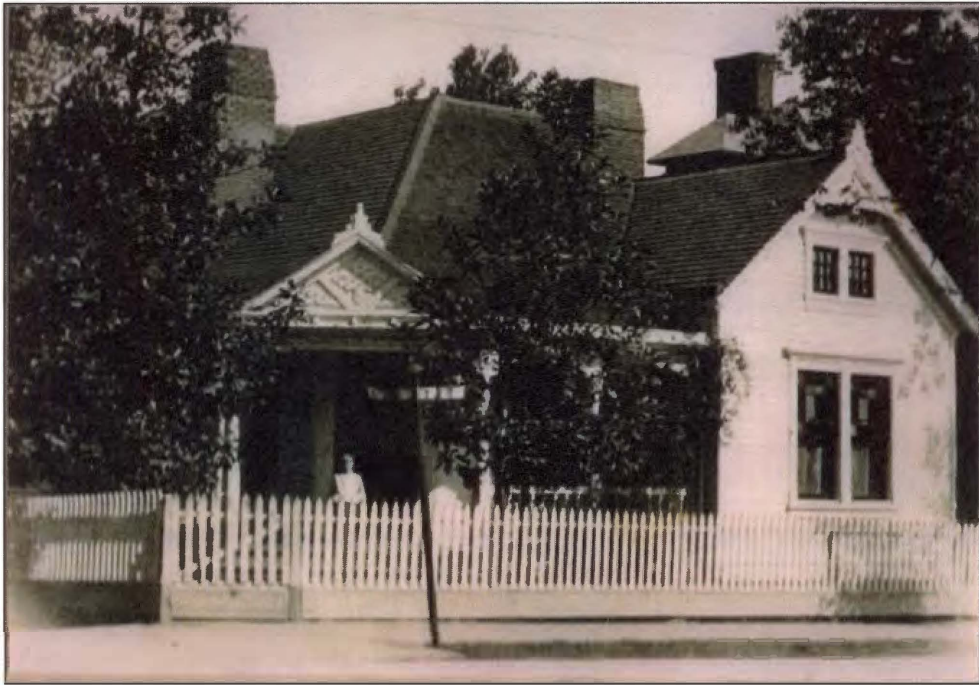
**Figure 4.** McBrearty house, ca. 1920.

All of the windows are one-over-one double hung sash windows with the exception of a stained glass window located on the front gable. The majority of the windows have been replaced. This is evident by a lack of waviness and other inconsistencies in the window glass. The stained glass window was reconstructed by the Powers family to mimic a similar window present in a 1920s photograph of the house (Figure 4).

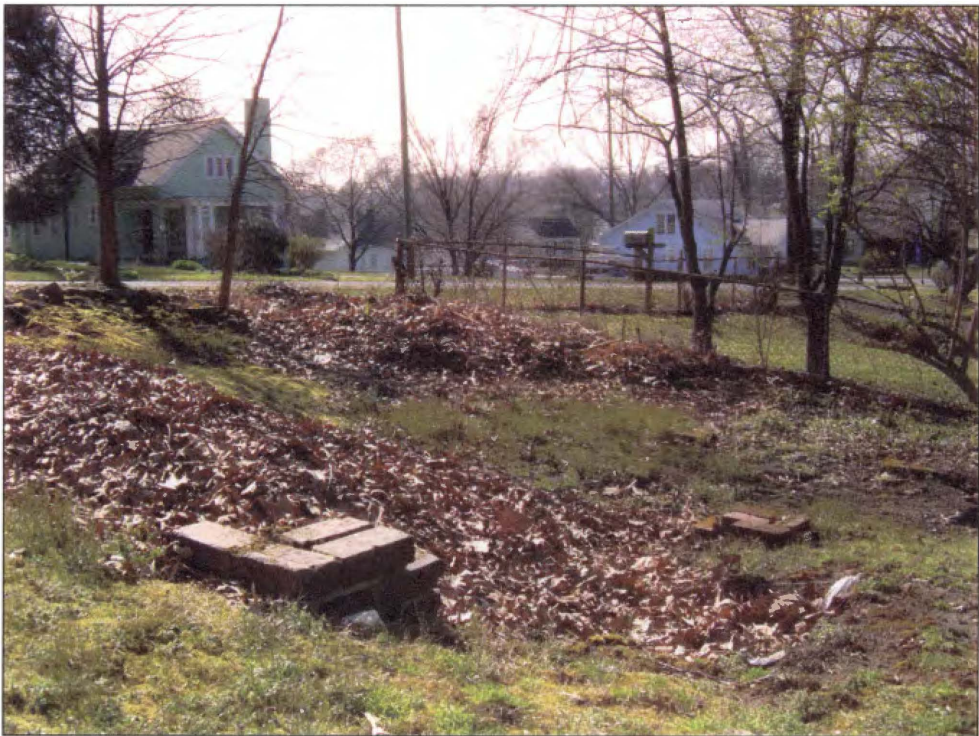
**Figure 5.** Brick piers of the McBrearty carriage house.

*Carriage House.* The McBrearty carriage house is located approximately 102 feet from the northwest corner of the McBrearty home (Figure 5). As mentioned previously, all that remains of the structure are 13 brick piers constructed predominantly of machine-made end-cut bricks. Six load-bearing piers are located at the corners and ends of the center sill of the structure, and seven rectangular piers are located along center and outer sills. The dimensions of the foundation are 18 feet 4.5 inches north-south, and 24 feet 0.5 inches east-west, respectively. Three brick footers, two load-bearing corner piers and one rectangular pier, are spaced approximately 6 feet apart, along the east and west wall lines of the carriage house, while the north and south wall lines were supported by three rectangular piers, spaced approximately 5 feet apart, and two load-bearing corner piers, positioned approximately 3 feet from the rectangular piers. A central row, laid in the same fashion as the long axis piers, is located approximately 9 feet from the north

and south wall lines. The rectangular piers are approximately 4 feet apart.

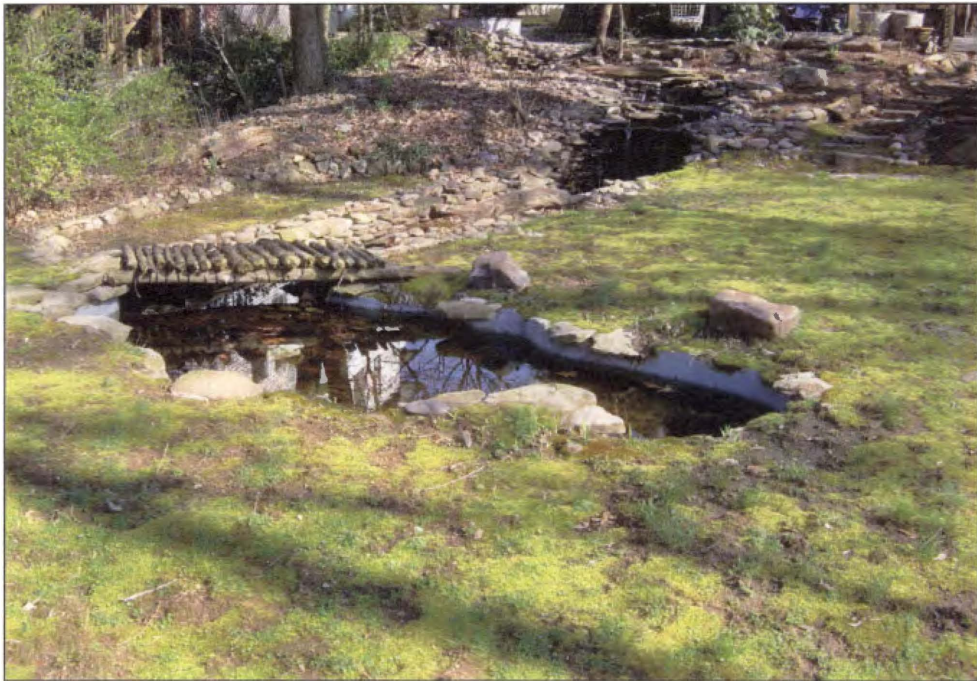
**Figure 6.** Concrete pond.

*Concrete Pond.* A concrete pond is located to the north of the house and southeast of the carriage house foundation (Figure 6). The pond, recently excavated by the current homeowner, is rumored to have been built sometime in the 1940s. A neighborhood informant remembers the pond during her childhood and stated that the pond was filled with water from the house's downspouts. Since the pond was excavated prior to this study, the exact date of construction cannot be determined; however, a *terminus post quem* of 1957 for the filling of the pond can be established based on the latest manufacture date of seven soda bottles recovered during its excavation. Furthermore, the pond is significant in that it demonstrates changes were occurring to the rear yard as early as the mid-20<sup>th</sup> century.

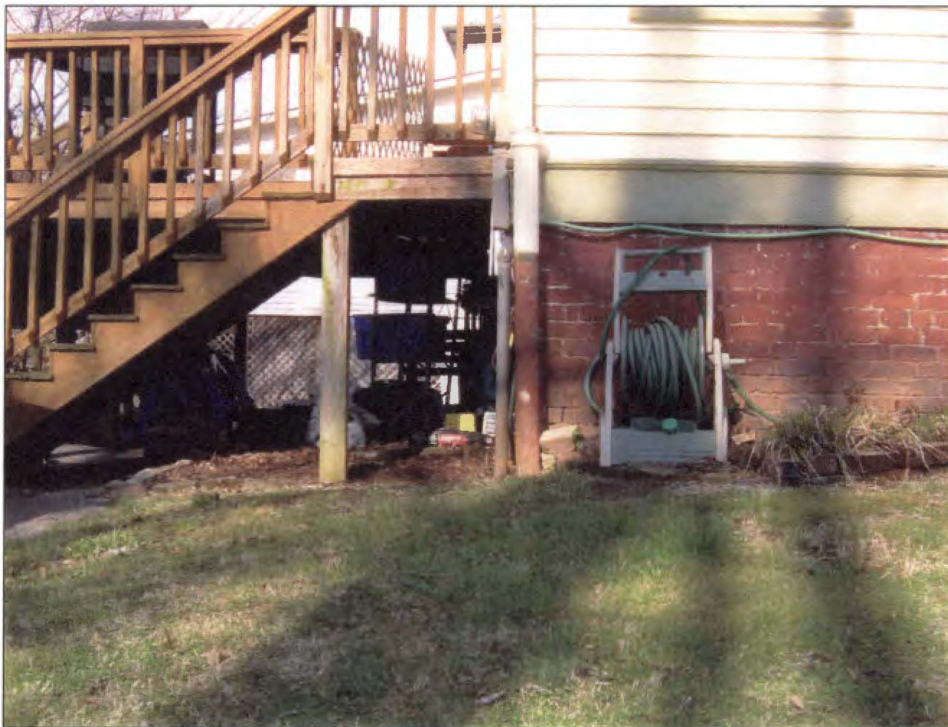
**Figure 7.** West elevation of the McBrearty house showing the location of the cistern.

*Cistern.* A probable late 19<sup>th</sup> century cistern is located on the northwest side of the McBrearty house (Figure 7). The concrete cap of the cistern is approximately 5 feet 7 inches from a downspout that runs off of the southwest corner of the dwelling's roof. A piece of ceramic pipe protrudes from the brick sidewalk nearly parallel to the concrete cap. This likely served as an overflow pipe used to release water when the cistern reached capacity. The location of the cistern was confirmed by an interview with Dale Powers.

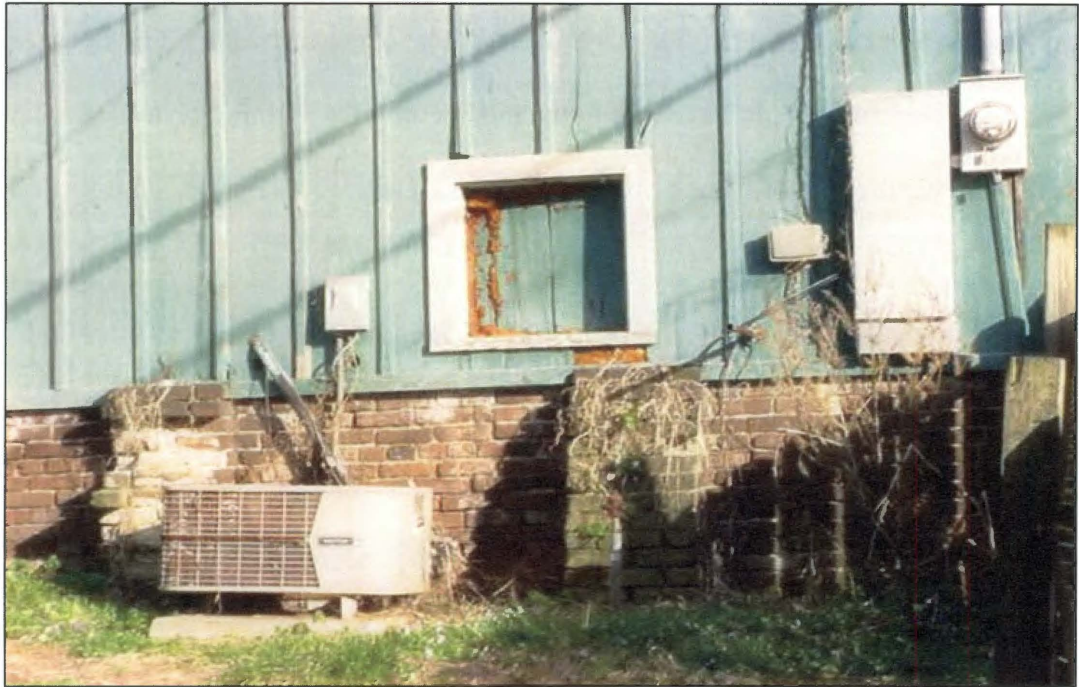
Also interesting is a feature on the rear of the structure that remains an architectural mystery. Two corbelled brick piers, each approximately 1 foot 6 inches wide, protrude from the brick foundation on the north side of the structure (Figure 43). The piers, mortared together with poorly made portland cement, are approximately 3

**Figure 43.** Parks carriage house, northern elevation.

feet apart. Above on the west wall, slightly off-center to the brick piers is an opening, approximately 3 feet 8 inches by 3 feet 8.5 inches. The opening has no hardware on the exterior, but appears to be accessible from the inside of the structure. Below the opening, the foundation bricks between the piers are badly eroded.

While no literature has been helpful in determining what this brick feature may have been, 19<sup>th</sup> century carriage house plans do make reference to a rear door used for sweeping out dust and manure. Without references to similar available features, it can only be surmised that this opening might have served the same purpose with the corbelled brick area below functioning as a storage pit for manure. The notion that the pit was used for manure storage is perhaps supported by the erosion of the bricks between the piers as the acidity of manure might have caused the damage. If this was indeed the function of

the pit, it seems strange that the doorway would not be centered over the brick piers; however, construction might have prohibited the opening from lining up directly over the area. Whatever their function, the opening and brick piers were constructed intentionally, as they are built into the brick foundation of the structure. This also indicates that they were built at the same time as the carriage house foundation.

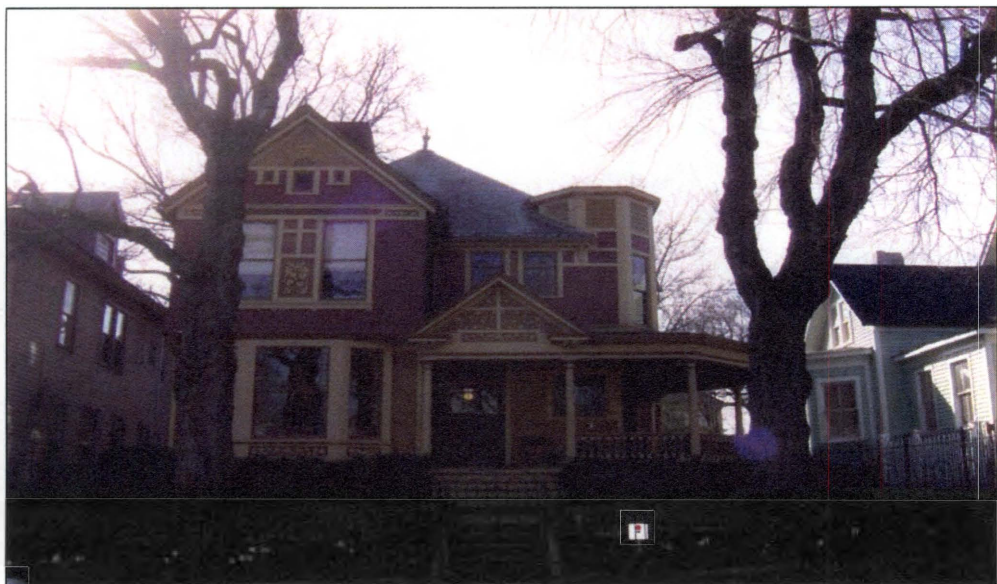
The Johnson house and carriage house are located at 911 Luttrell Avenue in the Historic Fourth and Gill neighborhood (Figure 44). Unlike the McBrearty and Parks property, the Johnson residence is not situated on a corner lot but is instead bounded on all four sides by streets and houses. Luttrell Avenue borders the house on the east, houses stand on both the north and south sides, and a dirt alley bounds the lot on the west side.

**Figure 44.** Johnson house, southern facade.

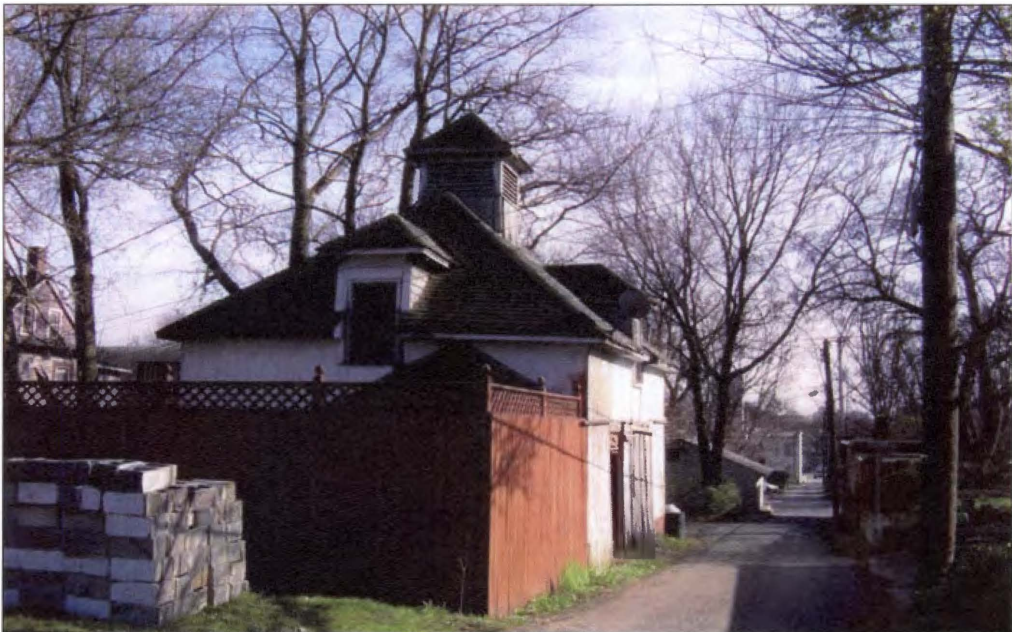
Unlike the Parks carriage house, which underwent extensive renovation in the mid-1980s, the exterior of the Johnson carriage house appears to have undergone few changes since its construction. The original sliding door and hardware still span the west wall of the structure, wooden pegged windows are found on the eastern wall of the first story, and the original cupola with iron lightening rod still perches on the top of structure's hipped roof. The absence of an addition on the northern portion of the structure, evident by triangular fading on the vertical weatherboard exterior, and the presence of a modern wooden stairway and concrete landing are perhaps the most noticeable exterior indication of change to the original carriage house.

**Figure 45.** Johnson carriage house, northwest elevation.

Similar to the Parks and McBrearty properties, the Johnson carriage house is located at the rear of the lot directly behind the dwelling. Currently, the Johnson carriage house serves as a storage shed for the house's current residents. The carriage house is approximately 30 feet by 20 feet, with the long axis of the building oriented to an adjacent alley that runs parallel to Luttrell Avenue. The exterior of the structure is well preserved and most architectural elements, such as windows and doors, remain in their

original locations (Figure 45).

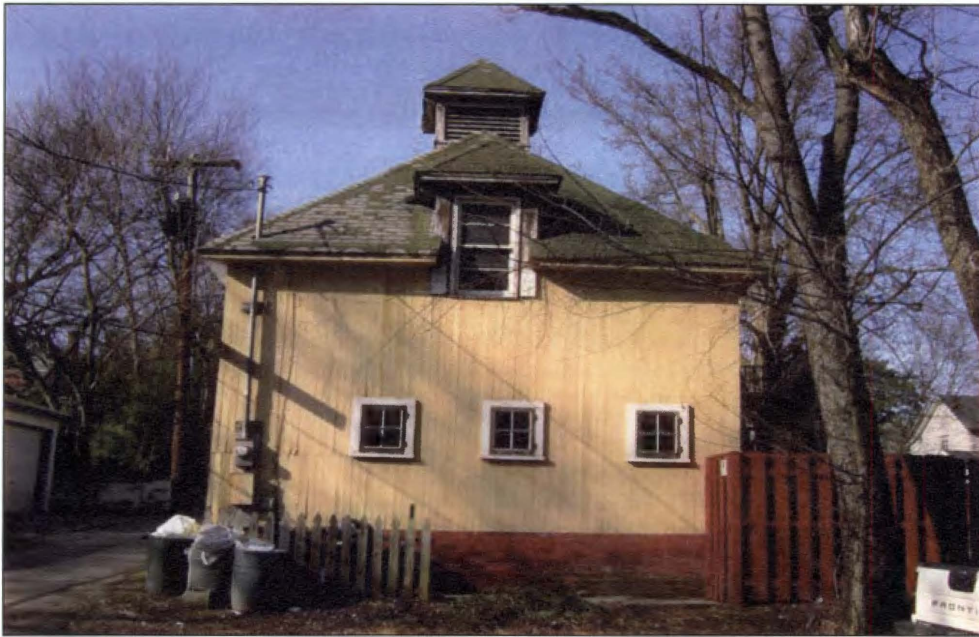
**Figure 48.** Johnson carriage house, southern elevation.

several of their drawings show horse stalls as being 6 feet wide. Similar to the Barber and Klutz plans, the barred windows are approximately 6 feet apart with 2 feet remaining on both ends of the southern wall.

When compared with 19<sup>th</sup> century combination carriage house and stable plans, the Johnson carriage house has a number of architectural similarities. Like the Parks carriage house, several architectural features suggest that the Johnson carriage house was used to house both a carriage and the horses that pulled it; however, whether the carriage house served as a temporary shelter for rented horses, or functioned as a permanent stable can only be speculated. Three small, barred windows are evenly spaced in the southern wall of the first story (Figure 48). The even spacing of these windows suggests that at least three separate stalls were present in the interior of the structure. This is further substantiated by the 1891 and 1893 Barber and Barber and Kluttz carriage house plans, as
