**Geotechnical Report for Appalachian Community Health  
and Disaster Readiness: Interprofessional Practice**

Chancellor's Honors Program Senior Thesis

The University of Tennessee, Knoxville

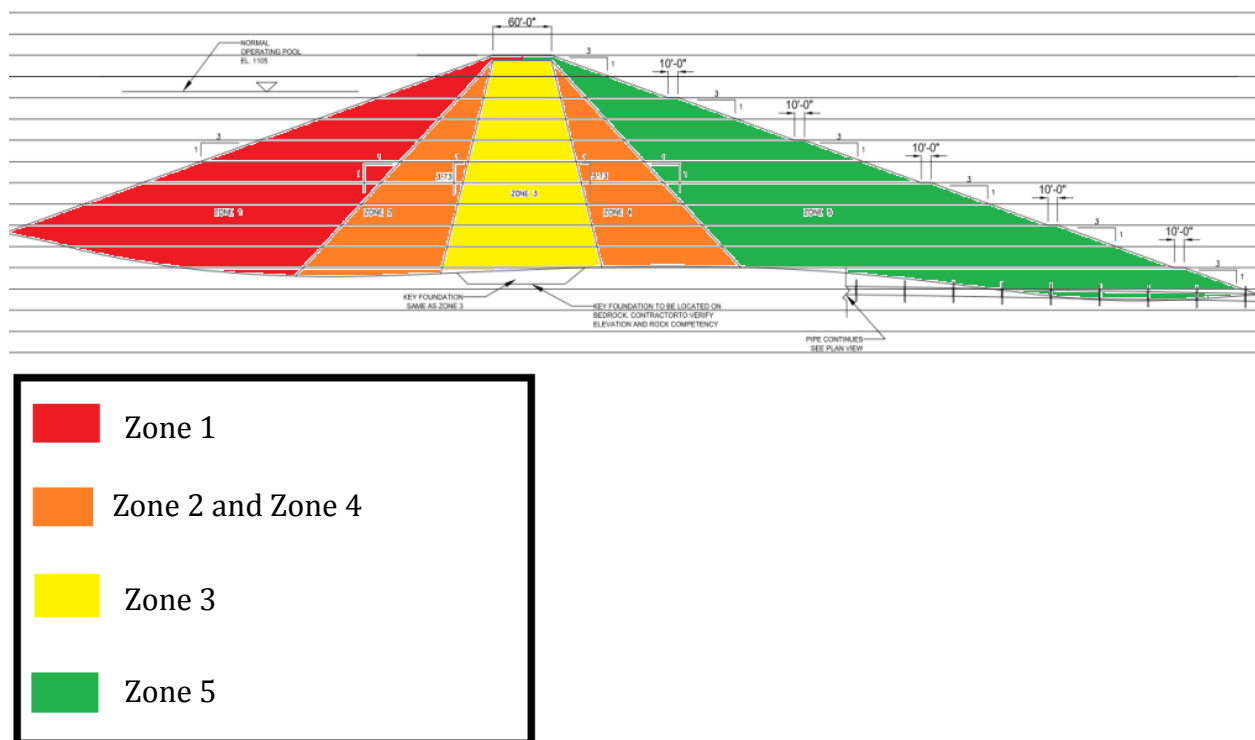
Figure 2: Material Designation Zoning for Layered Construction of Earthen Dam

Based on Trey Pippen's soil report and USGS soil maps, the soil in the area is classified as a gravelly silt-loam. Because of the lack of clay in the region and abundant rock, the dam will be a rock-fill dam. Rock-fill dams consist of a clay core and several transitioning rock layers. The dam consists of five zones found in Figure 2. The first zone is the outermost rock layer on the upstream side of the dam. The outside slope is set to 3:1 and uses a high-quality rock from a nearby quarry. Zone 2 and Zone 4 consist of intermediate-quality rock from the areas cut soil placed at a slope of 1:1. The inner clay core should consist of 80% clay and 20% sand and gravel and should be placed at a slope of 4:15. Finally, Zone 5 should be placed at 3:1 with the best quality rock from the areas cut soils.

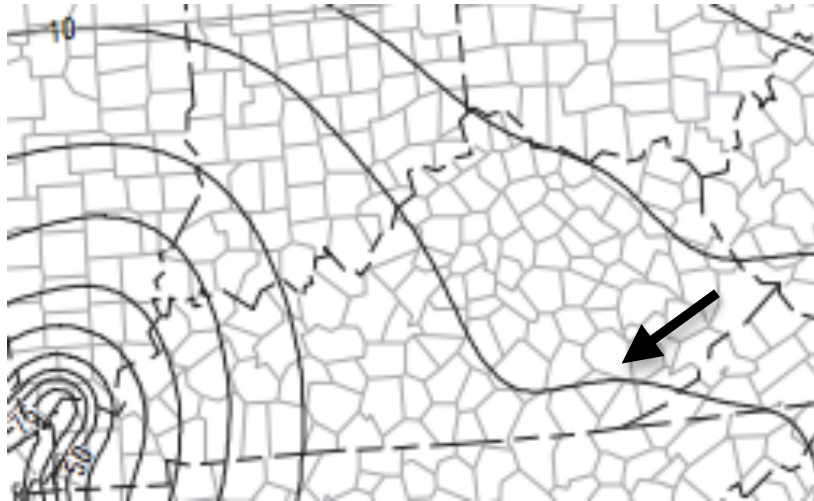
Figure 5: Seismic map indicating peak ground acceleration of Kentucky from USGS hazard design maps

Lastly, slope stability analysis was required to ensure safety during a seismic event. The earthquake analysis considers the peak ground acceleration for the area. Figure 5 is a portion of a map of the United States that illustrates seismic contours. Clay County is in the peak ground acceleration range of 10% of the acceleration of gravity associated with a 1% chance of exceedance in 50 years; however, the analysis was performed at 12% of the acceleration of gravity.
