# GIS-Based Streambank Video Mapping to Determine Erosion Susceptible Areas

A Thesis Presented for the

University of Tennessee, Knoxville

Brett Allen Connell

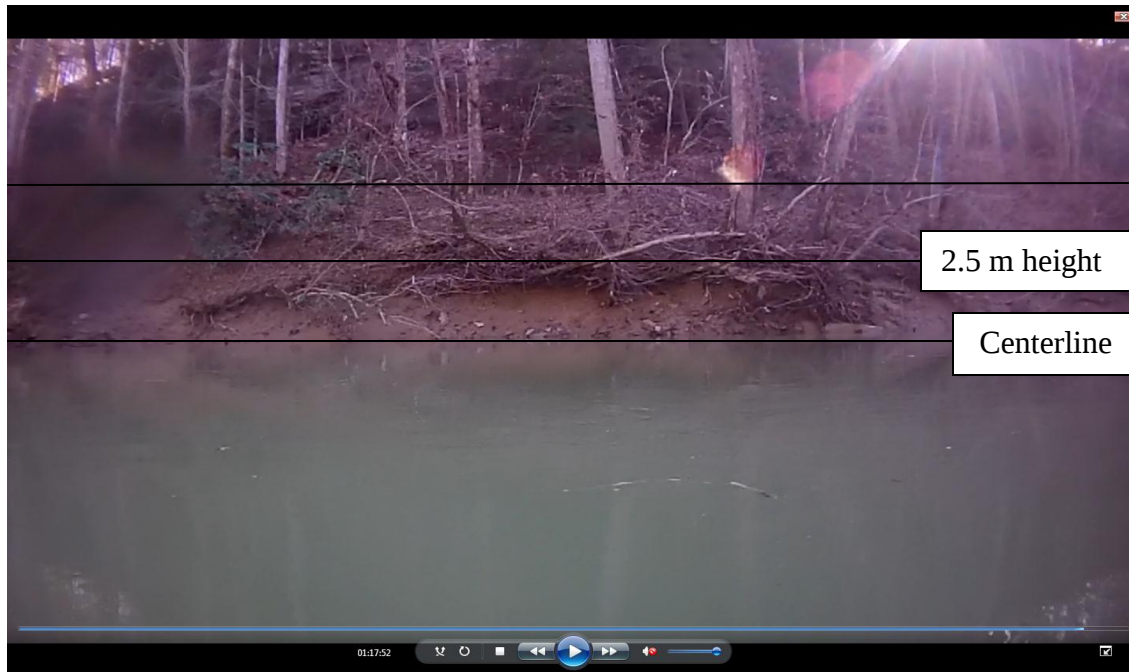
Figure 1: Photo from New River (TN) showing:

Bank Angle = 9, Bank Height = 7.5 ft, Surface Protection = 6.95, Riparian Diversity = 6.95.

Bank height to bankfull height ratio was determined by visual assessment with the calibrated lines on the screen (Figure 1, Figure 5, and Figure 6), in addition to the depth and distance data discussed in section 5.1. Distance from the streambank enabled use of the camera

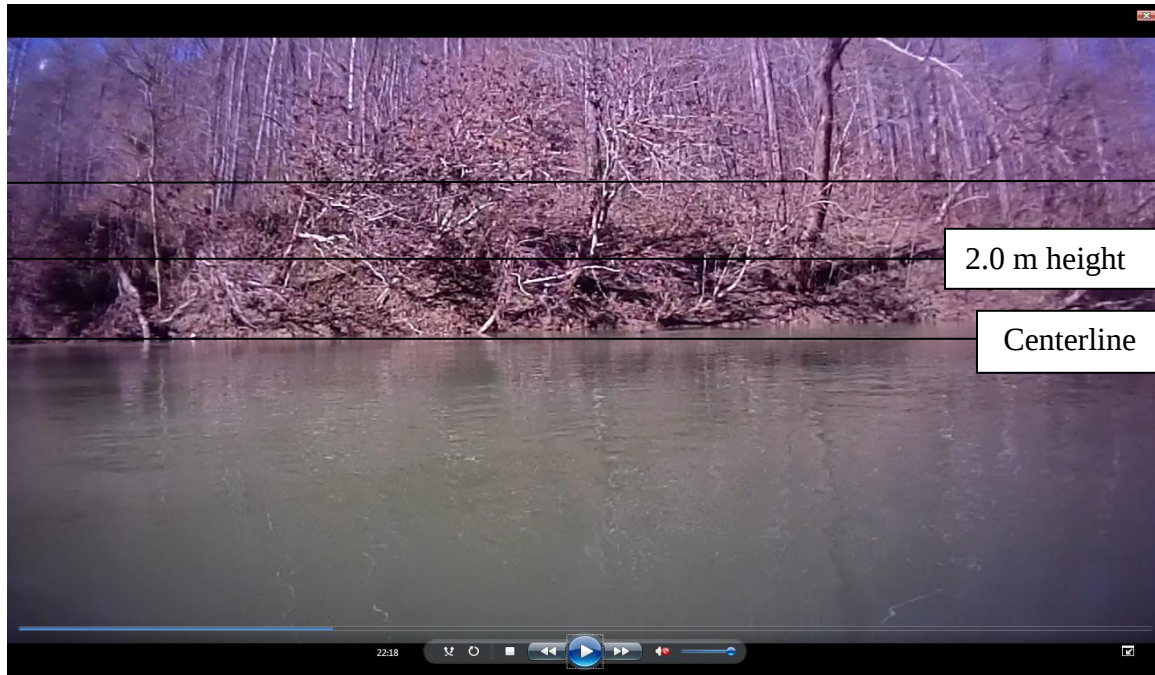
Figure 6: Photo from New River (TN) showing:  
Bank Angle = 2.45, Bank Height = 4.5 ft, Surface Protection = 2.45, Riparian Diversity = 2.45.

Root depth and root density are both part of the BEHI (Rosgen, 2001) which is impossible to detect from video. Using a substitute parameter named riparian diversity, a score was determined that reflects a similar score produced in the BEHI. Diversity, as well as riparian width, comes into play while determining the score for this parameter. Figure 6 shows several sizes of trees and brush which made this an area of optimal riparian diversity.

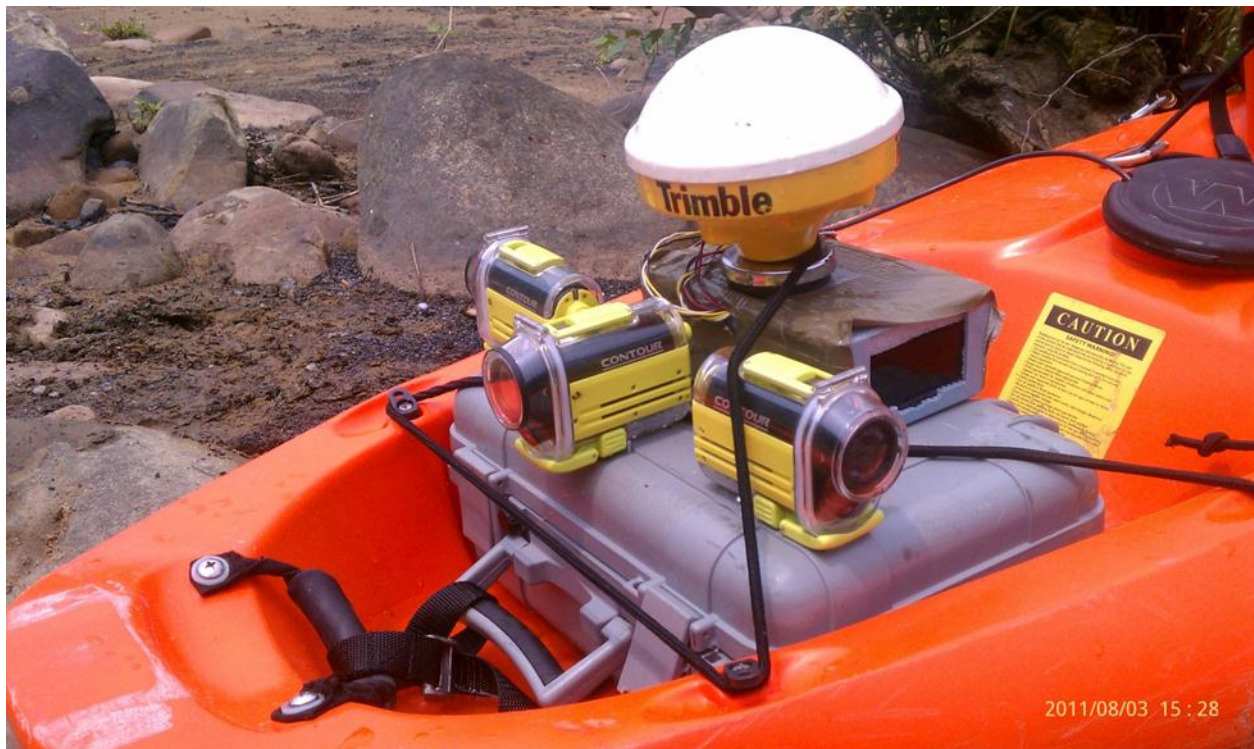
Figure 7: Streambank Video Mapping System.

The Streambank Video Mapping System (SVMS, Figure 7) consists of a Tarpon 100 sit-on-top kayak, up to three Contour GPS video cameras, a depth sensor, a NMEA multiplexer, two distance sensors, and a Trimble GPS unit. The Trimble 132 (1Hz) was used for sub meter GPS accuracy that was then recorded onto a flash drive along with two distance measurements and depth output data so that each point will have the associated Coordinated Universal Time (UTC) and location.

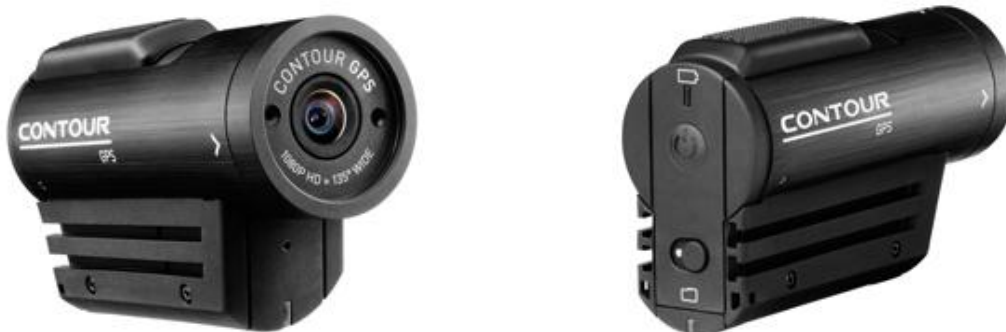
Figure 8: Contour GPS Video Camera (<http://contour.com/products/contour-gps>, accessed January, 2012).

The Contour GPS camera (Figure 8), uses the Neo-6 GPS module with three different video resolutions and two frame rates which can be used in any combination depending on the application (<http://contour.com/products/contour-gps>, accessed January, 2012). A water-proof case and a 135° wide angle lens enabled the Streambank Video Mapping System to capture continuous miles of high definition, streambank footage. The “Contour 720p” (1280 x 720 @30 fps) settings used in this project enabled us to capture up to 1 hour and 50 minutes of video before having to pull over and replace the batteries. For every 30 minutes of video, 2 GB of memory was used on a micro SD card. Depending on the length of stream being sampled, up to a 32 GB micro SD card could be used to increase storage capacity for a higher video quality and frame rate. A built-in omni-directional microphone could also be utilized if verbal field notes need to be taken when pen and paper are not available.

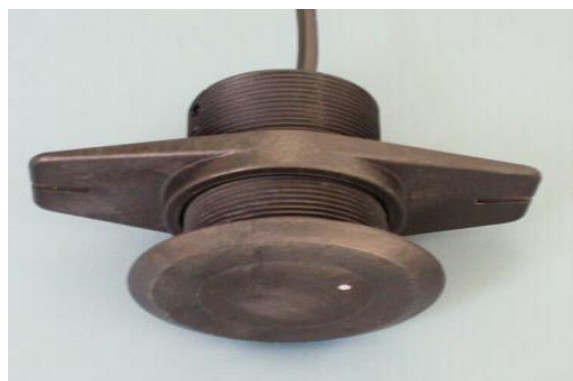
Figure 9: The Hull Mountable Depth Sonar. Cruzpro Model ATU120ST (<http://www.cruzpro.co.nz/active.html>, accessed on January 2012).

The CruzPro ATU120ST (Figure 9) shallow water depth sonar provided 3 mm resolution between bottom of stream and bottom of kayak (<http://www.cruzpro.co.nz/active.html>, accessed on January 2012). Additionally, this sonar transducer was calibrated specifically for this research, set to read a range of depth from 15 cm – 13 m (Candlish, 2010). The depth sensor provided a 1 Hz output that coincided with the Trimble output rate and presented its depth readings in NMEA 0183 data string format. Data sentences were then imported through the NMEA multiplexer (Figure 10) in the following \$SDDBT structure: \$SDDBT, 00.00, f, 00.00, M, 00.00, F\*CS. The number before ‘f’ gave depths in feet, while ‘M’ stands for meters.

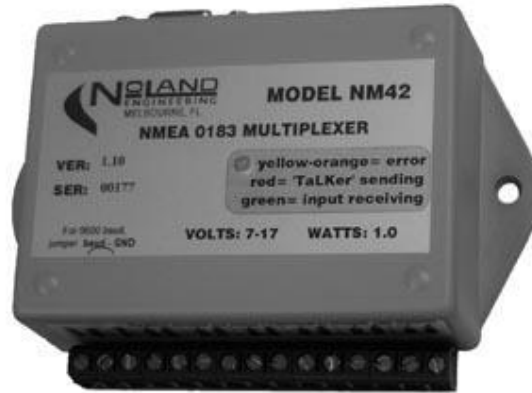
Figure 10: The NMEA 0183 multiplexer used to combine the two distance sensors, depth data and GPS data into a single data string (<http://nolandeng.com/nm42.php>, accessed January 2012).

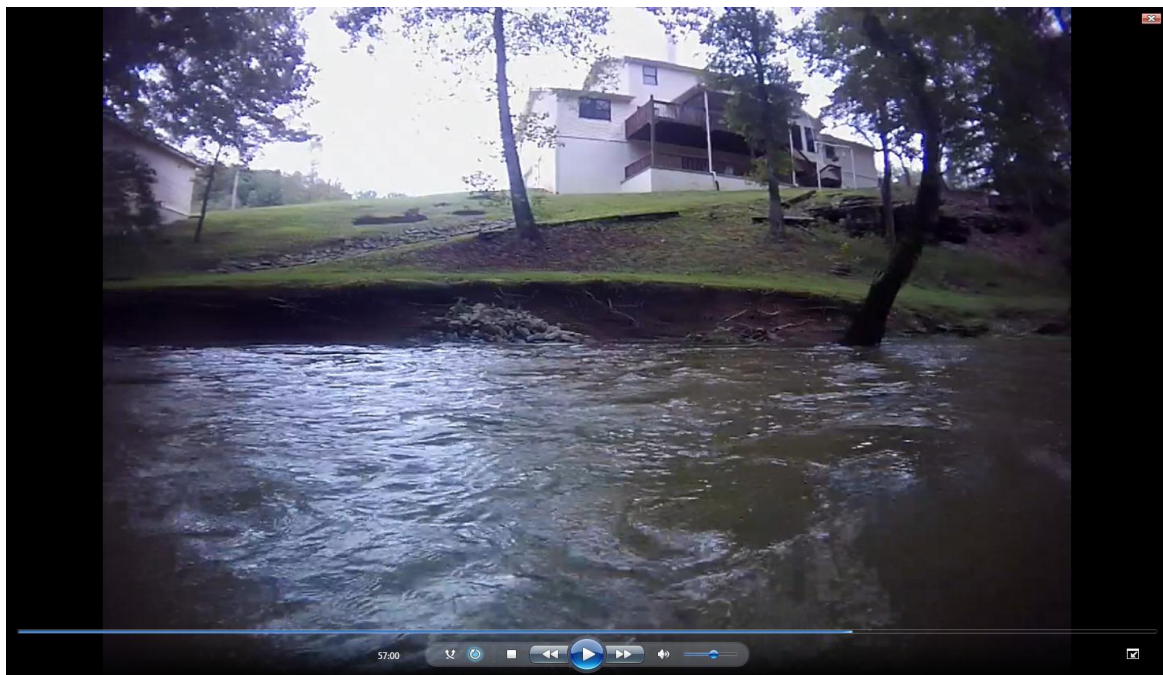
Figure 21: Beaver Creek site receiving a Bank Erosion Susceptibility Index score of 28.

The highest erosion susceptibility score for Beaver Creek circled in Figure 20, and shown in Figure 21, was two BESI score points away from reaching the very high category. The 1% portion rated high would be the areas in most need of attention and has a total length of 190 meters (Figure 22). With 81 % low, 18% moderate (Figure 23), and an average BESI score of 14, Beaver Creek received an overall low erosion susceptibility score. Figure 24 is thematically mapped with BESI scores of both the left and right streambank scores combined.

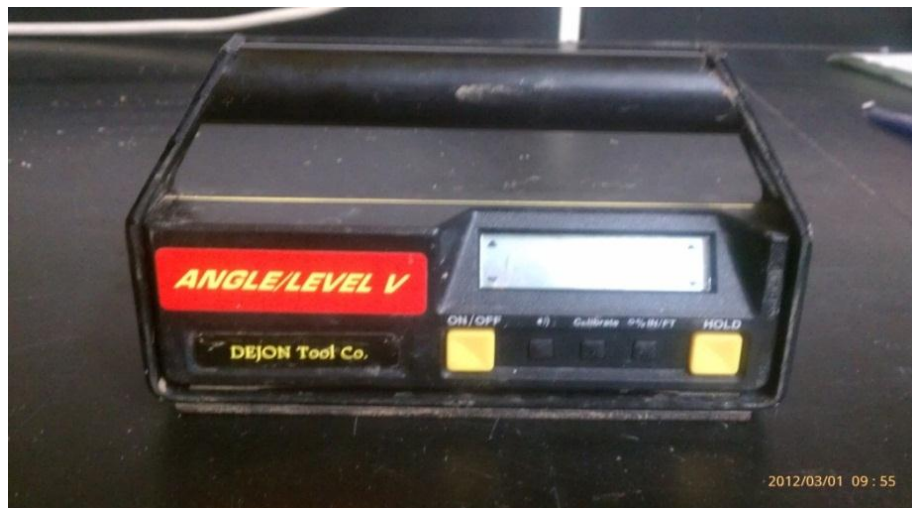
Figure 26: Inclinometer used to take bank angle measurements in the field.

To measure bank angle, an inclinometer (Figure 26) was used three times on each bank, with the average being used for the final validation score. Percent surface protection was scored using a measuring tape stretched from the water to bank height (Figure 27). That distance was

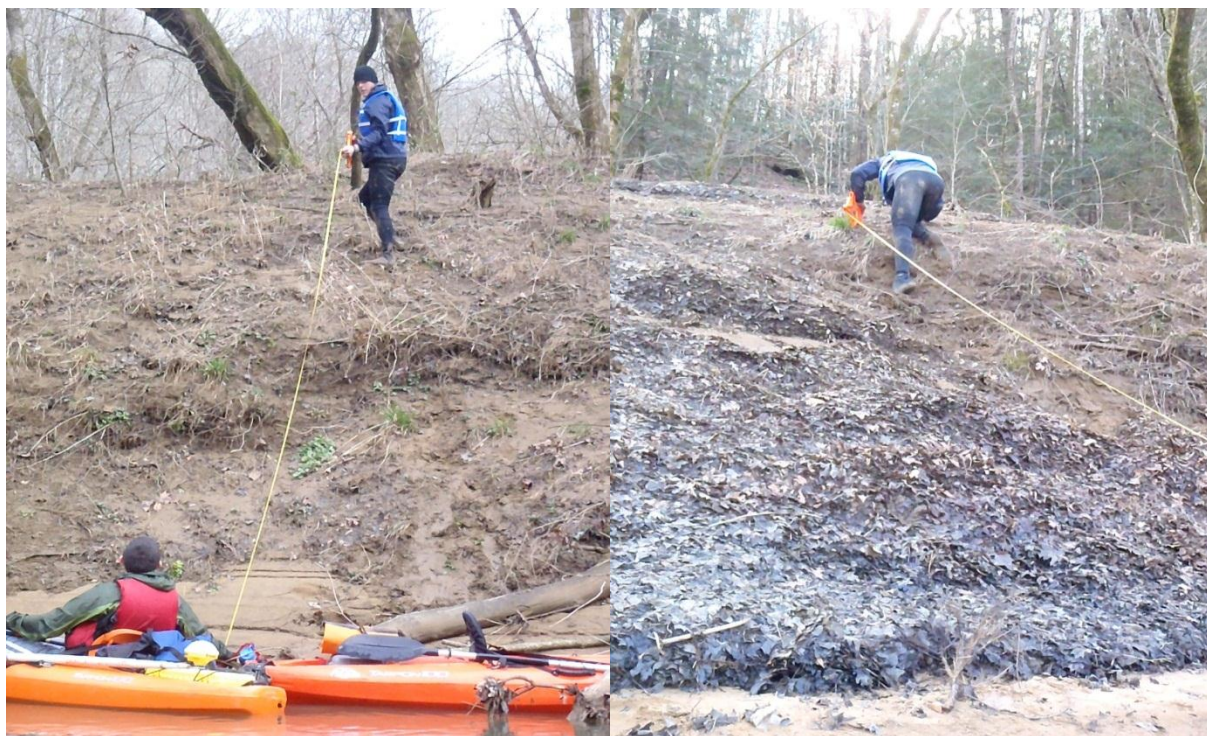
Figure 27: New River (TN) Surface Protection Field Measurements.

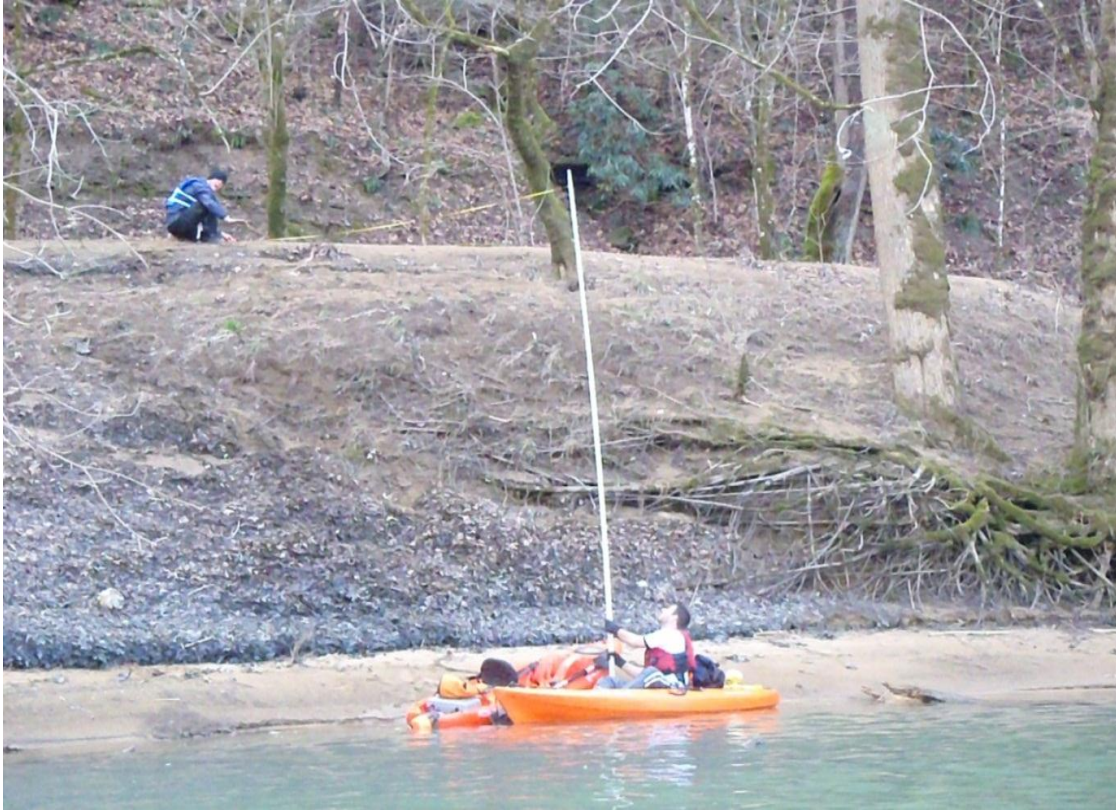
Figure 29: New River (TN) Bank Height Field Measurement.

divided by 20 to then used as the increment. Every increment received a score of either “protected” or “unprotected”, with the number of “protected” spots being multiplied by 20 for a final surface protection score. Riparian diversity was assessed by estimating the number and density of tree and plant species as well as taking the actual visible root density into consideration. Bank height was measured using a stadia rod (Figure 28), and when needed, measuring tape and a level were also used (Figure 29).

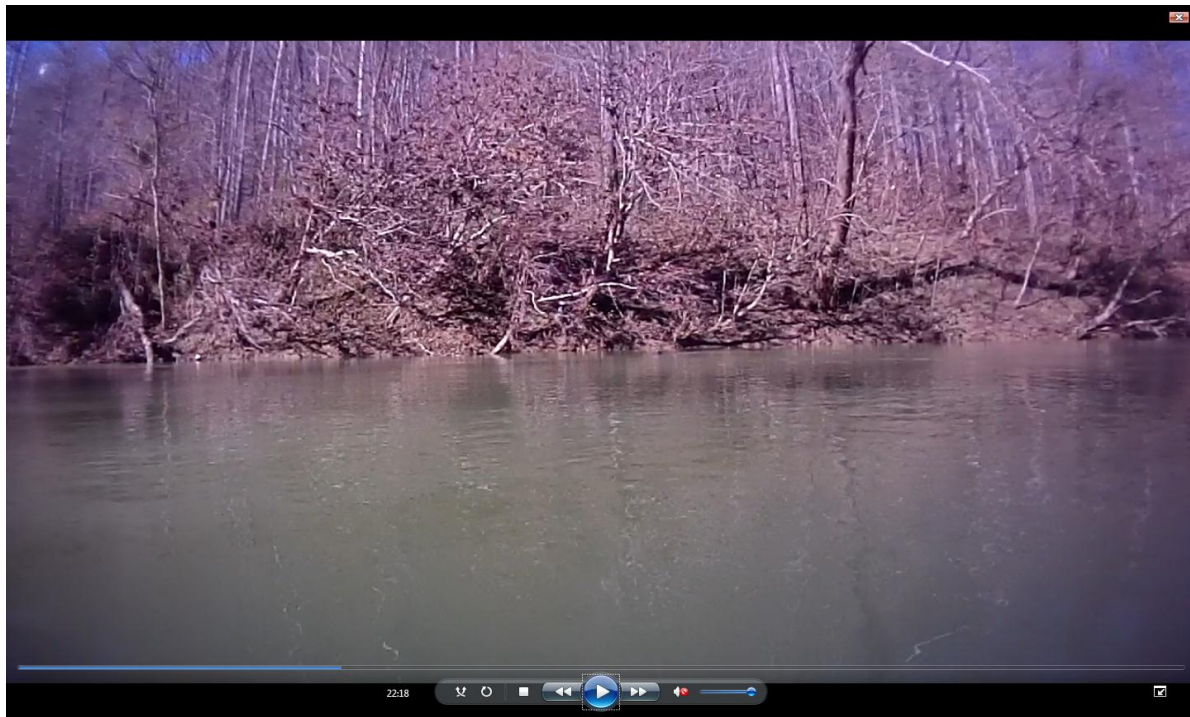
Figure 43: Bank Angle = 2.45, Bank Height = 3-6, Surface Protection = 2.45, Riparian Diversity = 2.45.

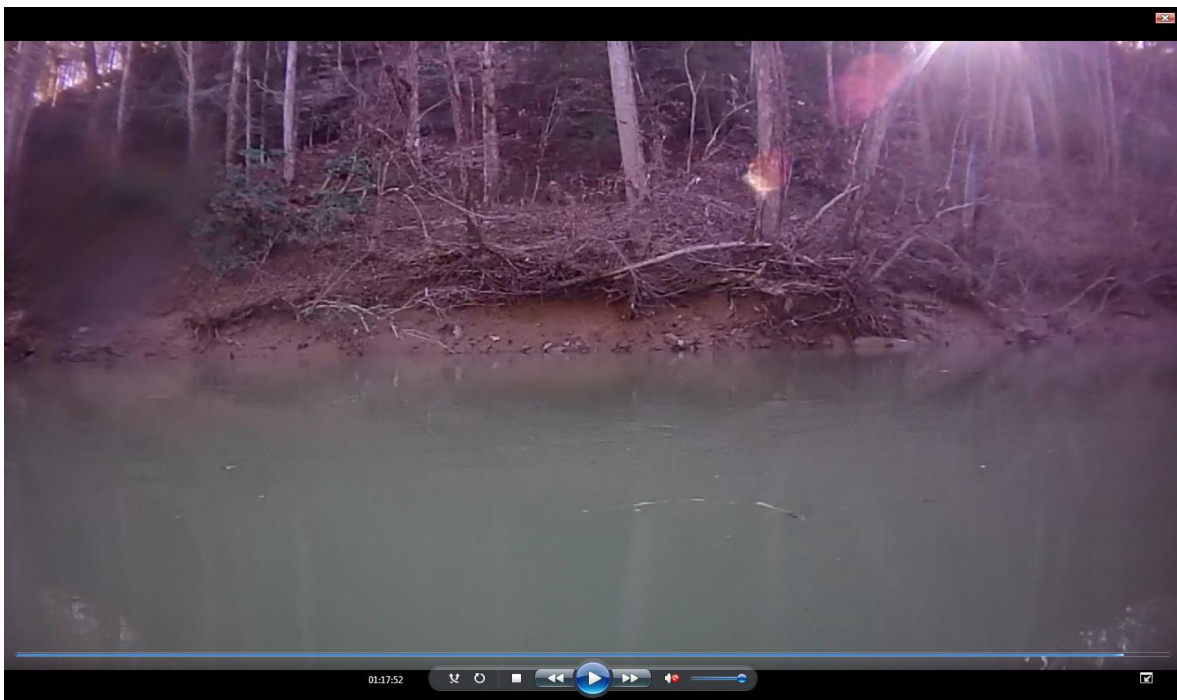
Figure 44: Bank Angle = 9, Bank Height = 6-9, Surface Protection = 6.95, Riparian Diversity = 6.95.
