Bulletin 437

# **Laboratory and Field Tests Of Pond Sealing By Chemical Treatment**

by John I. Sewell

The University of Tennessee  
Agricultural Experiment Station  
John A. Ewing, Director  
Knoxville

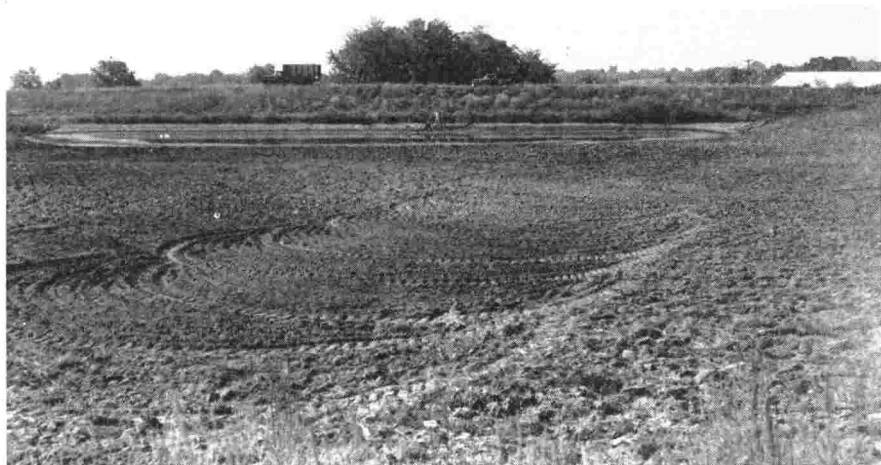
Figure 4. Pond 9 at the Middle Tennessee Experiment Station before application of a chemical.

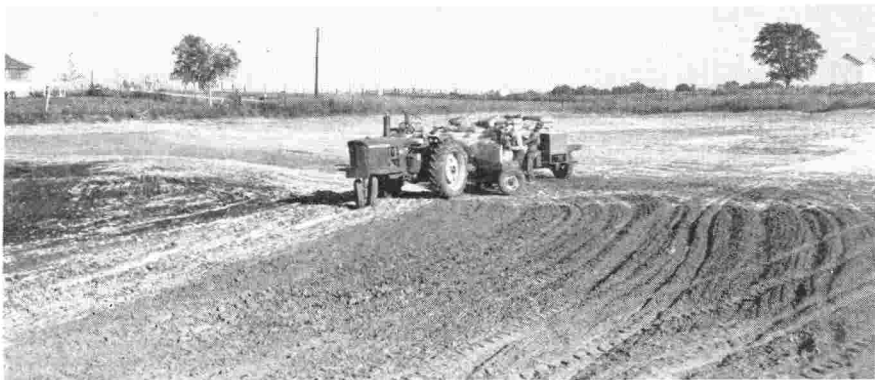
**Figure 5. Applying chemical to pond 9 at the Middle Tennessee Experiment Station in October, 1963.**

The application procedures used were similar to those of Fonner (3), except that Fonner recommends sprinkling the treated area and compacting it with a sheepfoot or rubber-tired roller. In the tests reported herein, compaction equipment was not available except for pond 2; the floor of this pond was dry enough to prepare it for chemical application; after the chemical was applied, however, the treated area rapidly became too fluid to achieve compaction.

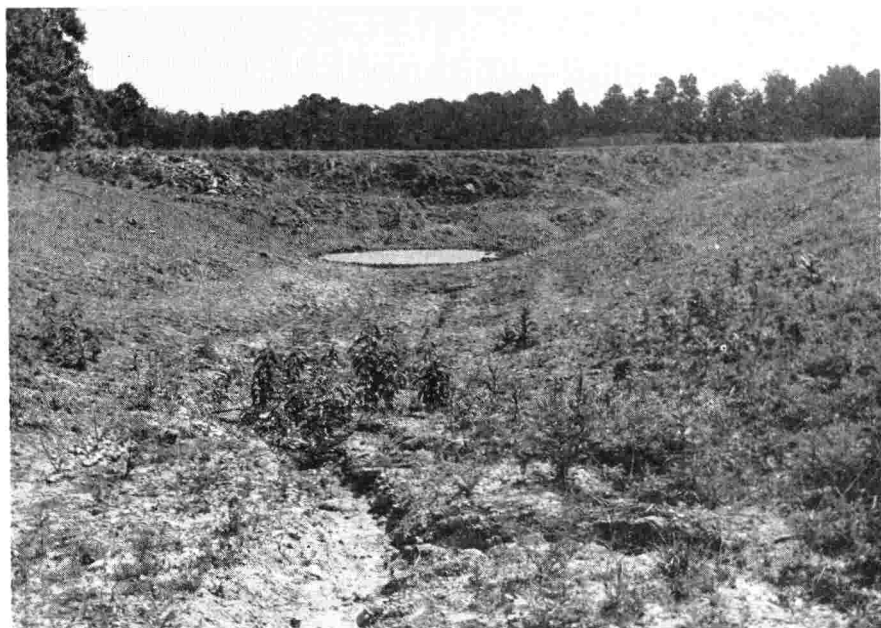
Figure 6. Pond 4 at the University of Tennessee-Atomic Energy Commission Agricultural Research Laboratory before treatment in July, 1964.

Ponds 4 and 5 had been dug for more than 1 year before treatments were applied. They held practically no water (Figure 6) before treatment. After treatment, they have held rather well (Figure 7) ; however, pond 5 has such a small watershed it catches little water during seasons of limited rainfall.

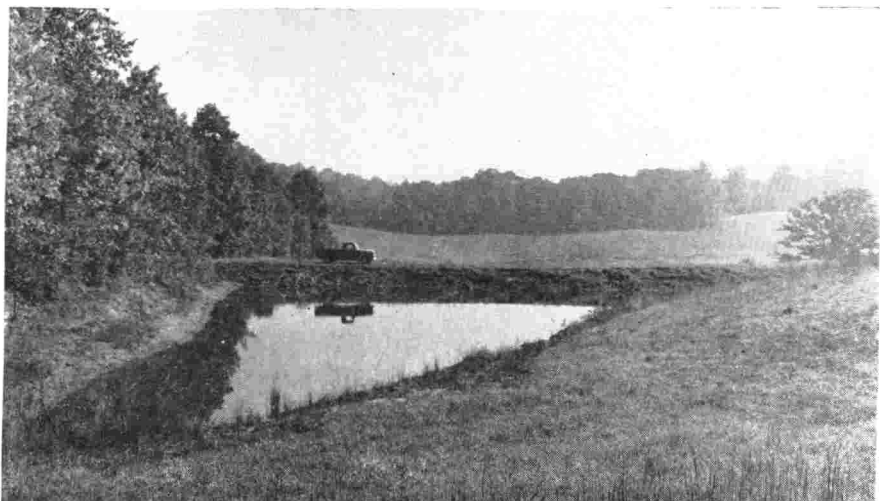
Figure 7. Water in pond 4 at the University of Tennessee-Atomic Energy Commission Agricultural Research Laboratory at a depth of 10.4 feet in October, 1967.

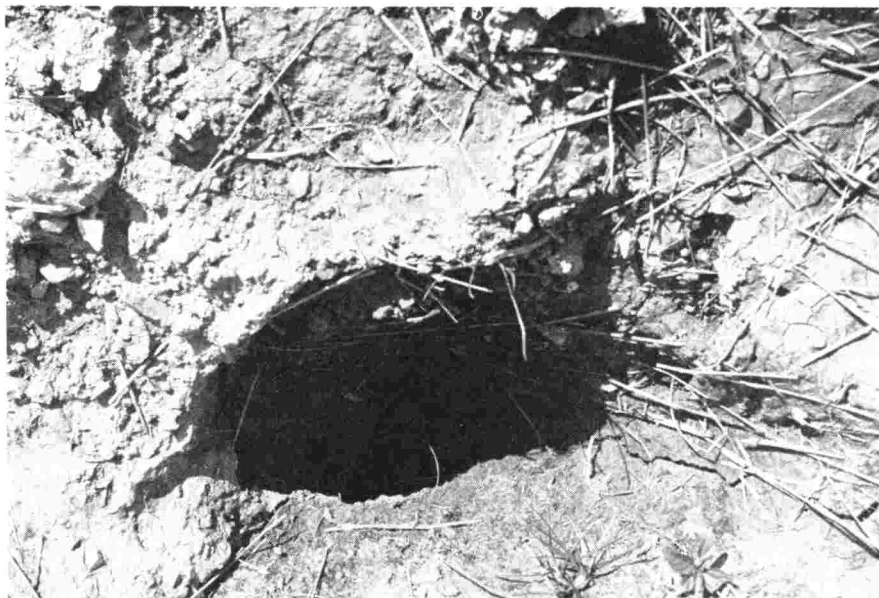
Figure 9. Leak into chert stratum in pond 6 at the University of Tennessee-Atomic Energy Commission Agricultural Research Laboratory, July, 1966.

Soon after construction, pond 6 developed leaks (Figure 9) in a chert stratum along one side of the pond at levels of about 5 feet above the bottom of the pond. In preparing the pond for treatment, the leaks on the side were blanketed with about 2 feet of fines from the bottom of the pond. After treatment, the pond developed a blowout in the bottom (Figure 10). Too much fine material had been removed from a weak portion of the bottom because the pond had withstood a head of 10.3 feet before attempt was made to repair the leaks in the side of the pond.

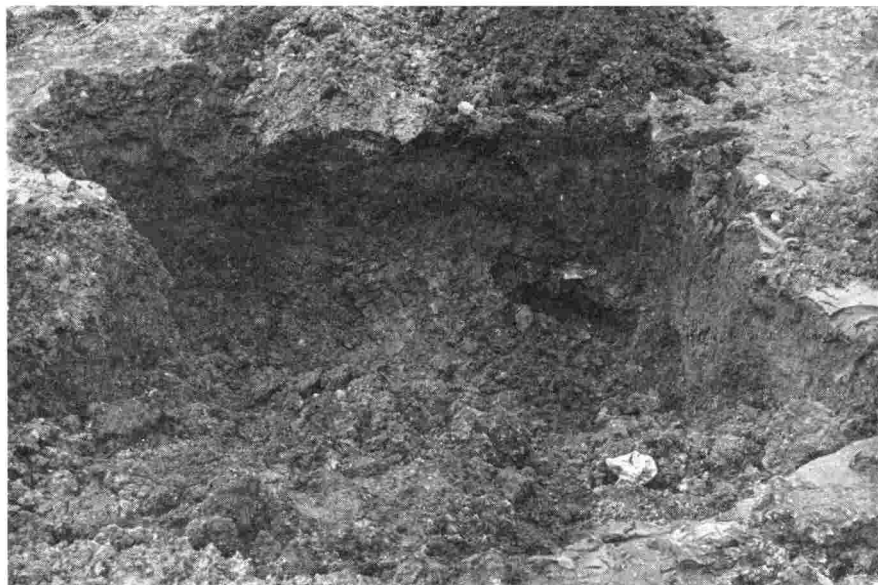
Figure 10. "Blowout" in pond 6 at the University of Tennessee-Atomic Energy Commission Agricultural Research Laboratory, November, 1966. The leaking area was excavated with a backhoe. Note the leakage cavity in the right rear of the excavated hole.

In June, 1967 about 600 cubic yards of clay fill material were hauled to pond 6, and it was spread and compacted with a bulldozer. The weak area was blanketed with about  $1\frac{1}{2}$  feet, and the remaining portion of the pond up to a depth of about  $5\frac{1}{2}$  feet was blanketed with  $\frac{1}{2}$ -foot of fill material. The pond has since withstood a head of 14 feet in a severe storm without developing a blowout in the blanketed area. The blanket was treated with  $\text{Na}_2\text{CO}_3$  at 5 tons per acre. The pond still leaks above the blanketed level; however, the water level has not been below 5.0 feet since 10 days after the pond was repaired.
