# Wastewater Treatment Improvements

## RUSH STRONG ELEMENTARY SCHOOL

SENIOR DESIGN COURSE CE 400 | UNIVERSITY OF TENNESSEE – KNOXVILLE | 4/28/17

# **WASTEWATER TREATMENT IMPROVEMENTS**

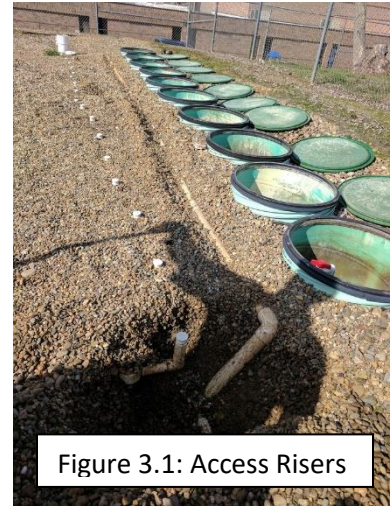
Figure 3.1: Access Risers

There are no engineered as-built drawings for the system; however, after numerous visual inspections the system's configuration has been determined. The existing conditions can be split into two separate categories: the physical system and the treatment system. The physical system begins where influent passes through a system of three septic tanks. The influent then flows into a dosage tank where the wastewater is pumped to a 1680 ft<sup>2</sup> sand filtration bed. The influent flow enters the recirculating sand filter system through a series of 10 PVC access risers, presented in Figure 3.1 to the right. The flow is equally distributed through each riser and is settled down into the recirculation chamber at the bottom of the filter system. From here, the influent flows to the pump tanks, and is then pumped to a six-way hydrotek valve that distributes the influent to each lateral; this flow process can be seen in Figure 3.2 below.

The team and the professionals involved also determined that risers should be implemented on the septic tanks to avoid excavation each time they need to be accessed. This would ease the maintenance of the septic system and would reduce the overall cost of maintenance.

From the recommended design, a portion of the improvements are intended to be updated through operation and maintenance. First, installing above-ground access to the septic tanks is recommended so that the operator can monitor the solids level. The operator needs to monitor

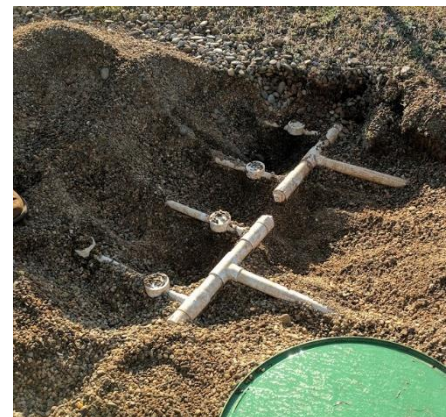
This physical system is made up of 12 zones and two hydrotek valves, where each valve serves 6 zones and each zone has 2 laterals (Figure 3.3). Once filtered through the bed, the treated flow collects in the underdrains to eventually discharge to the disinfection shed. The hydrotek valve that doses zones 6-12 is connected to both the primary and the final filter bed. The primary filter bed is made up of zones 1-9, while the final filter bed is the portion of the bed that discharges the treated wastewater and is made up of zones 10-12. One pipe from the hydrotek valve that doses zones 6-12 carries filtered water back to the septic tanks as water is divided into a 1:12 ratio for which the smaller quantity is sent back to the septic tanks. This recirculation line was installed recently to provide an amount of recirculation that was not being provided before. Before this installation, there was no recirculation occurring, which defeats the purpose of a RSF. Although this improvement has helped the system, a higher recirculation rate would be more effective in helping the effluent come into compliance. When the hydrotek valve distributes flow to the final filter bed, the treated flow is collected and sent to a tank under the UV disinfection shed. After disinfection, the effluent is discharged into Crowder Branch Stream.
